Classification of the Juturnaíba Dam: Potential Risk and Damage

Monica de Aquino Galeano da Hora Rocha, Manoel Isidro de Miranda Neto

Master's Program in Civil Defense and Security, Fluminense Federal University, Niteroi, Rio de Janeiro, Brazil

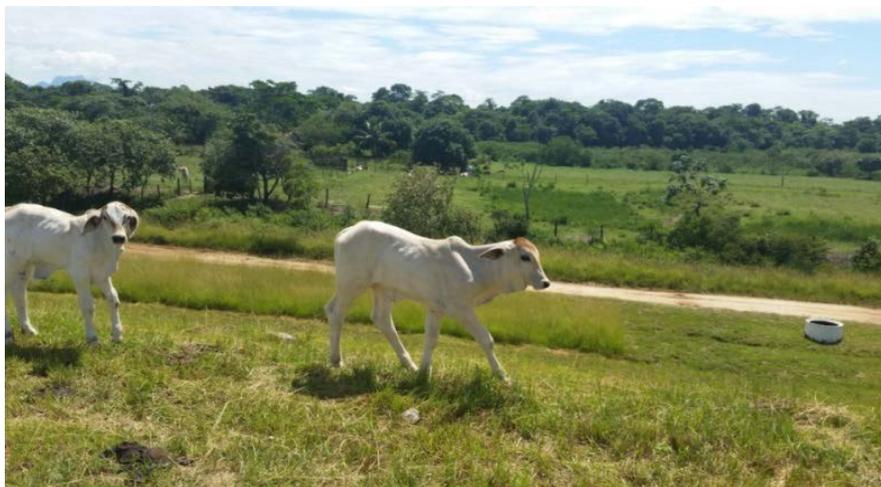
some near the foot of the dam and others in the downstream embankment. Some of the covers in these inspection wells were found to be damaged by rust, while others did not have covers. Given the dangerous conditions, it was not possible to inspect the interior of the wells, **Figure 4**.

Figure 4. Cattle circulating freely on the crest of the dam near an inspection well without a cover [26].

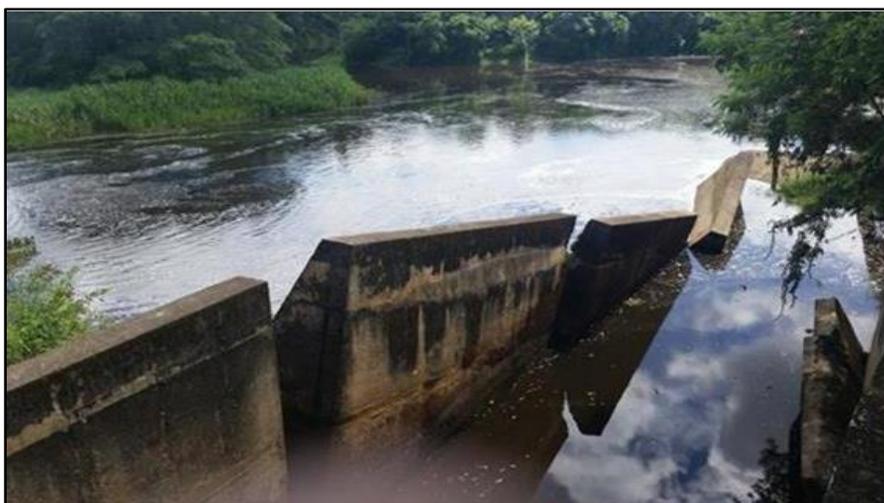
The hydraulic structures on the right side of the spillway are damaged, as shown in **Figure 5**. The structure of the restitution channel on the right side had collapsed; broken concrete blocks were visible. Vegetation was also found where the complementary channel should be. In addition, four sluices were found to be closed by their respective floodgates; however, water still flowed downstream, indicating poor sealing.

Figure 5. Broken concrete structure on the right side of the spillway [26].

Conducting interventions on degraded concrete structures and recovering or installing instruments to monitor the stability of the earth dam are also recommended.

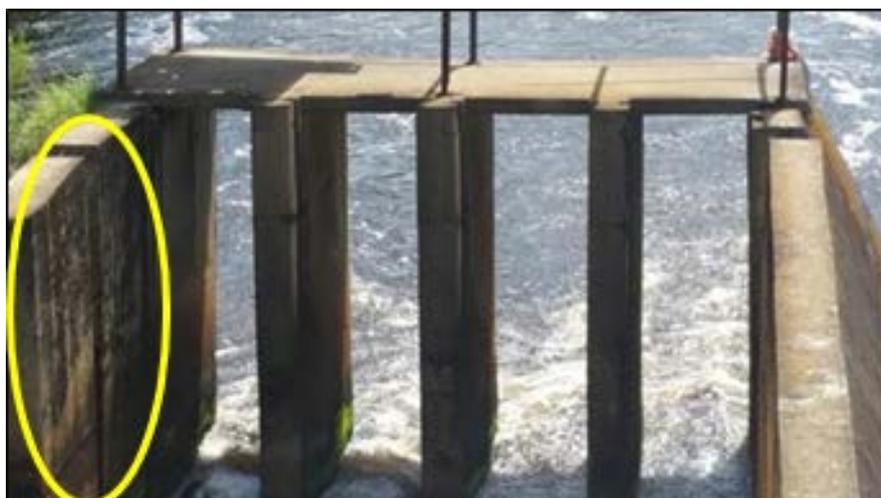
The walls of the restitution channel on the left side of the spillway were also found to be collapsed, as shown in **Figure 6** and **Figure 7**.

Figure 6. Downstream view of the restitution channel on the left side of the spillway [26].

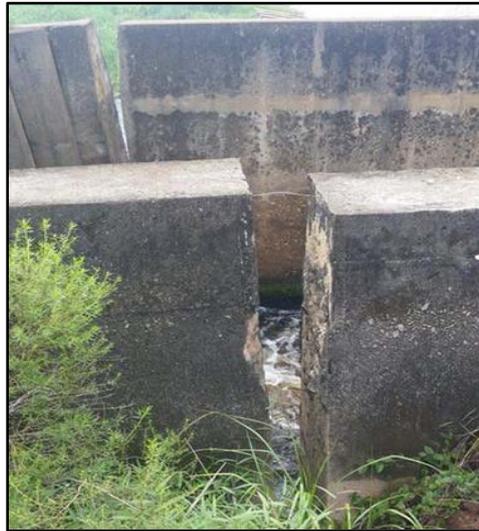
Figure 7. Detail of the rupture of the restitution channel on the left side of the spillway [26].

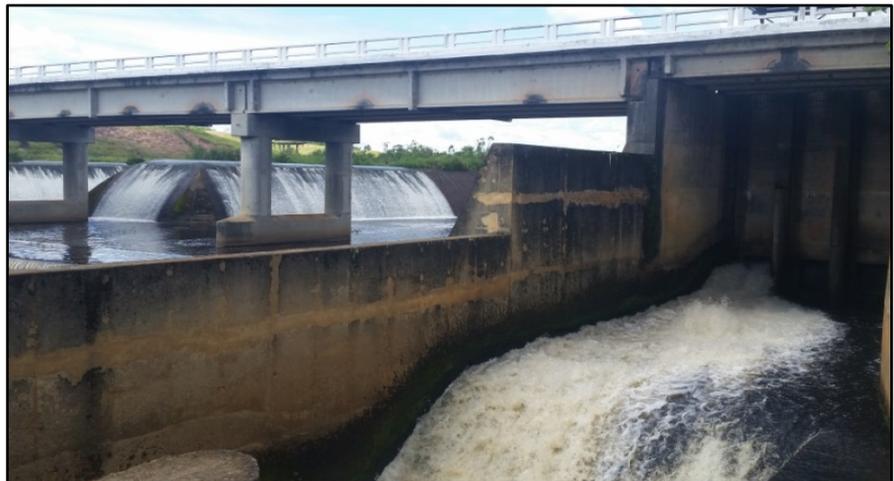
The structure was also found to be collapsing downstream of the dam. A large concrete block has already broken off and is now in the São João River just downstream of the spillway. If there is no adequate restoration of the structure, there will probably be a final separation of this main channel from the dam body and damage to the complementary structure for the irrigation channels. Another important observation is that only the left-side floodgates are in operation. During the visit, water flowing through the rightmost floodgate was observed, as shown in **Figure 8**.

Figure 8. Rightmost floodgate of the left side with spillway detail in the background [26].

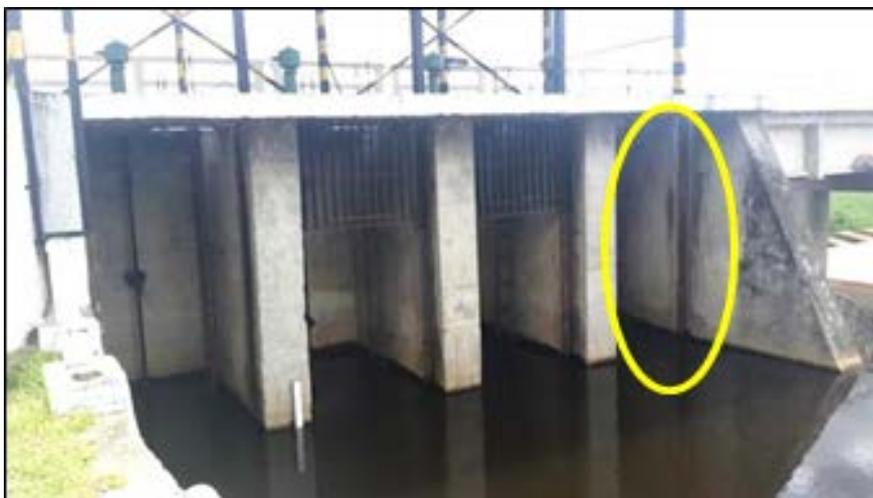
It was also found that 3 of the 4 sluices were closed with their respective floodgates and that only two protection grids were present to guard against floating material on the upstream wall, as shown in **Figure 9**. The operating sluice did not have a protection grid (detail).

Figure 9. Detail for the grid of the upstream wall of the left side of the spillway [26].

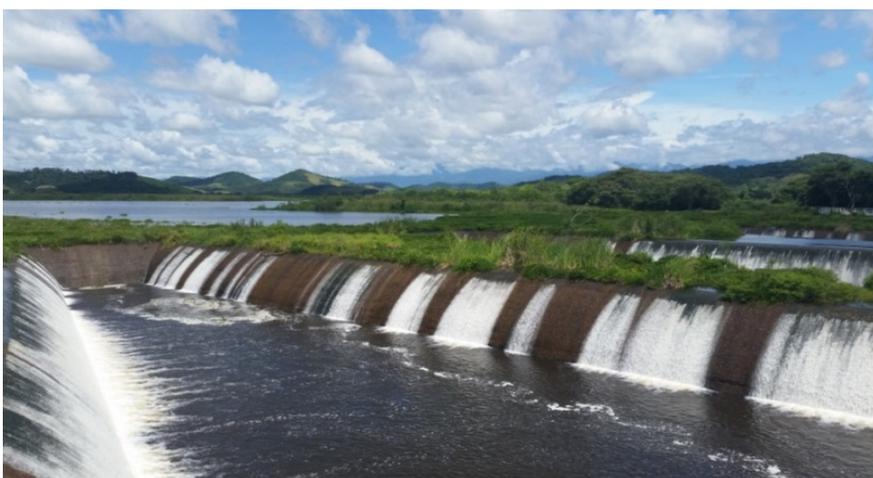
The presence of vegetation was also observed in the spillway, indicative of the relevant siltation and sediment accumulation process in the reservoir, as well as the lack of maintenance of the hydraulic structures of the dam, as shown in **Figure 10**.

Figure 10. Presence of vegetation above the spillway [26].

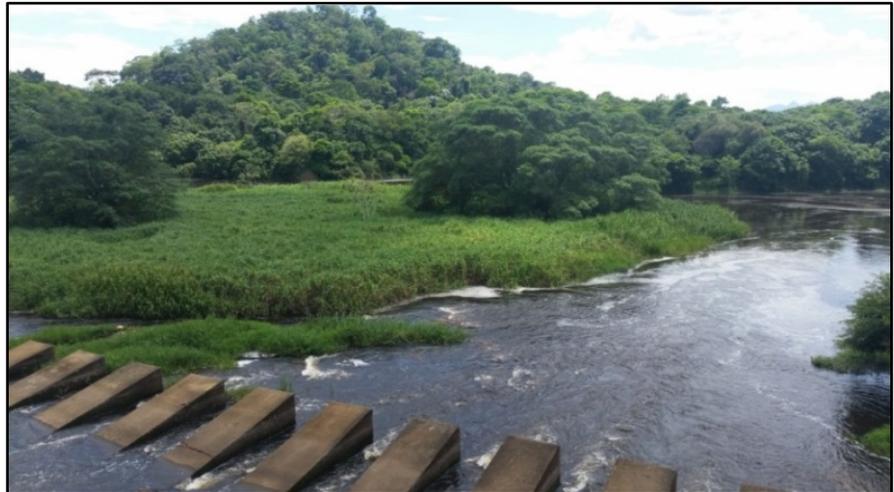
Downstream of the spillway there are two sediment islands that have large amounts of vegetation, as shown **Figure 11**. These islands were probably formed by the sedimentation of the São João River banks and the transport of sediments and vegetation through the spillway.

Figure 11. Islands of sediments downstream and close to the hydraulic structures of the dam [26].
