Mechanism of Haibat Sultan Mountain Landslide in Koya, North Iraq

Abstract

On the 11th of November 2015, a landslide had occurred after a heavy rainfall along Koya - Dukan main road, north Iraq, Kurdistan Region, and it will be called Koya Landslide in the current study. The sliding had happened due to daylight slope, which was formed after the road cut. The main road was blocked by the slid mass for overnight.

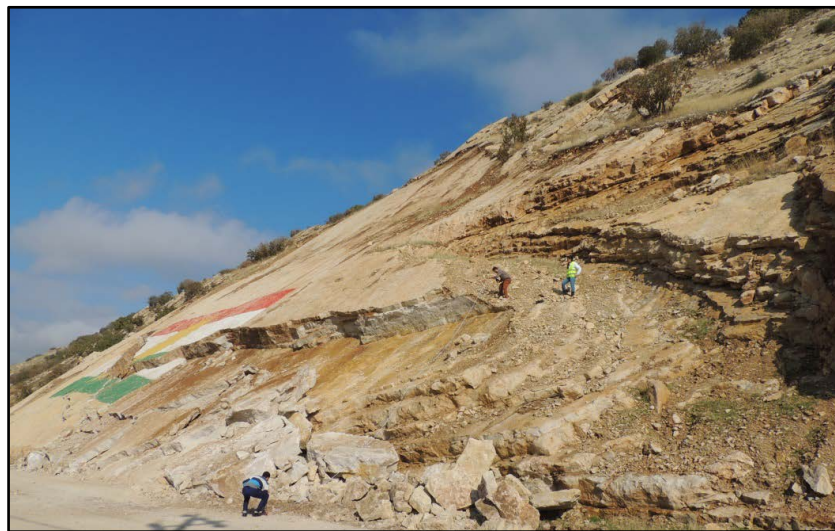
At the night of 11th of November 2015 a landslide (**Figure 2**) had occurred after a heavy rainfall that lasted for about 20 hours along Koya - Dukan main road that was constructed in 1976 but was widened many times leaving steep daylight slopes along the road (**Figure 3**).

Figure 2. General view of Koya Landslide (the slid mass is removed).

The length of Koya Landslide area; along the road is 90 m with height of 40 m forming almost a parallelogram shape (Figure 2); the thickness of the slid beds is about 2.5 m (Figure 4). The estimated volume of the slid mass is about 9000 m³.

Koya Landslide is a rock bedding slide that had happened along the bedding plane of the well bedded carbonates of the PilaSpi Formation (Figures 2-4). Two and locally three bedding planes are acted as sliding plain.

- 2) Decreasing the slope of the daylight slopes initiated by haphazard cutting of the slope during widening of the road.
- 3) Bolting and anchoring the massive carbonate beds (**Figures 2-5**). After performing special study to choose the proper length of the anchors and/ or bolts, intensity of the anchoring; including the distance between them, angle of the anchoring and location of the anchors [12].
- 4) Increasing the vegetation on the upper limits of the landslide area and near surroundings.
- 5) Construction of relevant concrete protection wall [10].

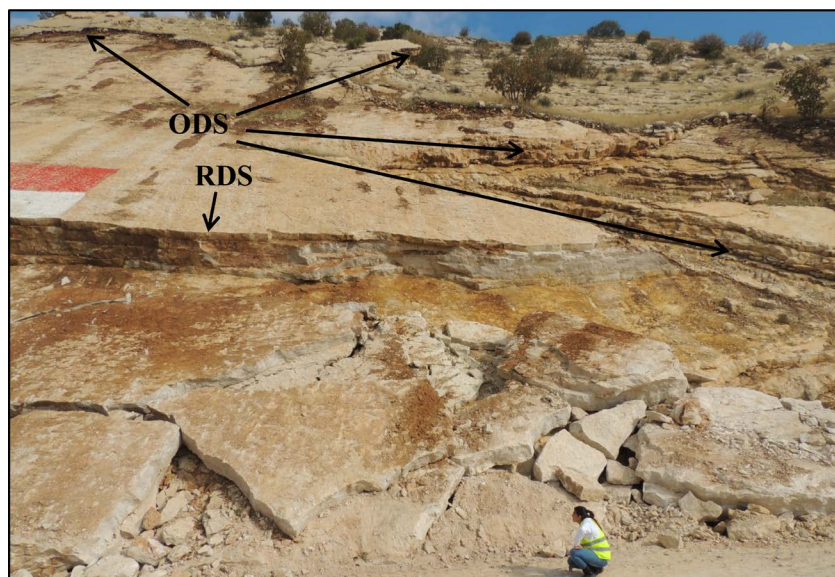
Figure 3. Part of Koya Landslide, note the old daylight slopes (ODS) formed due to the road cut and the recently formed daylight slope (RDS) due to the landslide.

The shear plane of Koya Landslide is very clear (Figures 3-5); since the landslide is of a plane slide type. The

shearing traces are very clear along the bedding planes of the slid mass as vertical grooves formed parallel to the dip direction, which is the same of sliding direction.

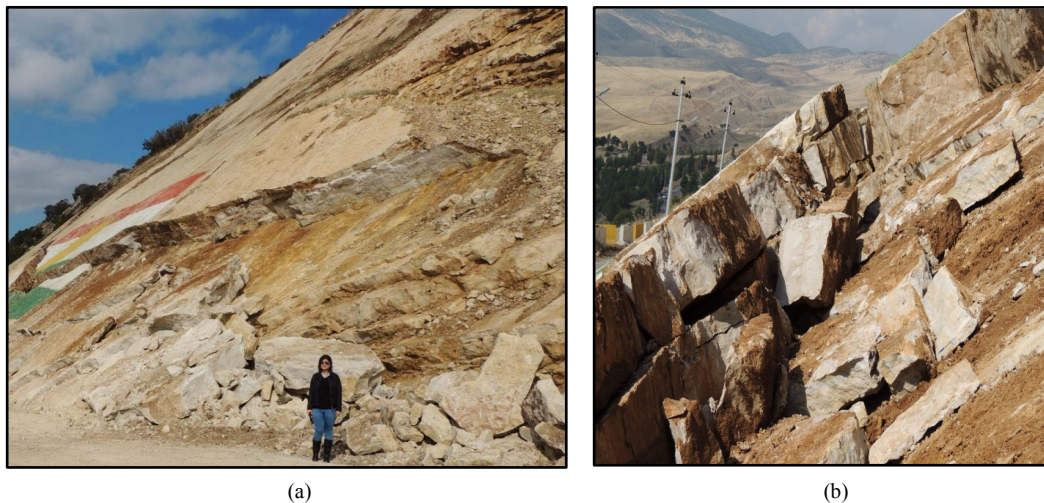
Figure 4. Koya Landslide, (a) Recently formed daylight slope and thickness of the slid blocks, (b) Thickness of the slid blocks.

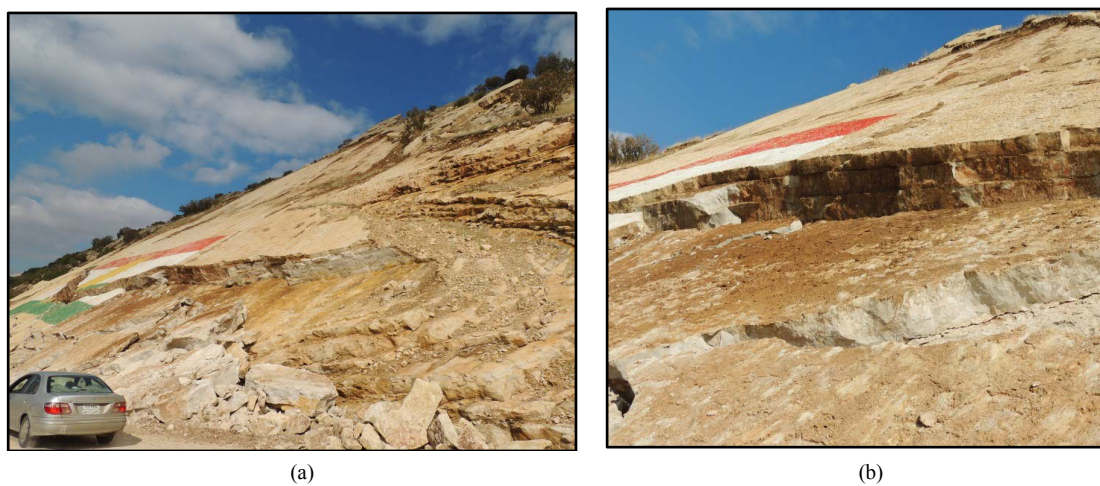
The crown area of Koya Landslide has not a continuous arch form (Figure 5) as it is usually in landslides [8]. This is attributed to the presence of old daylight slopes that have previously acted as crown area; therefore, the crown of the recent landslide is almost joined with the old forming irregular cliff of the crown area.

Figure 5. Koya Landslide, (a) The crown area, note the presence of a crown of an old landslide, (b) Details of the shear plane.

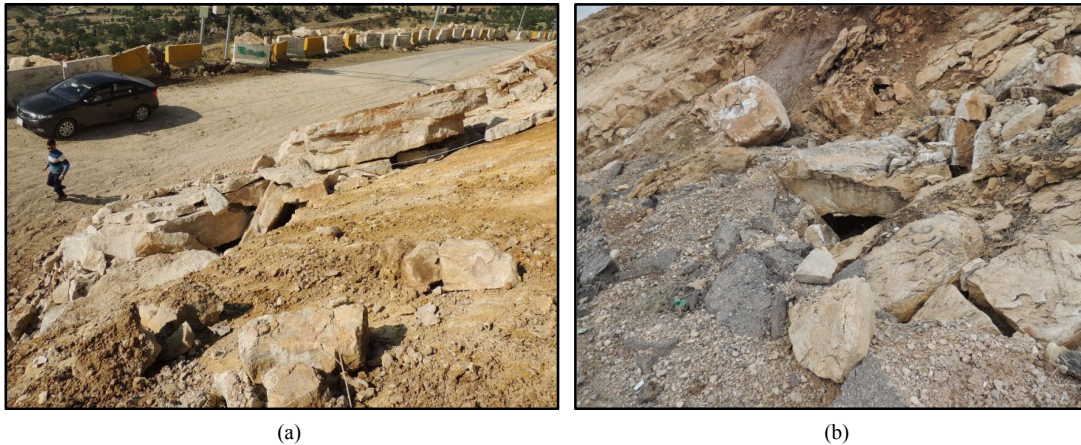
The toe area of Koya Landslide was removed in the second day of the sliding; since it was blocked the main road between Koisanjaq and Dukan towns. It was in form of accumulated blocks on the paved road (**Figure 6(a)**), locally mixed with blocks of the paved road that was damaged and cracked into blocks due to the sliding (**Figure 6(b)**).

Figure 6. Toe area of Koya Landslide, (a) The remains of the toe area, (b) Blocks of the toe area impregnated in the paved road.

The height difference between the crown area and the toe area is only 40 m; therefore, the landslide area is a small one. This is attributed to the fact that the bedding plane along which the slide has occurred; terminates just with the paved road (**Figure 6**), which has played the role of retarding the downslope forces and the speed, because the beds were excavated during the road cut and the flat area on top of which the road was constructed has played as a supporter to the slid mass (**Figure 11(b)**).

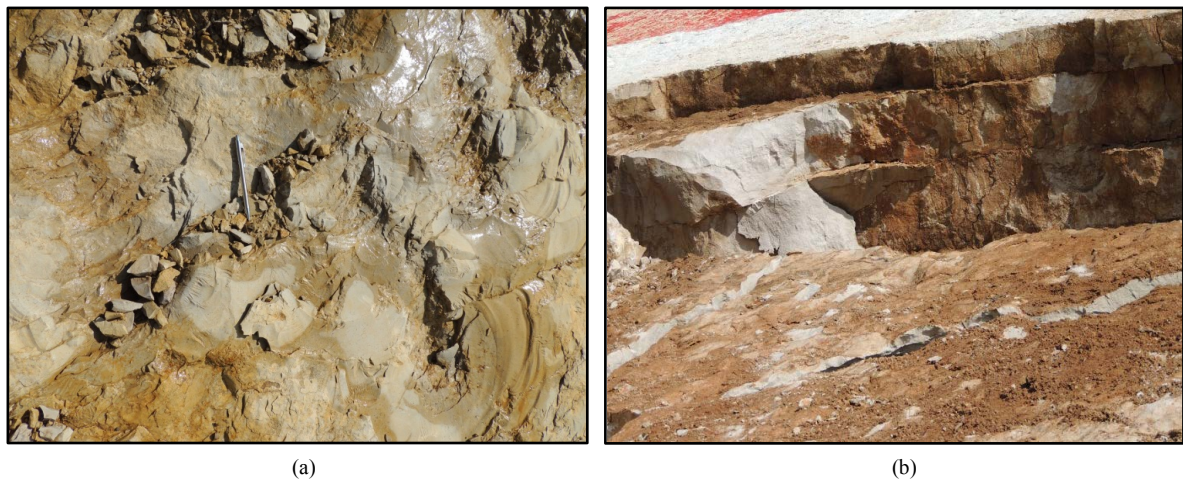
Among these causes are the presences of well bedded carbonates encountered rarely with marl horizons (**Figure 7(a)**) and weathered materials in form of reddish brown clayey soil that was filling the cracks and opened bedding planes (**Figure 7(b)**). Moreover, the presence of joints, well bedded; locally thinly bedding planes and fractures, all have acted as weakness zones, besides being good passage for the rain water in between the bed-

Figure 7. (a) Olive green marl encountered with the well bedded carbonates of the PilaSpi Formation, (b) Reddish brown clayey soil filling the cracks, bedding planes, fissured. Contrast in permeability and/or stiffness of materials.

The presence of clayey materials in between the open joint and bedding planes, and previously existing fractures (**Figure 7(b)** and **Figure 11(b)**), has accelerated the sliding and formed a slippery plain. The reddish

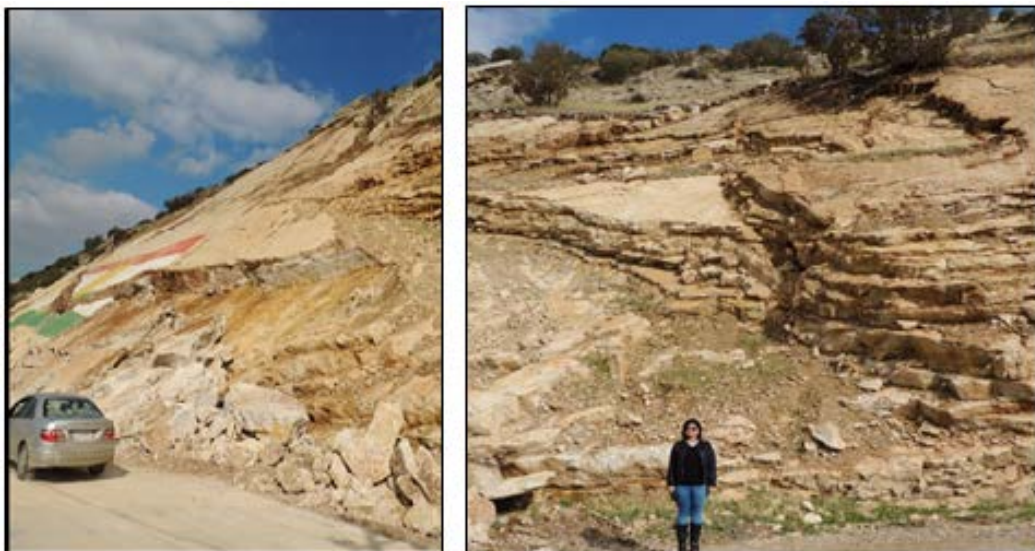
Among the human causes, the excavation and blasting of the rocks during widening of the road had formed fishers and cracks in the well bedded carbonates of the PilaSpi Formation (**Figure 8**). Moreover, the slide area and near surroundings are free of natural vegetation, whereas, there are dense trees and shrubs in the upper part (**Figure 8**).

Figure 8. Koya Landslide, note the well bedded, jointed, fractured and fissured carbonates of the PilaSpi Formation. Also note the absence of the vegetation in the slide area.

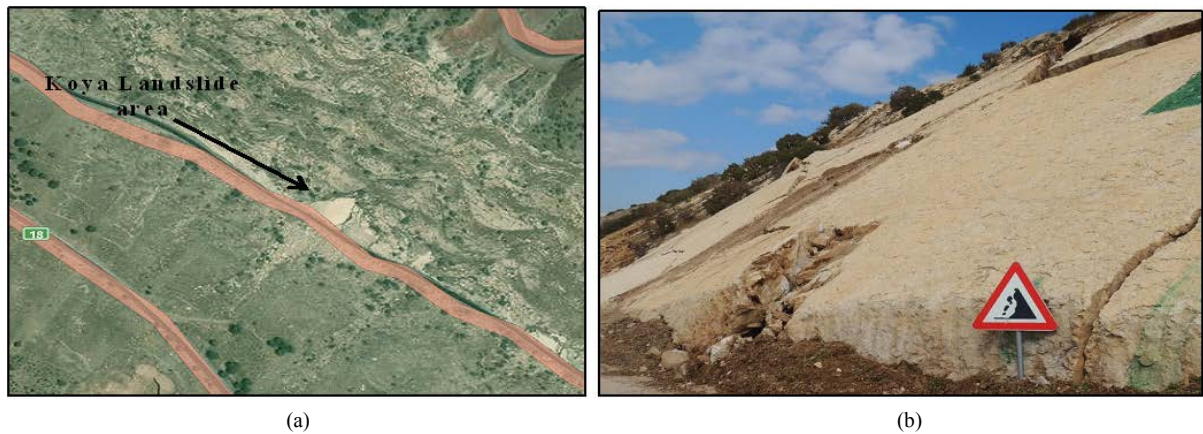
As in each mass movement phenomenon, Koya Landslide area is a prone area for different types of mass movements, especially landslide, toppling and rock fall (**Figure 9(a)**). Therefore, even traffic sign (**Figure 9(b)**) is fixed in the involved area indicating unstable slope and to pay attention of the drivers along the one lane road. Moreover, in the landslide area, there was an old landslide (**Figure 10**) and still is suffering from unstable slopes. It is worth mentioning that in each old landslide area, new mass movements are expected [8]-[11].

Figure 9. (a) Flash Earth image showing Koya Landslide area, (b) Traffic sign indicating unstable slope.

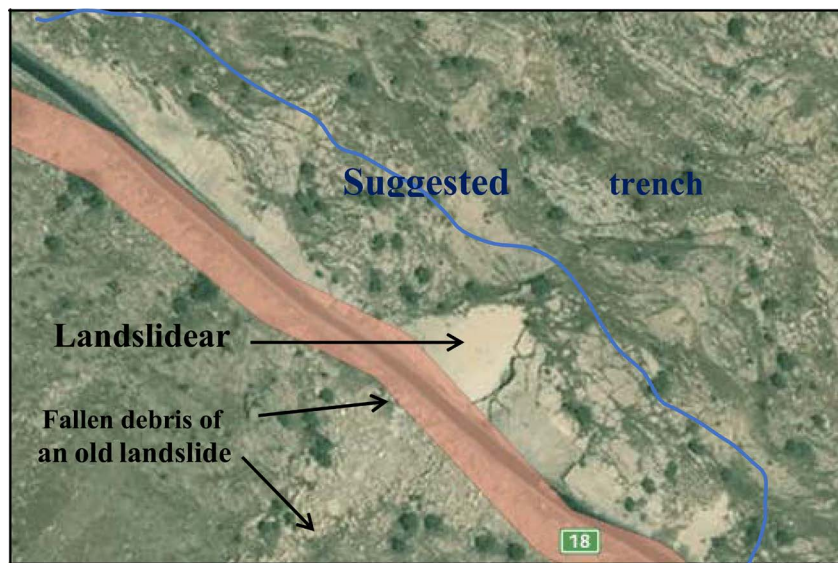
Figure 10. Here Maps image of Koya Landslide area showing the suggested.

The location of the Koya Landslide was suffering from slope stability problems. An old landslide and active rock fall (**Figure 10**) confirm the presence of unstable slope, which was easily, triggered forming the new landslide. Such cases are well known all over the world [7]-[11].

- 1) Digging a ditch surrounding the upper part of the landslide and near surroundings (**Figure 10**) and lining the ditch by concrete to prevent infiltration of the rainfall water to the slide area and near surroundings.

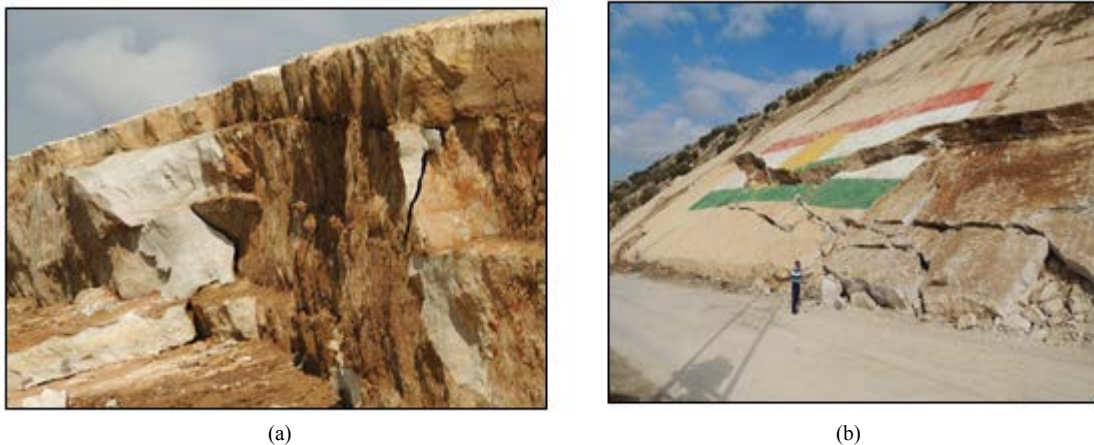
Slope saturation by water is a primary cause of landslides. This effect had occurred in Koya Landslide form intense rainfall, where there is a distinct zone of weakness that separates the slide material from more stable underlying material (**Figure 11(a)**). The infiltrated rain water has increased the pore water pressure and consequently decreased the internal friction angle [13]; therefore, the mass above the weakness zone has received more forces to move downslope and because the internal friction angle was reduced; therefore, the mass was separated from the bulk mass of the mountain and moved down slope freely, but for a limited distance.

Figure 11. Part of Koya Landslide. (a) Note the recently occurred surface due to sliding and compare it with previously occurring separated surface. (b) The lowermost part of the slide.
