Microstructural Degradation of Thermal Barrier Coatings on an Integrated Gasification Combined Cycle (IGCC) Simulated Film-Cooled Turbine Vane Pressure Surface Due to Particulate Fly Ash Deposition

Kevin Luo¹, Andrew C. Nix¹, Edward M. Sabolsky²

¹Department of Mechanical and Aerospace Engineering, Center for Alternative Fuels, Engines and Emissions, Morgantown, USA

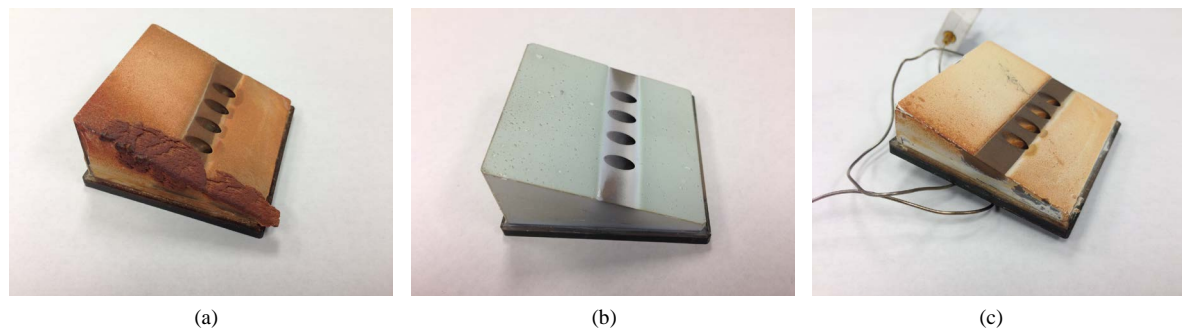
The test articles used in this study are labeled and shown in **Figure 2** [15]. The test article most heavily infiltrated was the 20-degree angled test article 1 (see **Figure 2(a)**). **Figure 2(b)** & **Figure 2(c)** contains images of the unexposed 20-degree angled test article 2 and the exposed 10-degree angled test article 3 respectively. To determine the effect of the fly ash deposition on the cross-sectional microstructure of the TBC, the test articles were sectioned into materials testing samples. The sectioning job produced flat test samples with an approximate thickness of 1/4 inches. **Figure 3** details the sample labels for each test article [15]. The heavy deposition on test article 1 is outlined in **Figure 3(a)**.

Figure 2. Labels of (a) Test Article 1—20° with deposition; (b) Unexposed Test Article 2—20°; and (c) Test Article 3—10° with deposition [15].

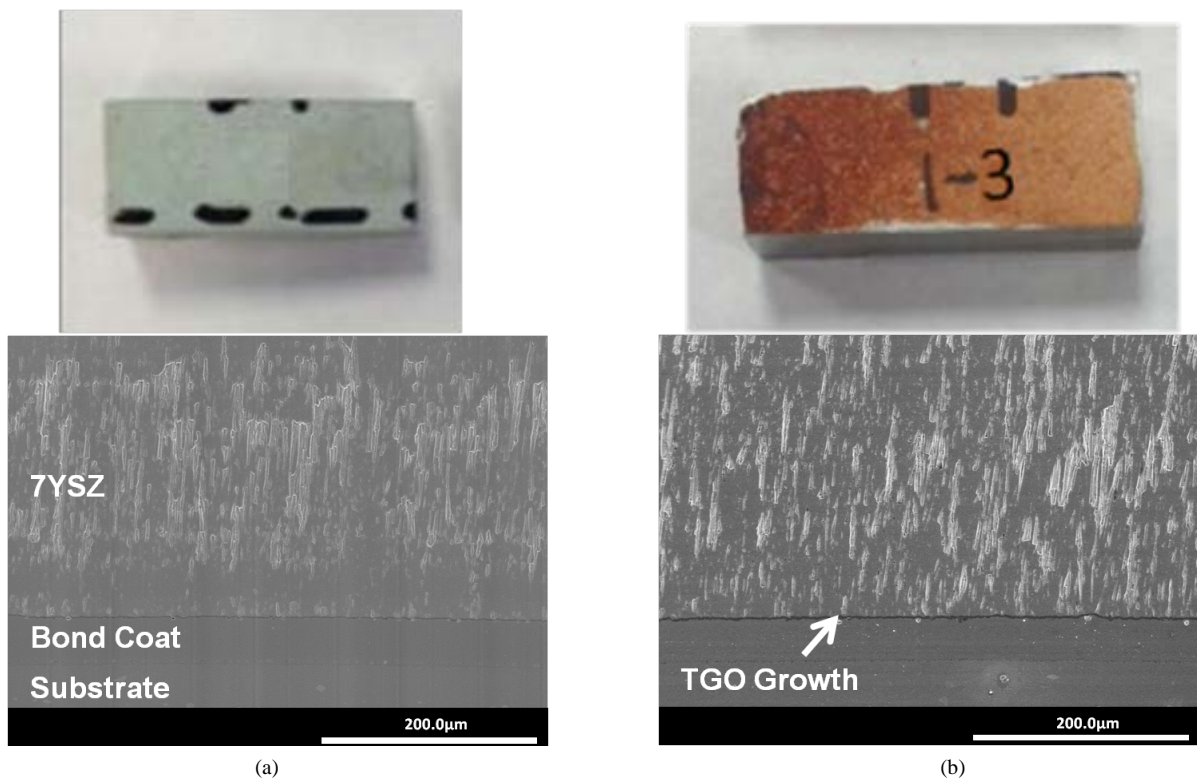
Microstructural characterization examinations commenced after the micro-indentation work was completed. **Figure 4** contains images of unexposed test sample 2-3 and deposition exposed test sample 1-3 and their corresponding cross-sectional SEM micrograph of the TBC layers. The columnar structure of the DVD YSZ can be seen in both cross-sectional views of the samples. The DVD ceramic coating exhibited a higher density than the EB-PVD YSZ found in CMAS studies by Wellman and Nicholls [4] and Peng *et al.* [16]. The only difference between the unexposed cross-sectional area in **Figure 4(a)** and the cross-section of the deposition exposed sample in **Figure 4(b)** at 250 \times magnification is the growth of TGO thickness ($\sim 5 \mu\text{m}$) and intercolumnar and internal pores due to sintering. The lack of significant microstructural changes away from the top of the YSZ coating meant the deposition had a shallow infiltration depth.

Figure 4. Cross-section SEM micrograph of the (a) Unexposed sample 2-3; and (b) Sample 1-3 (Exposed).

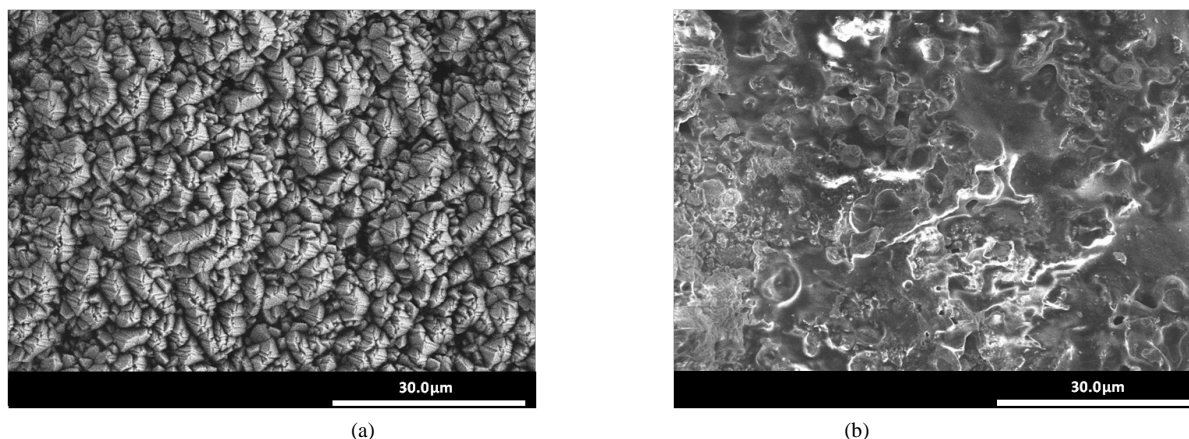
SEM micrographs of the top view of unexposed and exposed YSZ coatings are shown in **Figure 5** [15]. **Figure 5(a)** shows the top view of an unexposed, as-deposited YSZ coating on test sample 2-1. The columnar structure produced by the DVD application process has inter-columnar gaps which improves the lateral strain

compliance of the coatings. The top view of the molten deposits on the YSZ top coating of test sample 1-5 are shown in **Figure 5(b)**. The molten and cooled ash layer on top of the columns of the YSZ coating is thin, hardened, and almost glass-like.

Figure 5. Top view of (a) Unexposed Samples 2-1; and (b) Molten deposition on Sample 1-5 (Deposition Exposed) [15].

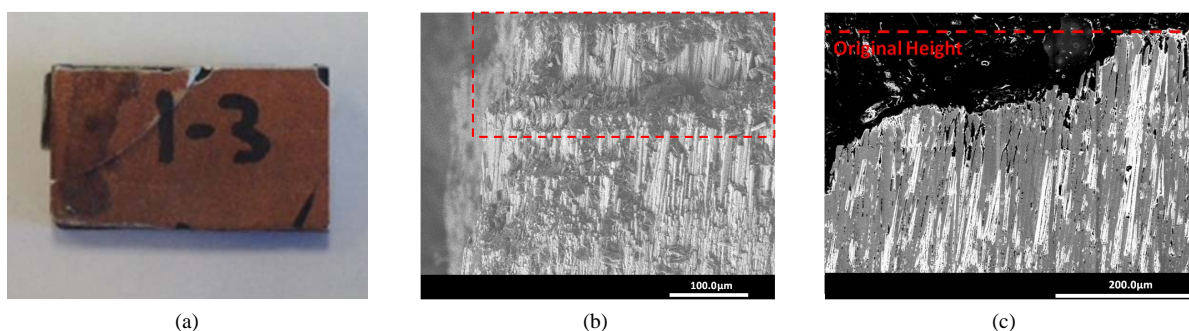
A molten deposit infiltrated top coat has been found to be more susceptible to delamination, and spallation of the YSZ coating was found for the samples in the current study. A diagonal crack developed after sectioning along the top surface of top coat of sample 1-7 (see **Figure 6(a)**) The crack further propagated during sample preparation procedures and led to delamination of the TBC. **Figure 6(b)** & **Figure 6(c)** show that Sample 1-3 lost roughly 100 µm of YSZ coating near the edge where deposition was abundant.

Figure 6. (a) Top view of sample 1-7 and cross-section micrographs of delamination in Sample 1-3 top coating; (b) After sectioning, post-sectioning; and (c) After mounting and polishing, mounted in a conductive mounting media [15].

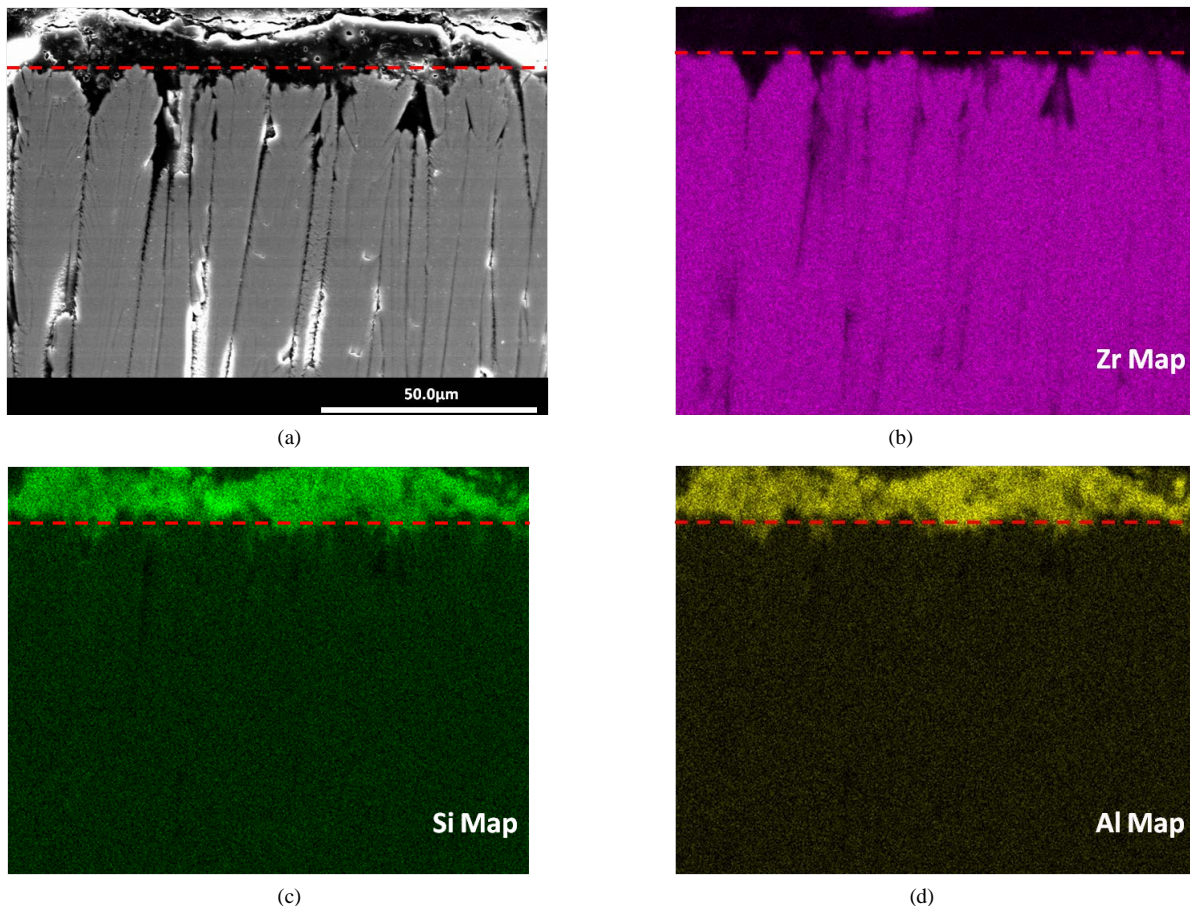
the fly ash deposition did not infiltrate deep into the top coat. **Figure 7** shows the infiltration of the fly ash deposits into the TBC on sample 1-3. **Figure 7(a)** shows a cross-sectional micrograph of the top surface of sample 1-3. The dashed red line shows the original top surface of the 7YSZ coating. **Figure 7(b)** & **Figure 7(d)** shows corresponding Zr, Si, and Al EDS elemental maps, respectively. Silicon and aluminum are chosen for the elemental mapping since they contain the two highest elemental percentages that make up the composition of the fly ash. **Figure 7(a)** & **Figure 7(d)** shows that even the most heavily deposited test article only sees an infiltration depth into the YSZ coating of 10 - 20 μm.

Figure 7. (a) Cross-section SEM micrograph of Sample 1-3 that has interacted with molten fly ash and corresponding elemental maps: (b) Zr, (c) Si, and (d) Al. The horizontal dashed lines denote the original top surface of the TBC.

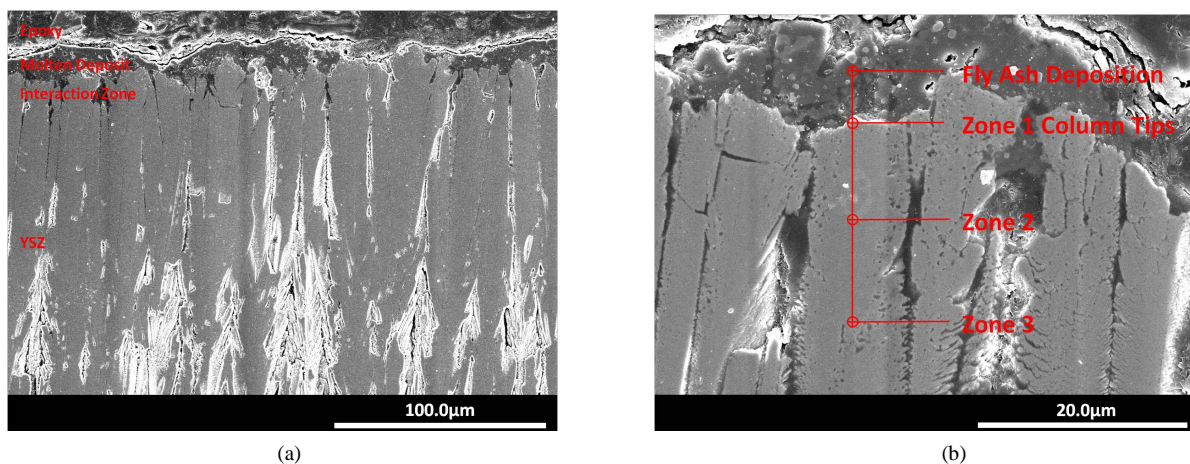
A cross-section of sample 1-3 where a heavy amount of deposition is on top of the YSZ coating is shown in **Figure 8**. The image in **Figure 8(a)** is divided into four regions: epoxy, molten deposits, interaction zone, and unaffected YSZ. The elemental distributions of the latter three microstructural regions are listed in Table 2. The results are the average of several EDS Point & ID spectrum results at each columnar center and infiltration depth locations. The interaction zone is broken up into sub-regions Zone 1 and Zone 2 in **Figure 8(b)**. Zone 3 represents a YSZ depth relatively unaffected by the molten deposits. Silicon, aluminum, and iron comprise the three largest elements by percentage in the original processed fly ash. The molten deposits that lie on top have a comparable elemental distribution. The small change in the weight percentage between the processed fly ash and molten deposits was found in this study and was also found for the coal ash particulate in a study by Bons, Crosby, Wammack, Bentley, and Fletcher [17]. The detection of yttria and zirconia in the deposit layer indicates that some of the TBC has migrated into the molten fly ash deposit. Zone 1 is placed at the tips of the YSZ coatings, and although the spectrum results show that zirconia is the predominant element, there is still presence of the molten deposits on the column tips. The weight percentage level of yttria at roughly 5% is lower than the 7% - 8% normally found in 7YSZ. This agrees with the yttria migration into deposit layer found in the study by Peng *et al.* [16]. The study by Peng *et al.* completed the same type of EDS analysis using CMAS and an EB-PVD YSZ coating and showed yttria migration to the CMAS deposit. Zone 2 lies 10 μm into the columnar tips and shows just a trace amount of deposit elements in the YSZ of the zone. Zone 3 is 20 μm into the columnar

Figure 8. Cross-section views of (a) TBC on sample 1-3 with molten deposits, their region description; and (b) Locations of EDS spectrum analysis.

tips and contains even less of the fly ash composition. The results in **Table 2** agree with the EDS maps in **Figure 7** for infiltration depth.

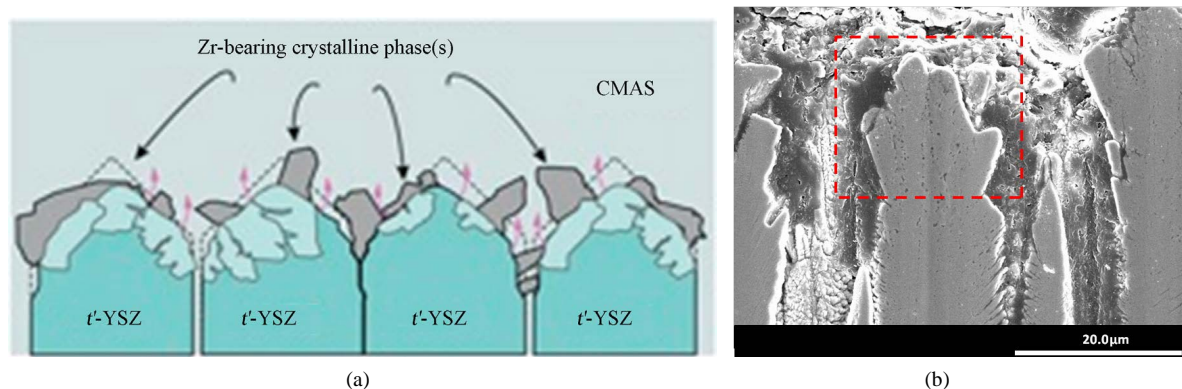
**Figure 9.** (a) Schematic illustration of the dissolution-precipitation mechanism in YSZ [4] and (b) SEM micrograph of a reprecipitated YSZ columnar tip of sample 1-3.

glass and reprecipitates in one of the modified crystalline phases of the YSZ as the yttria is leached out of the YSZ. **Figure 9(b)** contains a micrograph of a YSZ columnar tip in sample 1-3 that was reprecipitated in the molten fly ash deposit. The column tips have lost their identity. The molten fly ash does have similar degradation to the ceramic top coat tips as the molten glass from CMAS. The reprecipitated YSZ columnar tips, along with the stress mismatch caused by the molten deposit, may have attributed to the strain tolerance loss found in the study of the mechanical properties of the test samples [15]. Further penetration of the deposition and heat treatment can result in floating YSZ in the deposits leading to the appearance of globular particles found in studies by Levi *et al.* [3] and Peng *et al.* [16].
