Engineering Investigations and Durability Problems of the Construction Materials of the Roman Babylon of Egypt

How to cite this paper: Hemeda, S., Akarish, A.I.M. and El-Nagga, A.A. (2018) Engineering Investigations and Durability Problems of the Construction Materials of the Roman Babylon of Egypt. *Open Journal of Geology*, 8, 404-436.

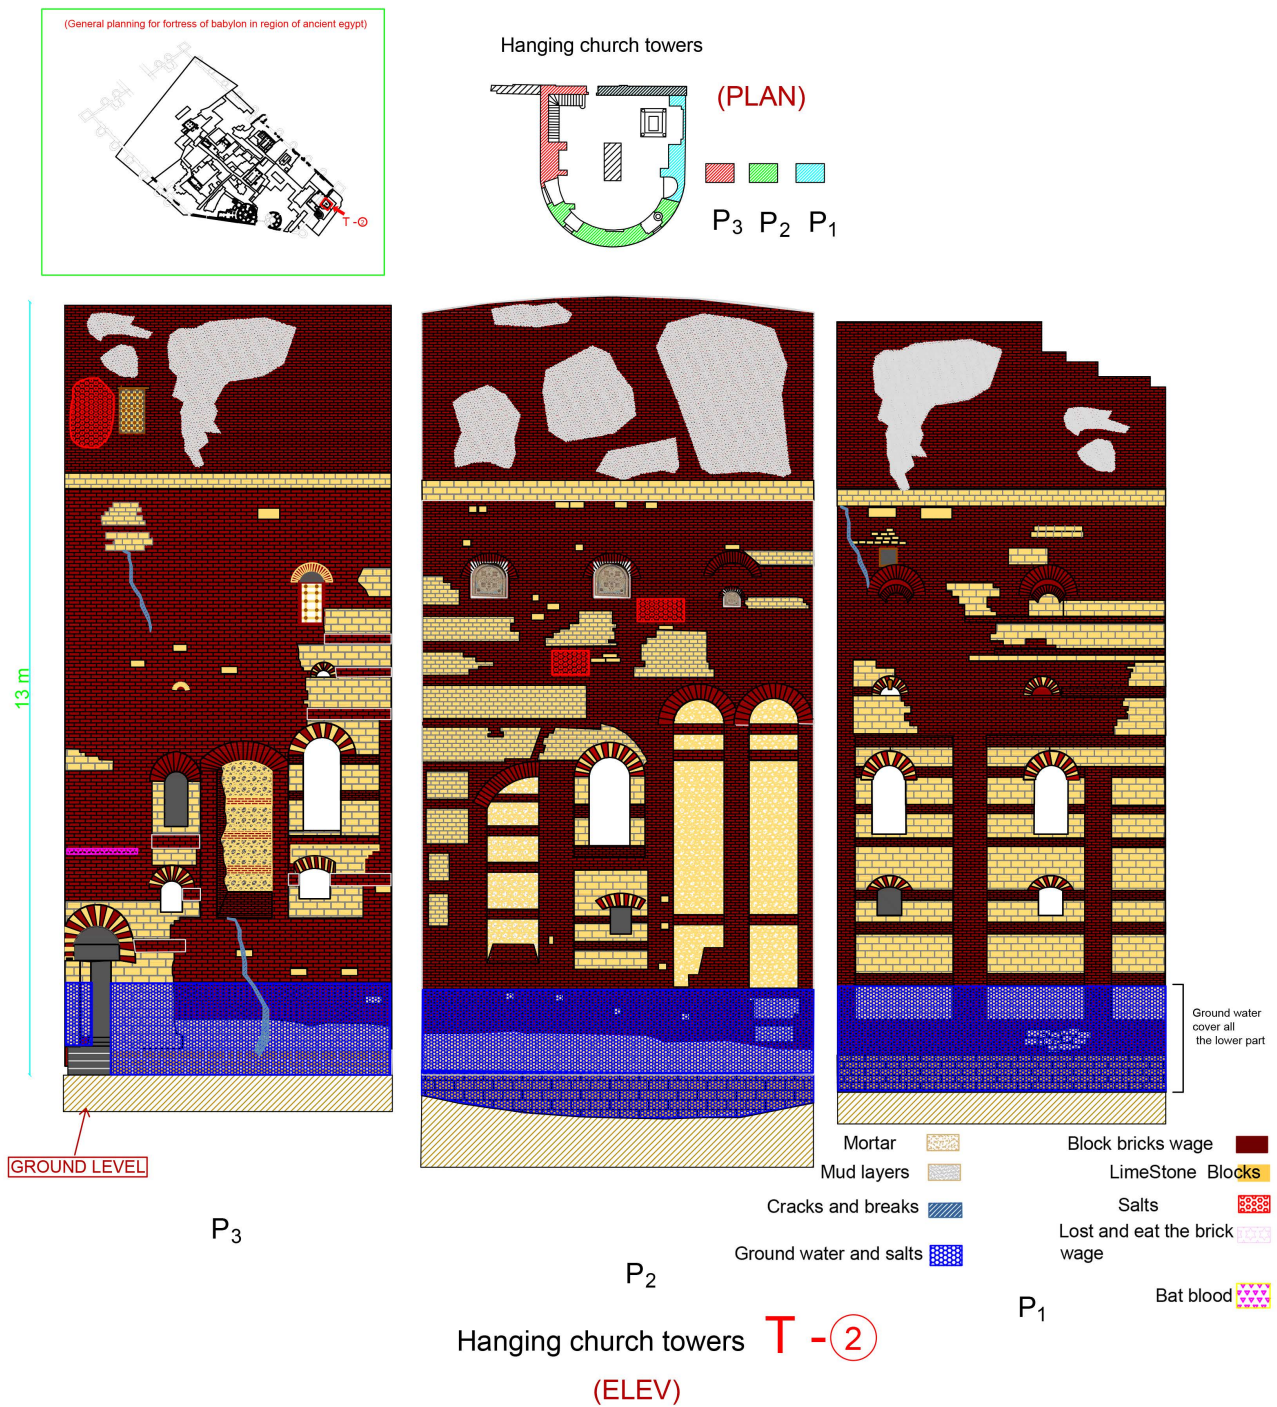
2) The second tower: It is lower than the first one (height is about 11 m, **Figure 4(a)**). The essential element is the wage bricks with some regular rows of limestone in different parts. The bottom part was built of old limestone, in which some parts are ruined and are replaced by new limestone in the frame of the contract 102. It has three big and six small holes with arches. Also, has three solid entries having different sizes of ruined limestone courses with regular wage bricks lines, **Figure 3** and **Figure 4**.

Figure 4. Architectural documentation and degradation map of the roman towers underneath of the hanging Church.

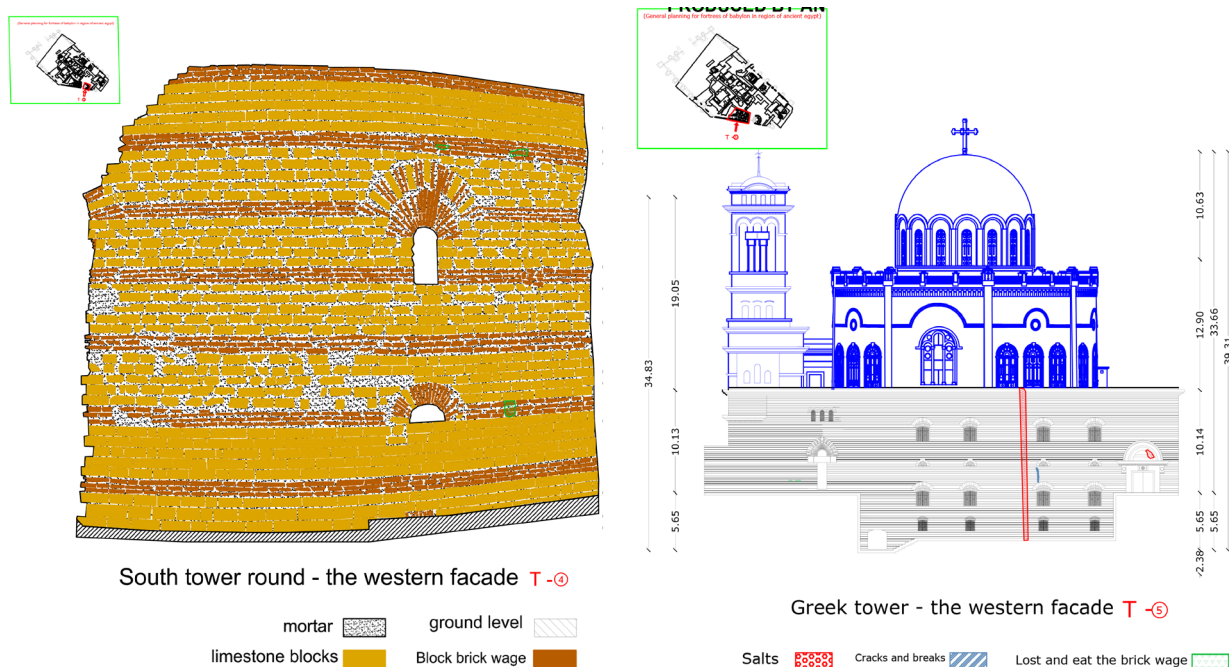
Figure 6. Degradation maps of the wall of the south round tower next to the Coptic Museum (a) and level of the roman tower underneath of the Greek Church (b).

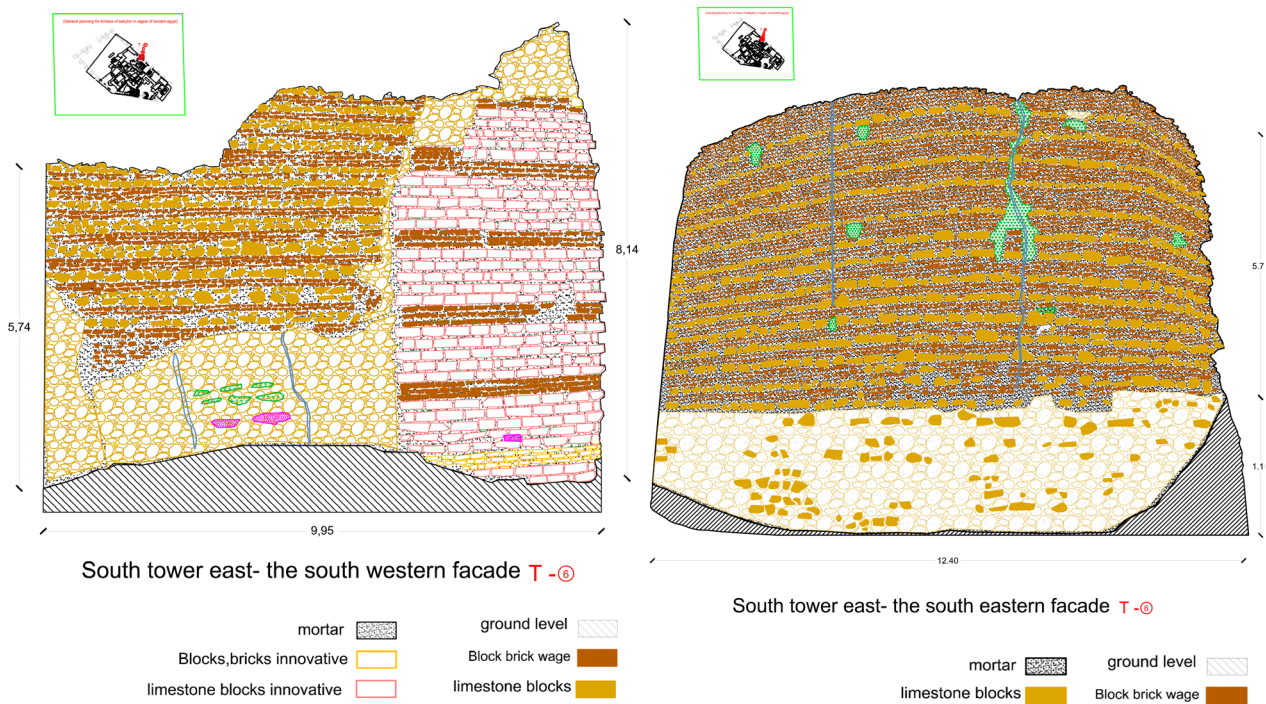
Figure 8. Present state of deterioration of the south east tower next to the Armenian tombs.

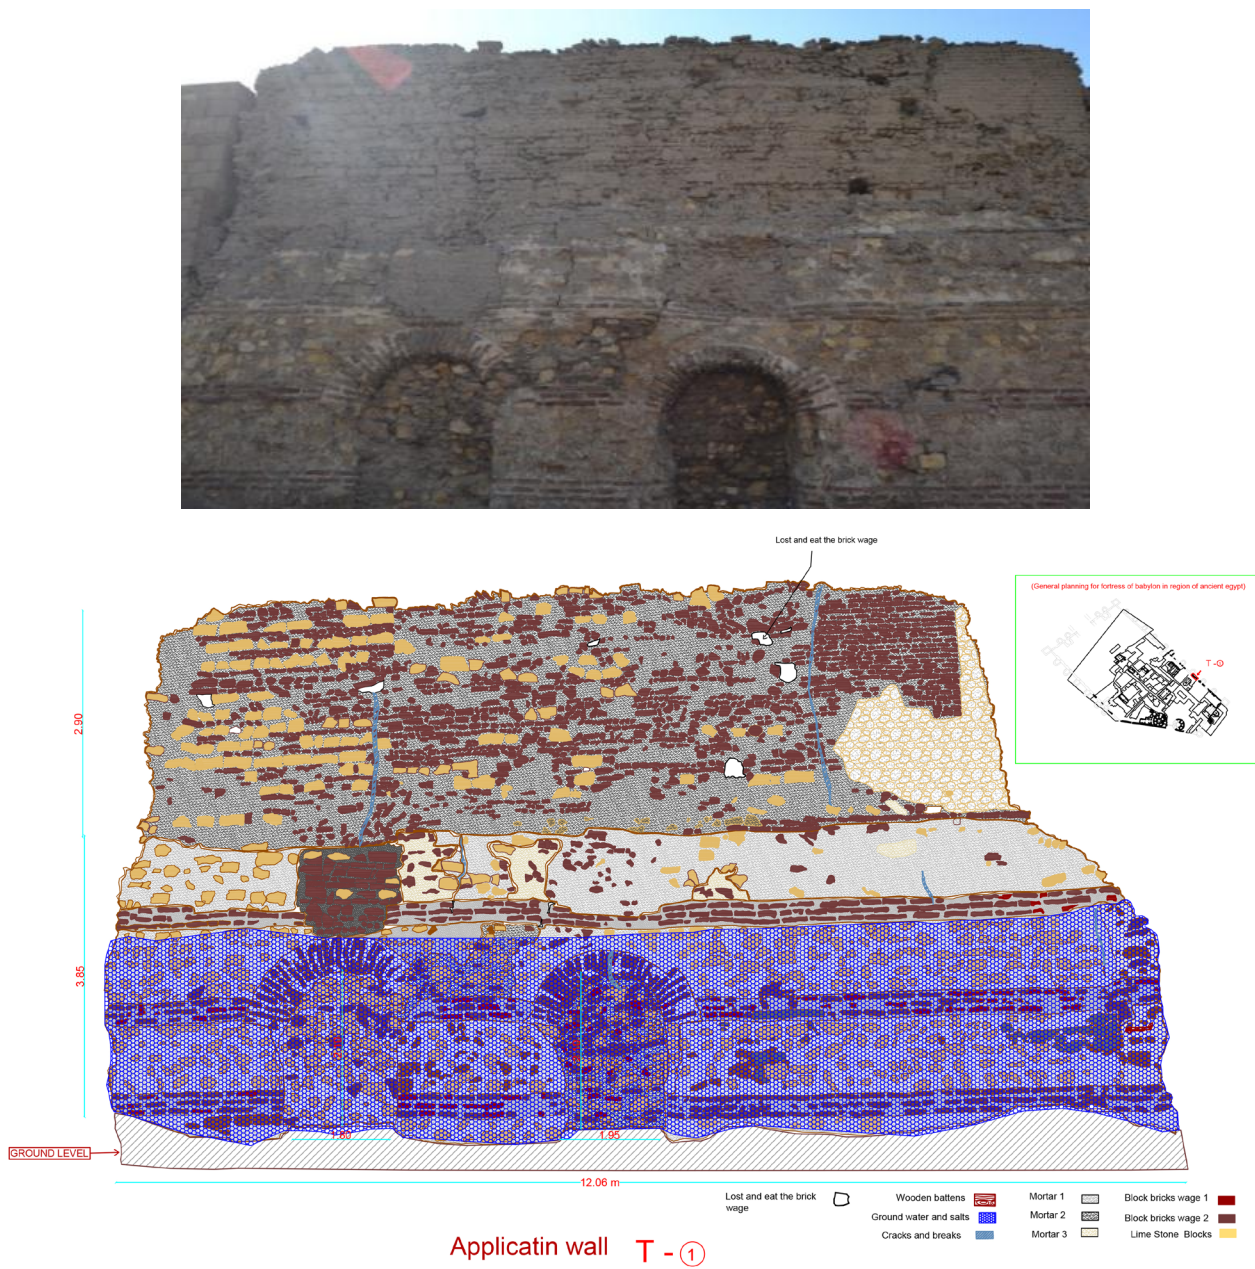
The new part of the wall is formed of an irregular line of limestone and wage bricks having height about 2.90 m, it has a group of vertical and straight cracks and some corroded limestone and wage brick courses. Impact of humidity and salts crystallization are present, may be according to the humidity state and the nature of the area which is threatened always by the underground water (Figure 9).

Figure 9. North-eastern wall next to the Jewish temple from the original part of the Babylon.

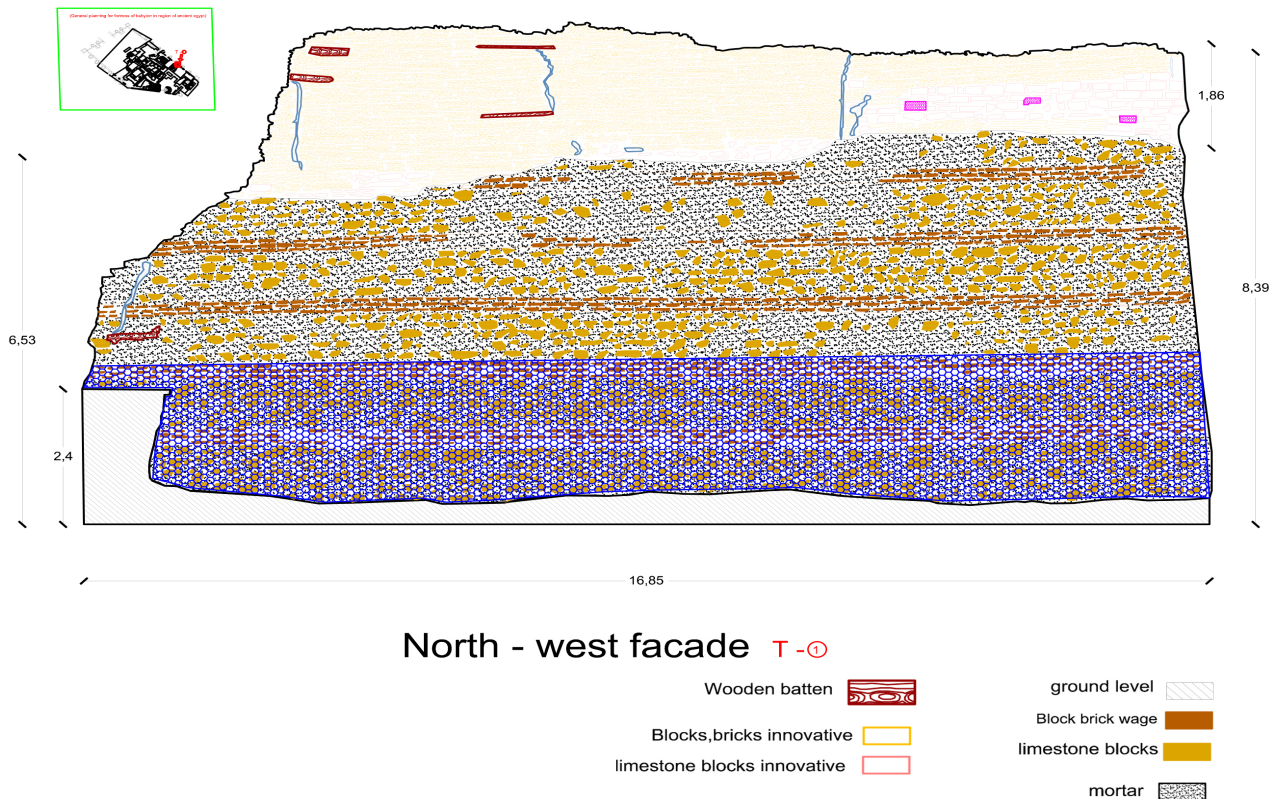
Figure 11. Degradation map of the North western wall of the fortress of Babylon.

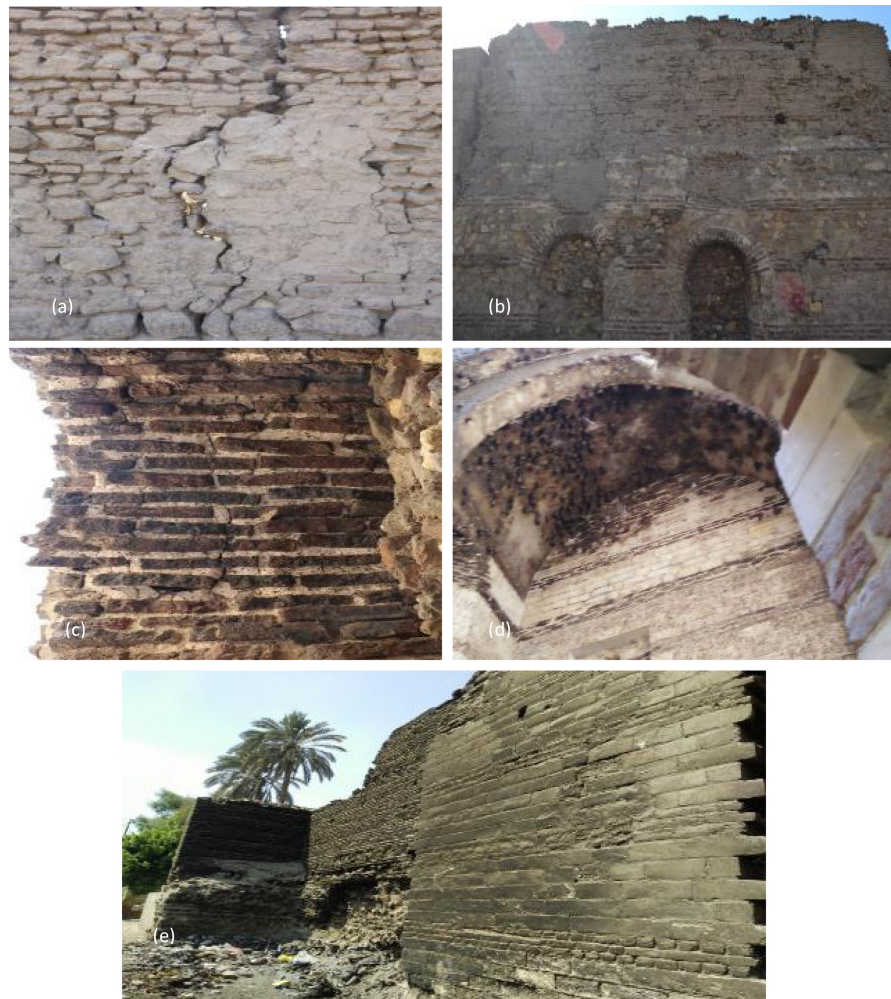
Figure 12 presents the observed main aspects of the structural deficiency of many walls and towers of the Babylon of Egypt. Cracks and fissures took place in the vertical walls. Permanent deformation of the bricks is observed in the zone of the borders and main wall of the façades. Dangerous cracks appeared in some towers and separation between the façade and the radial walls are obvious. These damage forms are related to the mechanical actions in particularly the seismic hazards and geotechnical problem of the bearing soil.

Figure 12. Structural deficiency of many walls and towers of the Babylon of Egypt: (a) cracks and fissures in the vertical walls; (b) permanent deformation of the bricks in the zone of the borders and main wall of the façades; (c) danger cracks appeared in some towers; (d) one very significant source of surface damage resulted from the fesses of bats that inhabited the tower in thousands. And (e) separation between the façade and the radial walls are obvious.

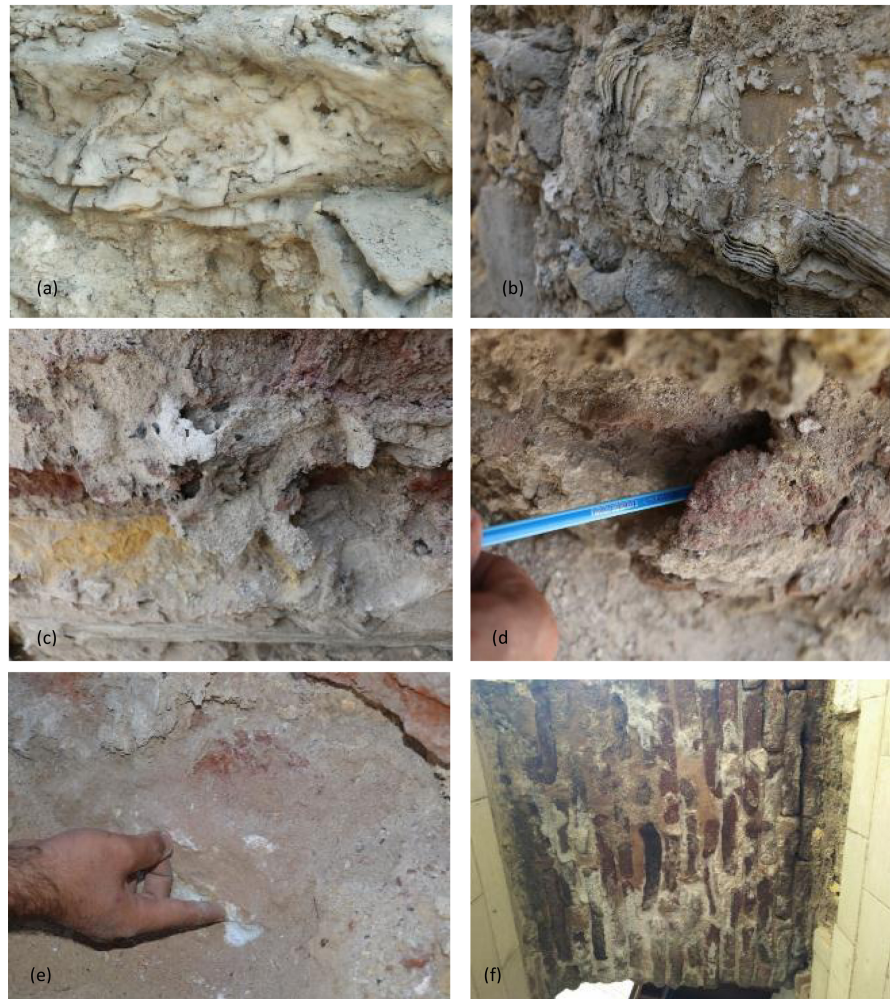
Figure 13 shows some of the recorded forms of the physical and chemical

deteriorations due to subsurface water rising and salt weathering affecting the roman and byzantine bricks and the joining structural mortars.

Figure 13. Physical and chemical deterioration forms due to subsurface water rising and salt weathering affecting the roman bricks and structural mortars; (a) and (b) salt efflorescence; (c), (d) and (e) cryptoflorescence, layers exfoliations and hard black crust formation; (f) brick and joining mortars disintegration due to salt weathering mechanisms.

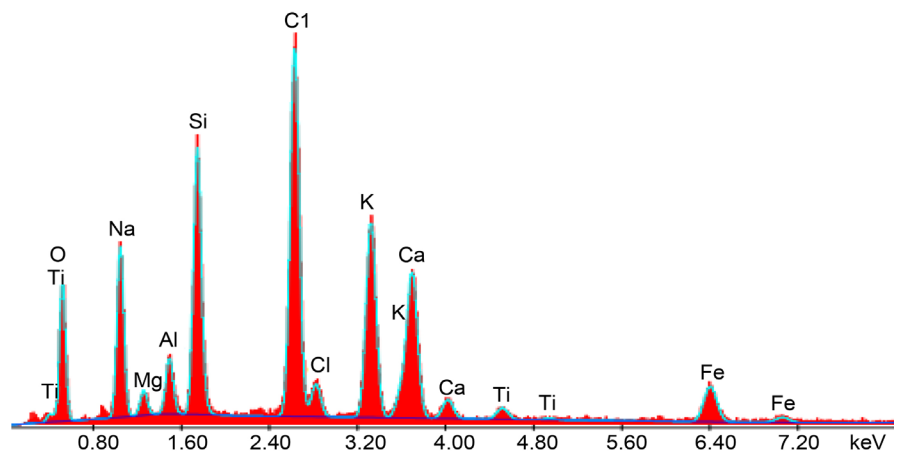
Figure 37. EDX microanalysis showing the intensive presence of Halite in the mortar composition.

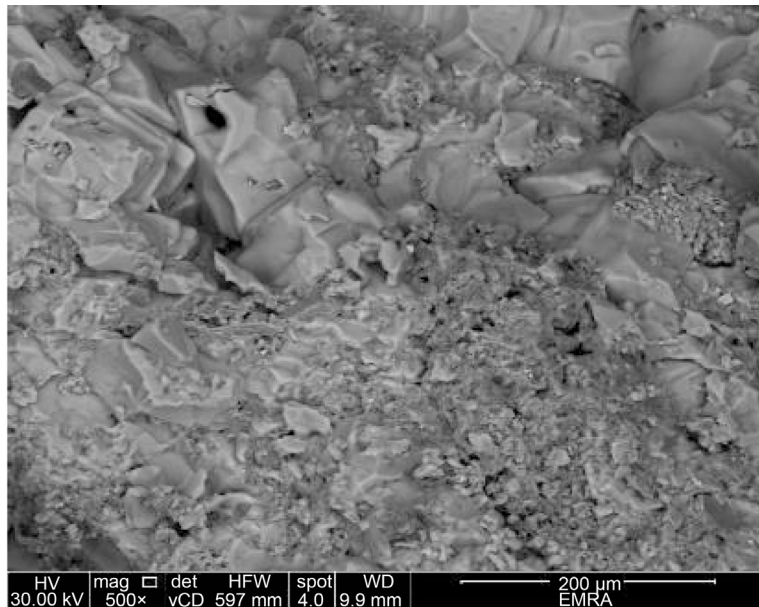
Figure 40. SEM image showing the presence of limestone and bricks aggregates and the contamination with the chloride salts.

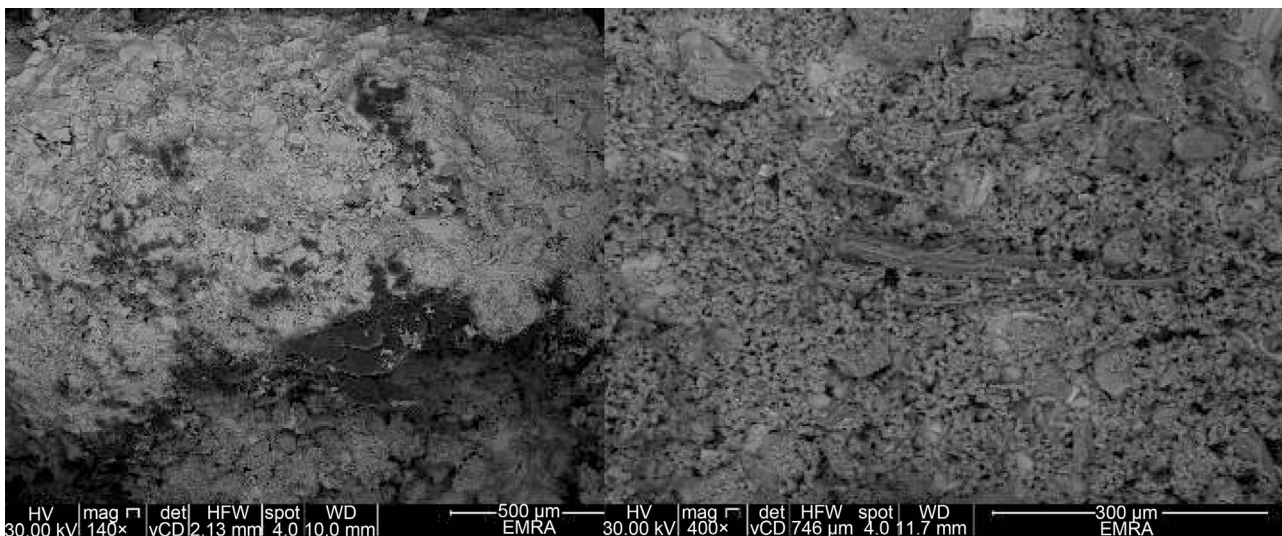
Figure 42. SEM image showing the disintegration of the structural mortars due to the ground water and salt weathering.
