Reconstruction and Restoration of Main Facade and Wooden Ceilings of Hasan Basha Tahir Kuttab & Sabil, Cairo—Egypt

Mahran F. Anwar

How to cite this paper: Anwar, M.F. (2019) Reconstruction and Restoration of Main Facade and Wooden Ceilings of Hasan Basha Tahir Kuttab & Sabil, Cairo—Egypt. *World Journal of Engineering and Technology*, 7, 175-192.

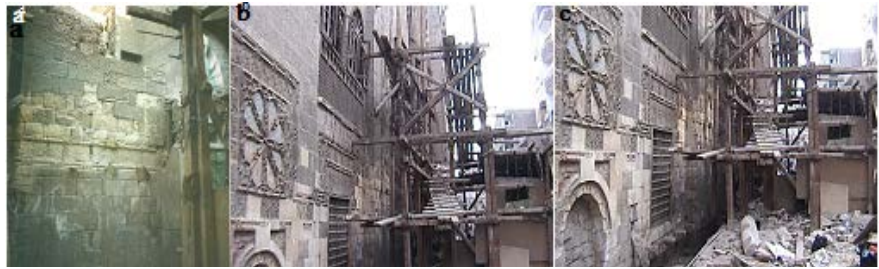
Several weathering forms were identified and recorded at the façade of the Sabil & Kuttab of Hassan Taher Pasha. The foundations were hidden below the layers of fill and indicate the poor condition of the general tendency of the structural elements starting from the base, indicating the positional crushing of the foundations and lower pillars. Partial collapse and serious tendencies in arches and vertical elements such as walls and columns in the facade were clearly noticed, mainly due to the dynamic factors (earthquake) which occurred on October 1992. The bearing walls under the influence of the wheel of vibration and horizontal pressures due to earthquakes send a range of wave shocks and have a mechanical effect on the strength of structural elements, causing partial and totally collapse because the building under the pressure of a sharp vibration wheel led to that each structural element takes an independent behavior according to its properties (**Figure 5**) [1]. Seismic performance is affected to any premises with two main factors soil properties that it is building, and earthquake waves depending on soil type and shape layers and their characteristics in terms of solidity and coherence, as well as seismic performance is affected by the properties

of the building itself, whether the underground or the tip above in terms of guiding a projected interfaces and type of construction in the building [2]. Tendencies and incline the marble column and fall off area of gravity and move the wooden pillow top of the crown. Many vertical, diagonal cracks in the walls as shown in which led to dangerous deterioration in the architectural elements like arches, gifts and threshold more cracks were found at top of the façade. The cracks at top of facade and at the end of facade are indicating to continuous wave movements. Vertical cracks generally indicate poorly bonded material that has, vertical cracks generally indicate to poorly bonded material that has lost its cohesion and is therefore weak. Black crust and soiling were coated the surfaces of Sebil and Kutab building materials resulting from atmospheric pollution from the center of Cairo (Figure 6). The main of stone deterioration of the façade results from combination of raised groundwater level and the capillary transport of salt laden water due to the actual level of humidity and its continuous mechanism. The pressure of salt crystallization enhances the growth and development of micro and macro fractures and consequently leads to granular disintegration, scales, spalling, flaking prevail inside and breaks up stone surface and also decrease the overall strength of the stone especially in the lower parts of the walls [3].

Figure 6. The deterioration aspects at the façade of the Sebil and Kuttab.

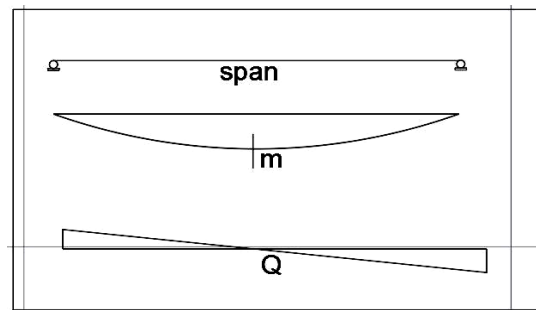
- Bending in the wooden beams and receding in the riding area on the walls (Figure 7).
- No Wooden Pillow bottom of beams which led to bad in distribution of loads in the headrest's areas.

Figure 7. The kinds of binding occurred in the ceiling of the complexes of Hasan Basha Tahir.

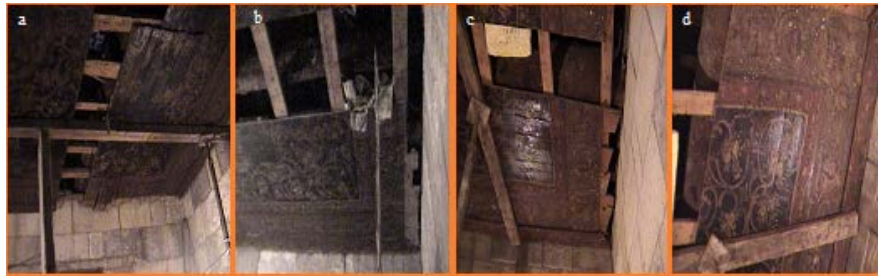
- The wood ceiling and its decorative paintings on the Sabil and Kuttab were in a very bad condition, which created by a combination of organic and inorganic materials. It had several different deterioration marks, as; warps, twists and irregular shape dry wood used in the ceilings, to shift mostly to curly plates wrapped wooden beams as a result of changes in temperatures and humidity daily, seasonally and annually, which lead to the separation of wood panels that carry layers of color, which lost large parts of them.

- Spread of cracks and deep cracks between wooden panels: that comprises the ceilings as well as the proliferation of these cracks in colorful layers above those panels.

- Colored material used in decoration had an occurred chromatic as color shift phenomenon of change as a result of chemical degradation resulting from the impact of heat and humidity and air pollution and the material became darker and lost its originality and beauty.

- The ceiling had been damaged and loss of many architectural elements as a result of biological attack.
- In addition to insects attack ceilings and caused tearing wood fiber with microorganisms and turned large parts of that to weak soft wood.

- All of this type of physical damage has had a direct impact in the collapse of these ceilings, especially with the continuous movement and collapse of the walls carrying them. All deterioration aspects shown in (**Figure 8**, **Figure 9**).

Figure 8. Shows the deterioration aspects of Sebil ceiling before decoding the wooden ceiling units.

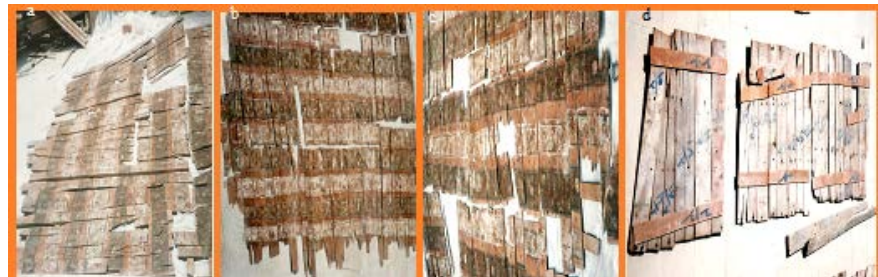
Figure 9. Shows the deterioration aspects of Sebil ceiling after decoding the wooden ceiling units.

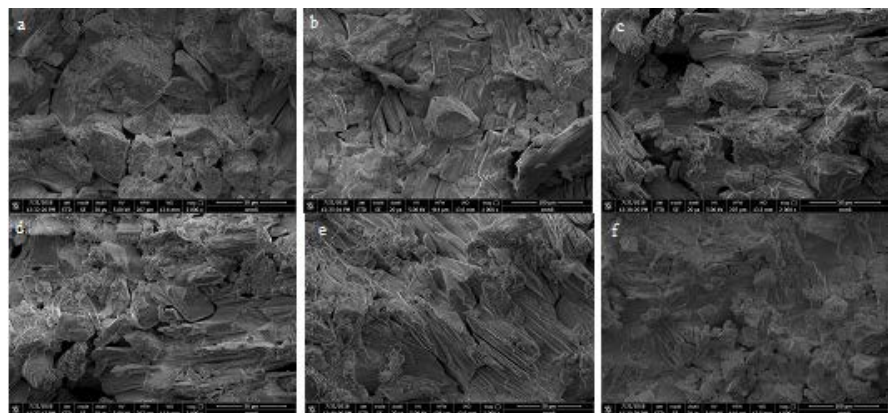
The obtained results showed that there is a wide range of deterioration of limestone (**Figure 11**) such as; disintegration between calcite crystals, dissolution of calcite crystals and loss in the binding materials between grains by the effect of salts crystallization, small fissures and cracks, localized cavities. Microscopic investigation of the mortar from filling the Interior between stone walls samples used in Sabil & Kuttab revealed deformation in mineral composition, the crystal edges and surface tissue and spaces between quartz, covering sodium chloride crystals for most samples of minerals composition (**Figure 12**).

Figure 11. SEM micrograph of limestone sample from Hassan Taher Mosque.

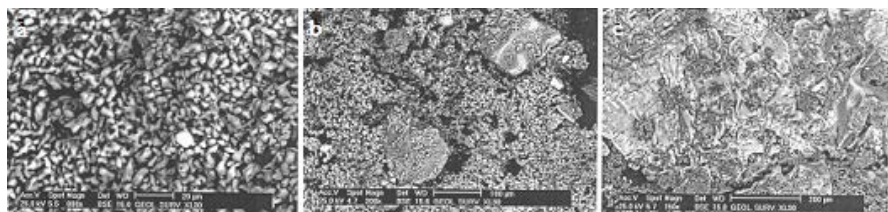
Figure 12. SEM images of mortar samples: (a) deformation in mineral Composition (800×), (b) the crystal edges and surface tissue and spaces between quartz, (c) Covering sodium chloride crystals for most sample of metal composition.

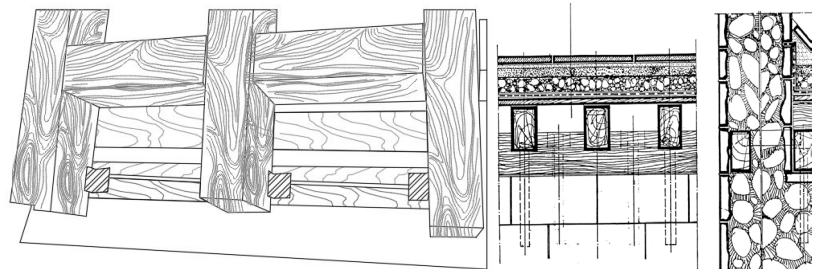
Figure 19. Show detailed section of wood beams and wood plates Panel when re-construction wood ceiling.

- **Reconstruction of wood ceiling**
- The flat ceilings consist of a group of wood beams based on the walls according to the distance between the walls and then come a vertical layer of wood panels (Figure 19).

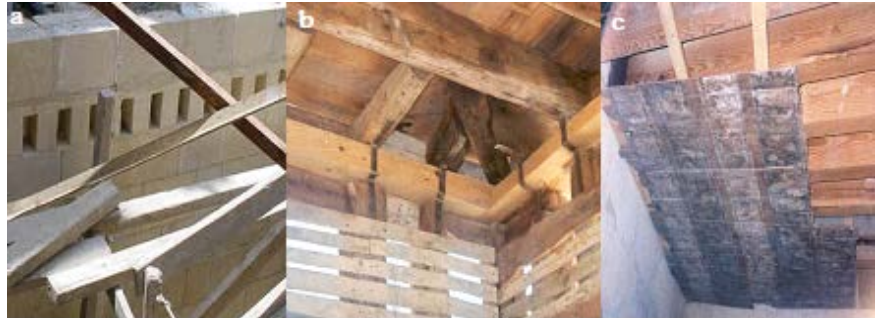
Figure 20. reconstruction and commplition technique of wooden painted piceces at the celieng.

- In the reconstruction, wooden beams added on the walls so that they can distribute loads along the wall (Figure 20).
- Construction filling layers and the necessary tendencies for water drainage.

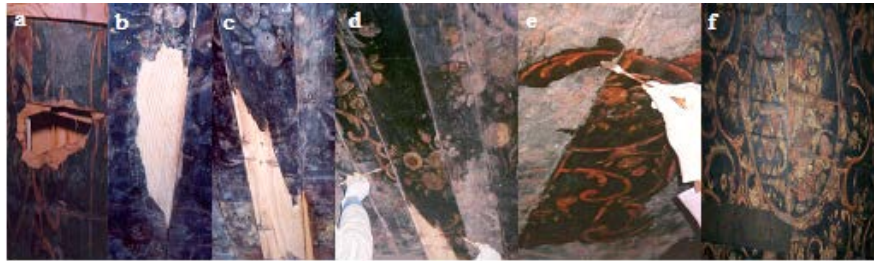
Figure 21. fine restoration work of painted wood at the celieng of sebil.

- **Filling gaps**
- Either the spending gaps in the ceiling were filled with a paste consisting of fine powder of wood material mixed with Paraloid B.72 dissolved in acetone by concentration of 10% as a proportion of the pesticides were added and last entomological innate components of this Putty (**Figure 21**).

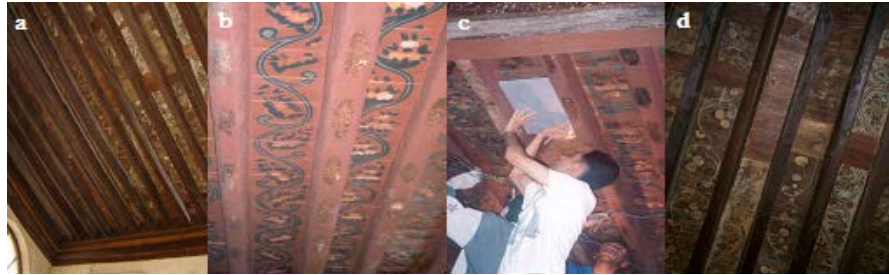
- Microscopic analysis results showed that most of the wood panels and the overlying colored layers in a severe case of weakness and incoherence. To strengthen these panels and those layers chemically using modern chemical polymers that are suitable for such cases has been tested many polymers such as polymerized vinyl acetate, caltone and area gal all which were Acrylic polymers, but they did not give good results (**Figure 22**).

Figure 22. restoration work at the ceiling of Kutab.

- So, we turned to the use of Paraloid B.72 is a Poly-methyl methacrylate acrylic material which gave good results in treatment where the melting Polymer in acetone and get a homogeneous solution concentration 3% used a spray Spraying several times to colored layers as well as wood panels that consist of the Ceilings.

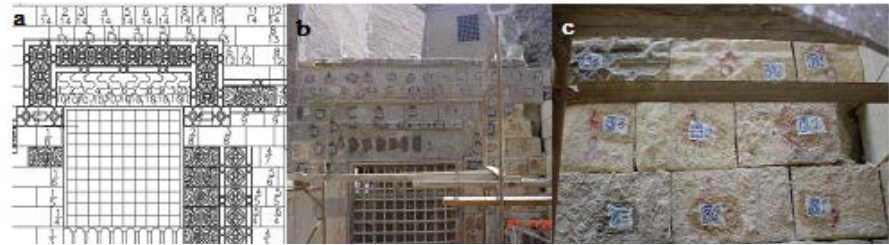
Figure 23. Numbering process for Façade elements on drawings and indicated in current position.

- Conduct an integrated and scientific study to determine the current status of the interface elements.
- The numbering system for each piece is determined exactly the exact position and sign this numbering on drawings, and the classification tables for the numbered pieces were made (**Figure 23**).
- The monitoring work was carried out by a surveying system to determine the directions and to monitor the elevations necessary to ensure that the pieces were reconstructed in their original positions and directions.
- Determine the relationships between the numbered pieces and recording on drawing works to ensure the reconstruction process [4].

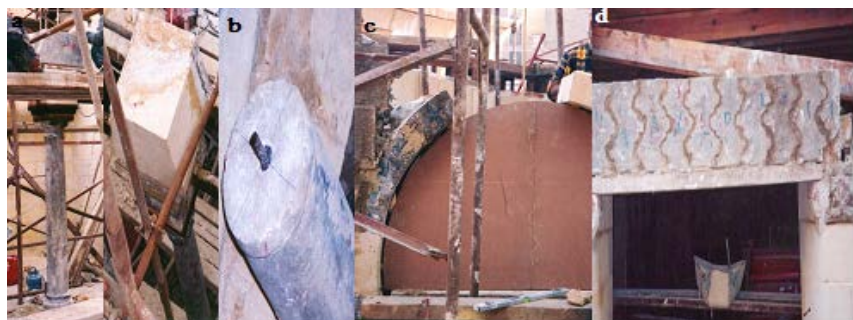
Figure 24. Reconstruction work of the façade.

- **Reconstruction of main façade**
- Construction begins to reverse disassembly work from bottom to top of the last recorded number on sheets of registration (**Figure 24**).

- Reconstruction using the same quality mortar and same recorded dimensions on registration sheets.
- The internal filler consist of breaking new stone free of salts according to the original mixtures or those selected after testing.

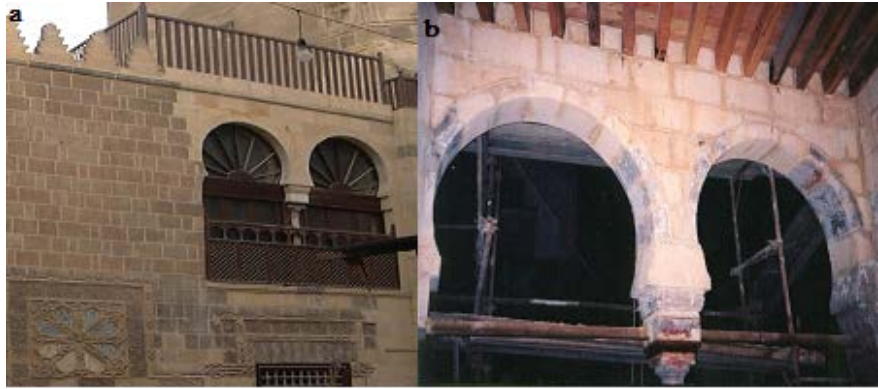
Figure 25. The Sabil and Kuttab of Hassan Taher after restoration.

- **The column** are the elements that carry the forces resulting from the ceilings and arch in building Sabil & Kuttab when reconstructing, the balance of these columns must be adjusted based on monitoring system by the total station. Considering the central pressure forces are the main loads applied to these columns so as to ensure that stress stresses are among the permissible values

for carrying buildings, also the wooden pillow was replaced which are usually a middle stage between the leg of arch and crown of column for the importance of its structural role in the reduction of loads and absorption of vibrations (Figure 25).
