Mosul Dam Problem and Stability

How to cite this paper: Al-Ansari, N., Adamo, N., Al-Hamdani, M.R., Sahar, K. and Al-Naemi, R.E.A. (2021) Mosul Dam Problem and Stability. *Engineering*, 13, 105-124. <https://doi.org/10.4236/eng.2021.133009>

Mosul Dam is located on the River Tigris about 60 km northwest Mosul in Iraq. It is the biggest dam where its storage capacity reaches 11.11 billion cubic meters at normal operational level (330 m. above sea level). The dam was constructed on alternating beds of karstified limestone, gypsum and marl. This dam suffered from water seepage under its foundation since its operation in 1986. Grouting operations were implemented since that time to overcome this problem. This seepage is believed to be due to dissolution of gypsum beds under the foundation, which was not carefully considered by the designers. It was recommended by the international board of experts that the water level should be kept at or below 319 m.a.s.l. to minimize damages in case of the failure of the dam. ISIS occupied the dam site on 8 August 2014 and it was seized back from the hands of ISIS on the 16th of the same month. They did plenty of damage despite the short period they

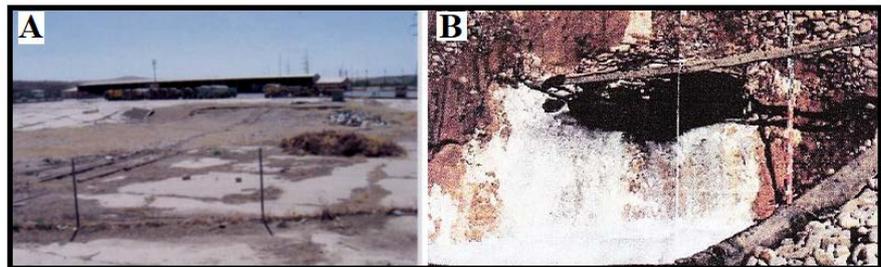
Sinkholes in the downstream of the dam are believed to be developed due to fluctuations in the tail water level of the main dam during operation of the dam and the down-stream regulating reservoir [41] (Washington Group International, 2005). Before the impoundment of the reservoir, substantial flows of order of 360 l/s were noticed from a gypsum layer found during excavation of the tailrace tunnel for the pumped storage scheme. The seepage water had a high sulphate content, which was different from the reservoir water (Figure 9(B)). These

Figure 9. (A) One of the four sinkholes which had appeared in the 90's at the downstream right bank near the contractor yard. (B) Spring of discharge 360 l/s which is connected to the ground water aquifer connected to the reservoir ([47]).

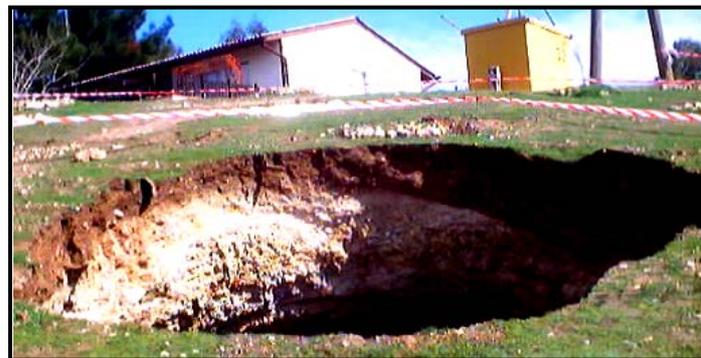
highly karstified [47] (Al-Ansari *et al.*, 2015). Most of the karst forms are sinkholes that were developed in gypsum and/or limestone [56]-[67] (Figures 8-10). The karst extends to a depth of about 100 m below the dam foundation (Figure 8).

Figure 10. An example of sinkhole that appeared in 2003. The left bank sinkhole after full development ([47]).

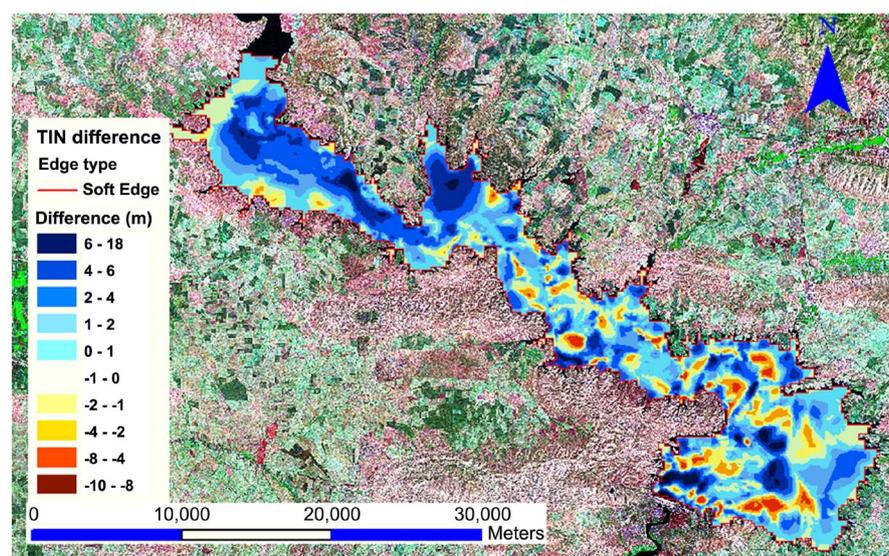
The operation of the reservoir had led to a new groundwater dynamic that accelerated the dissolution of gypsum under the foundation of the dam and within the reservoir area. A sediment and bathymetric survey was conducted during 2011 to the reservoir area and the bathymetric map (**Figure 11**) showed formation of sinkholes within the bottom of the reservoir [68]-[75].

Figure 11. Holes noticed at the bed of Mosul reservoir [73].

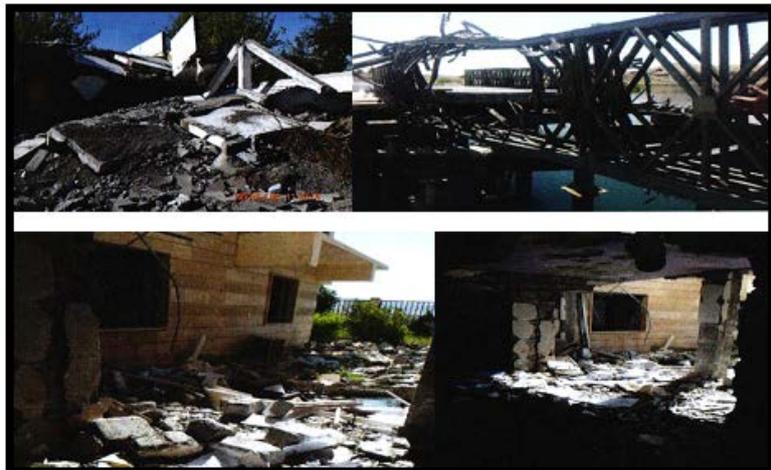
ISIS occupied Mosul Dam area on 8 August 2014 and they were seized back from the hands of ISIS on the 16th of the same month. ISIS destroyed the buildings, equipment, bridges, etc. on the site (**Figure 12**). As a result, the grouting

Figure 12. Destructions of buildings and bridge as an example of what ISIS did at Mosul Dam site.

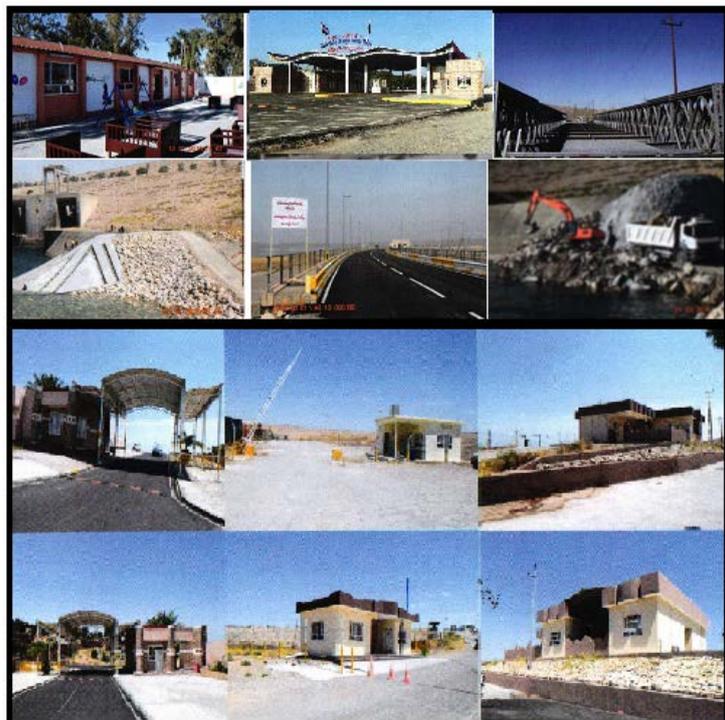
Figure 13. Reconstruction of different sites in Mosul Dam area after ISIS occupation.

After the defeat of ISIS from Mosul Dam area, the Iraqi Ministry of Water Resources started to rebuild and construct the destroyed parts of the site and started again the maintenance program for the dam (Figure 13). In addition, they signed a contract with an Italian company (Trevi) (contract No. 1002/2016) to do maintenance work at Mosul Dam area. The work mainly included the rehabilitation of one of the bottom outlet gates and grouting.

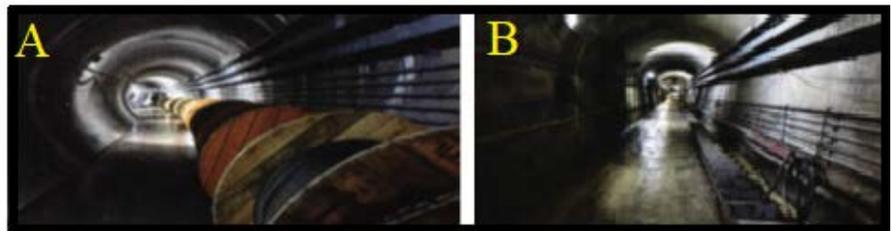
Figure 16. Electrical cables (A) and water pipes (B) were replaced in all galleries at Mosul Dam site.

Grouting operations now follow very highly upgraded system (Figure 15). Furthermore, advanced stations and equipment for preparing and pumping grout mix are used now. All the operation is computerized. All electrical cables (98 km long) were replaced in grouting galleries. Pipes that are used for pumping grout mix (15 km long with 1.5-inch diameter) and water pipes (5.7 km long and 6 inches diameter) were all replaced (Figure 16).

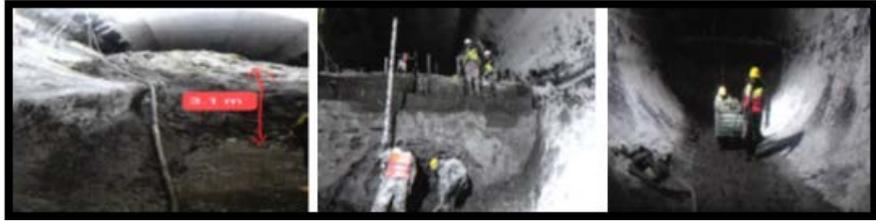
Figure 22. Cleaning operations at Aljazera irrigation tunnel.

It is noteworthy to mention that different galleries and tunnels were cleaned and repaired from grout waste mainly Aljazera irrigation tunnel. This tunnel is 450 m long with 6 m diameter which is lined by concrete layer 1 m thick and another iron layer 18 mm thick (Figure 22).
