Dye Test within Mosul Dam Area

Mohammed Sami Safi¹, Nadhir Al-Ansari²

Abstract

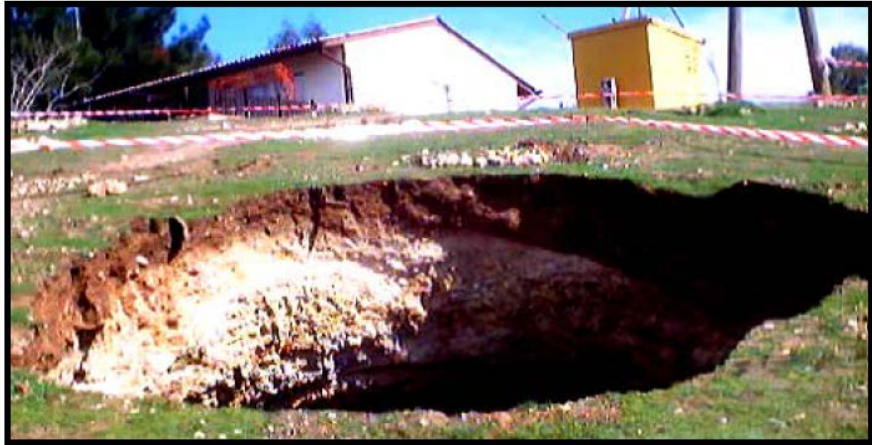
Figure 6. An example of sinkhole that appeared in 2003. The left bank sinkhole after full development.

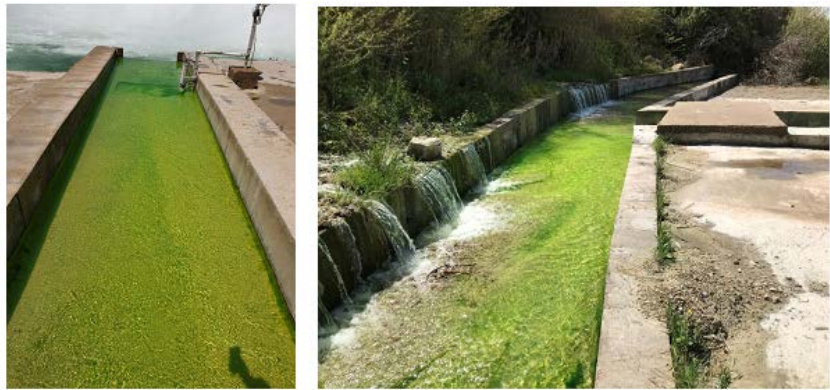
On 12 April in the morning, MoWR personnel visited the seep area and observed green dye in Weir 4 (**Figure 12**). Additional samples were collected from all the previous collection points. Samples were also collected from one seep from which the dye could visually be seen. It was a large seep above Weir 4 exiting near the top of the LST-2 Limestone in the Lower Marl Series (**Figure 13**).

Figure 12. 18 - 24 dye test with green dye observed in Weir 4 on April 12, two days after injection.

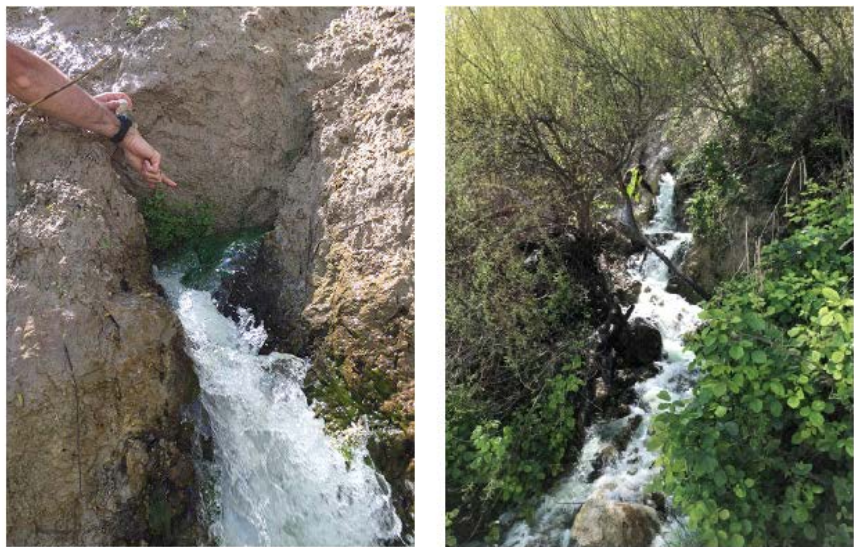
Figure 13. 18 - 24 dye test collecting samples of dyed water from seep above Weir 4 at top of LST-2.

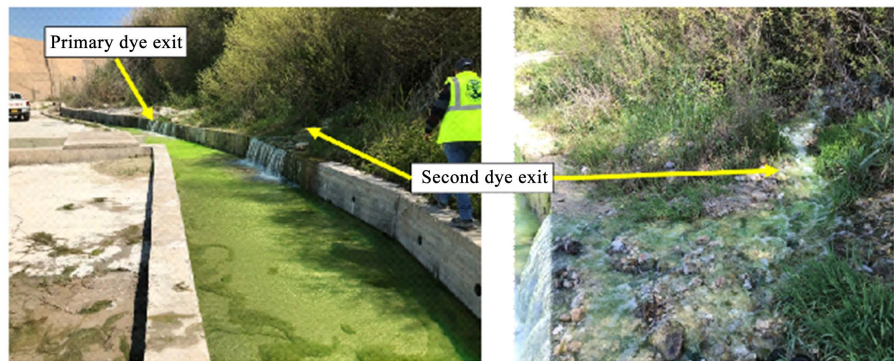
On 13 April the dye continued to exit from the main seep above Weir 4, but also was visibly exiting from a seep a couple meters downstream (**Figure 14**). The second seep was also located near the top of the LST-2 Limestone (**Figure 15**). No additional samples were collected on 13 April.

Figure 14. 18 - 24 dye test green dye entering Weir 4 from two separate seeps.

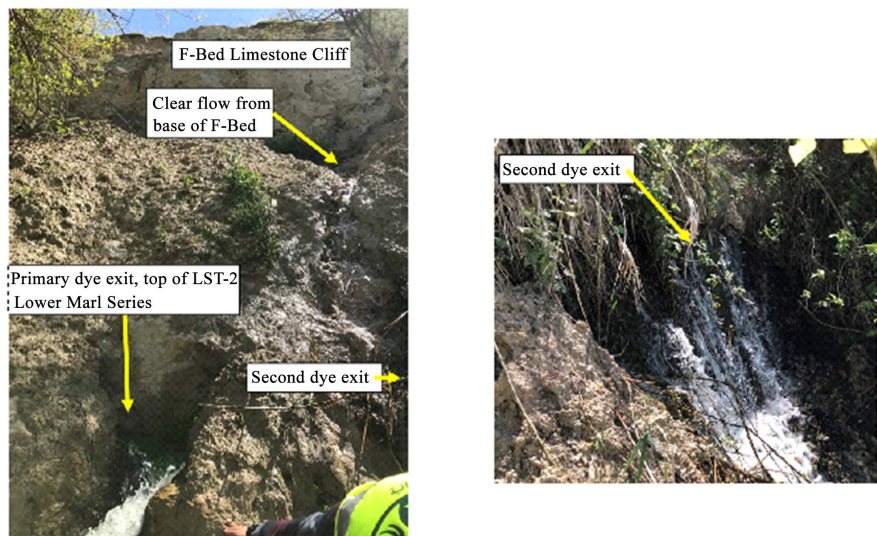
Figure 15. 18 - 24 dye test green dye exiting the LST-2 from two separate seeps.

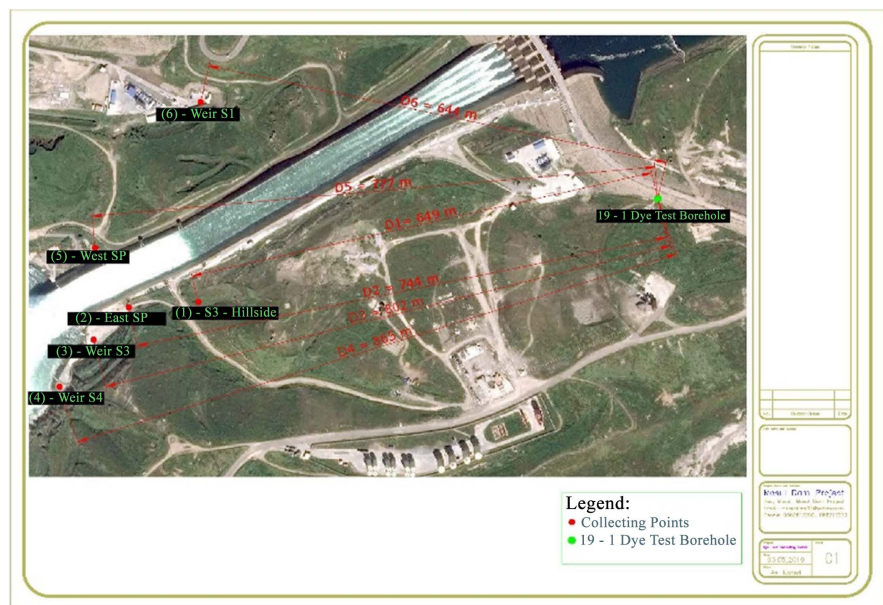
Figure 19. Points where dye was noticed after injection in Pz 19.

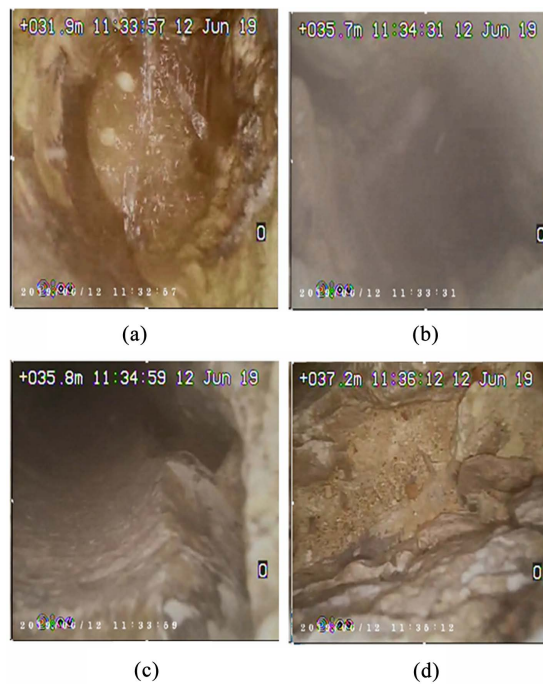
Figure 23. Photos taken by CCTV from the borehole.
