The Effects of Freight Vibrations on Slope Stability along the SH35, Bay of Plenty East, New Zealand

Angelo Indelicato

Stantec UK, Reading, UK

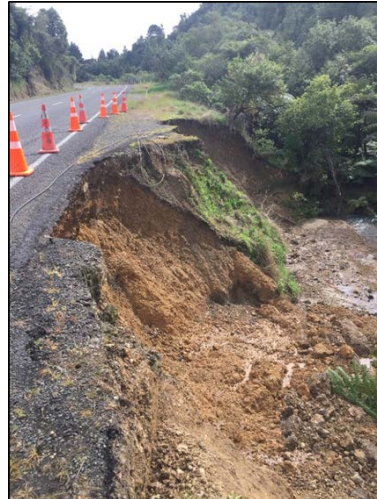
Site 1 is an under slip located at circa 7.7 km East of Tirohanga (Figure 2). The first slip developed in 2016. The most recent slip surface occurred in early September 2018 (Figure 3). The scar is 6 - 7 m high and 13 m wide with a crown that is 0.85 m away from the edge line. The pavement has been undercut so that it is currently overhanging, (i.e. the slip surface is under the road surface). The slope is made of silty clayey sand with an occasional gravel from the Quaternary terrace deposit. Spring water is also present on the slipping surface.

Figure 3. Site 1 under slip (erosion in the base of the road).

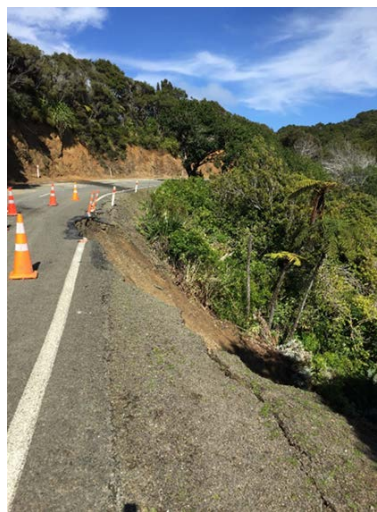
Site 2 under slip occurred in mid-July 2018 (Figure 4) along the white edge line of the carriageway (Figure 5). The width is approximately 35 m. Tension cracks measure up to 100 mm wide with vertical displacements below 80 mm in length. Based on the scouring on greywacke at the cut slope above the carriageway at road level, it is concluded that the slump area was likely within the water runoff flow path. There were visible signs of erosion at the base of the cut slope.

Figure 5. Under slip site 2.

The second episode occurred in the late August 2018 when the slip regressed thus affecting a portion of the outer lane. This was damaged, causing restricted traffic. The slip is 13 m wide, with tension cracks located at 1.5 m from the edge line. The under slip affected only the top 6 m of the entire slope. The debris consists mostly of residual soil from highly weathered greywacke.

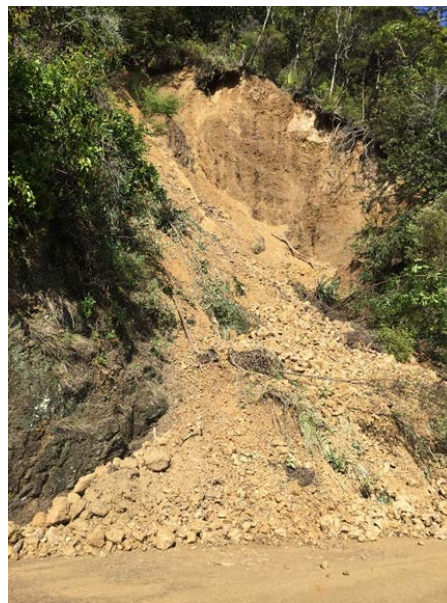
Site 4 over slip released a fair amount of debris estimated to be between 400 to 500 m³. The geometry follows what appears to be a wedge feature within the residual soil. Spring water was still present at the base of the gully (Figure 6).

Figure 6. Over slip site 4.

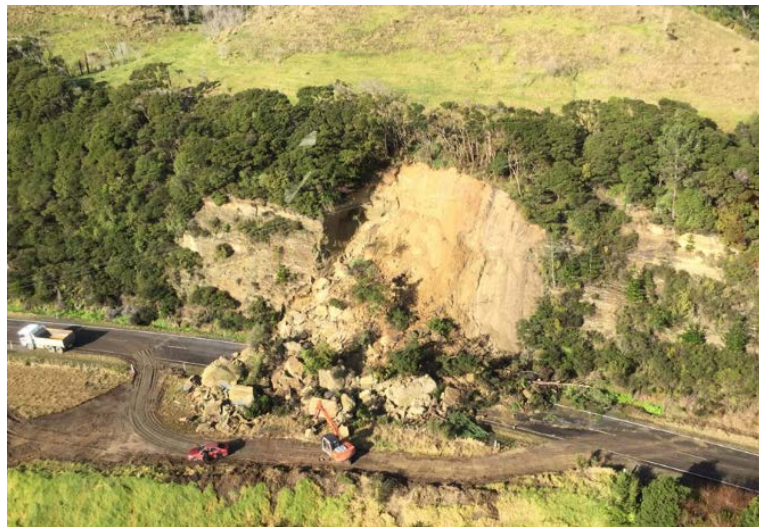
On June 20th, 2018, an earthquake of 4.7 m centered 4 km deep and approximately 35 km southwest of the current rock fall location was recorded. The seismic event may have damaged the already marginally stable site and pushed it close to failure.

One month later, the heavy rain has triggered the rock fall which affected an area 30 m wide by 20 m high located approximately 1 km East of Cape Runaway (Figure 8). The geology of the area shows the failing slope is made of weak to moderately strong sandstone with local tuff beds and marine sandy cemented deposits (Figure 9). Jointing daylight on the road are at an angle of 45°. Bedding plane appears to dip gently back into the slope. Sub-vertical cracks have been identified at the time of failure, and these were likely responsible for the rock fall.

Figure 9. Site 8 rockfall (image courtesy of J. Griffith).
