Assessment of the Current State of Qanibay al-Rammah Complex (908 AH/1502 AD), as a Procedure Precedes the Restoration Process

Essam H. Mohamed

Archaeological Conservation Department, Faculty of Archaeology, South Valley University, Qena, Egypt
Email: essam.mohamed@arch.svu.edu.eg

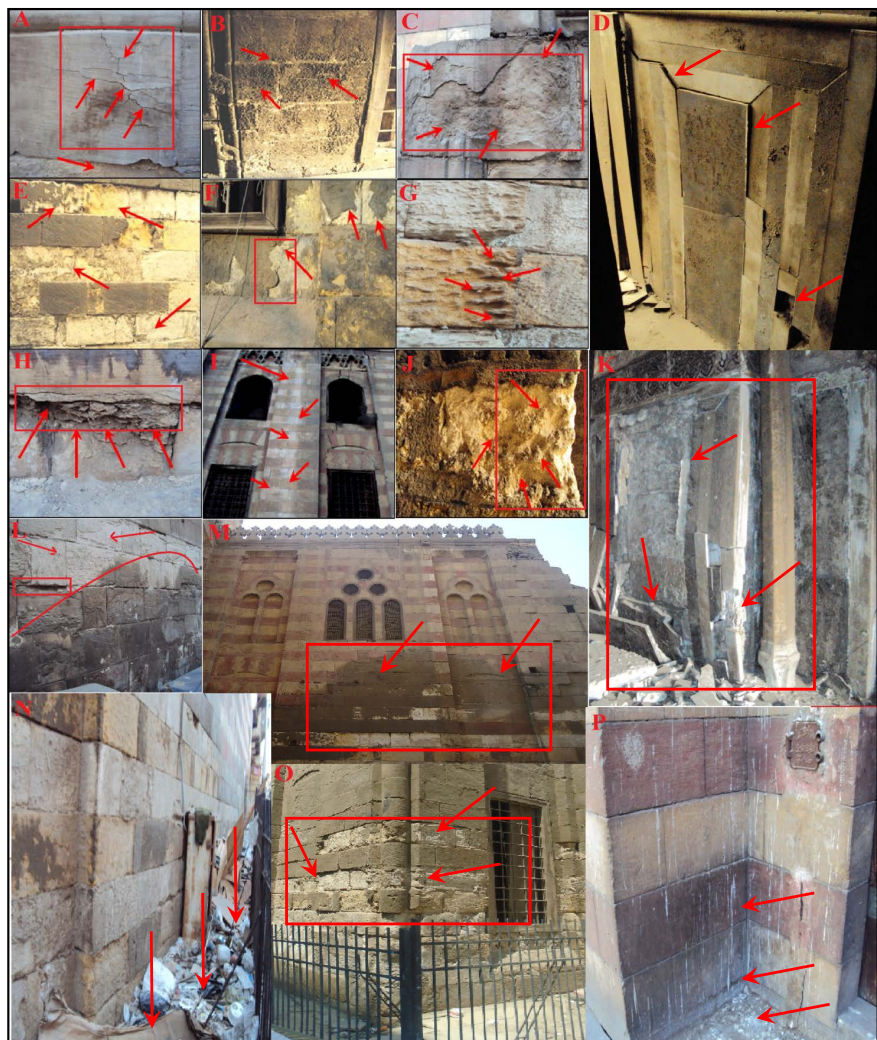
as; efflorescence salts, granular disintegration into powder, separation of crusts or thin sheets of stone surface this phenomenon is known as back weathering, hard black crust on stone surface due to effect of air pollution, loss of stone material, exfoliation, bleeding of stone, fissures, cracks and chipping off pieces,

spots on the stone surface ranging from brown, black, red and green, relief, and pitting on the limestone surface (**Figure 3**).

Figure 3. (A, C, E, F, H, I, P) Micro crack, separation to scaling in external layer, Peeling, erosion, loss of stone material of limestone and biological deterioration symptoms (The western south façade). (B) Soiling on the external surface of stone. (G, J, M, N, O) Alveolization, rounding, soiling, erosion, loss of stone material of limestone, and accumulation of rubbish next to the external façade (the eastern south façade). (D, K) Deterioration and fall down of marble casings (the southern wall of the shrine).

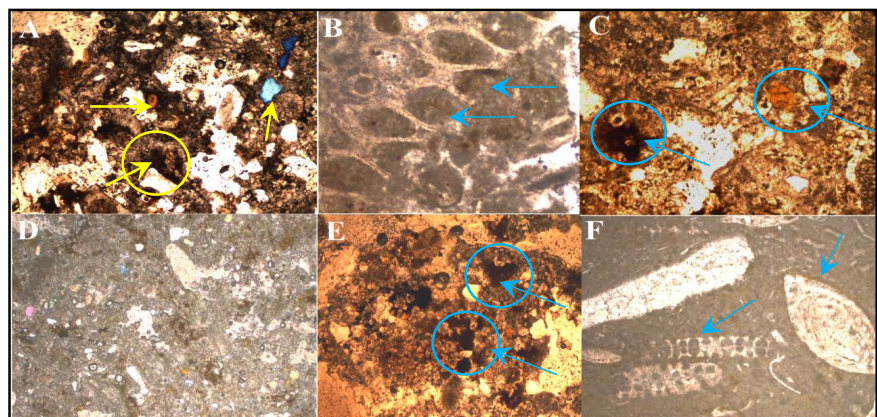
Figure 4. Investigation of thin section shows the presence of calcite with fine grained crystals lined with different iron oxides, in addition to presence nummulite microfossils, foraminifera and Bryozoa echinoid fossils.

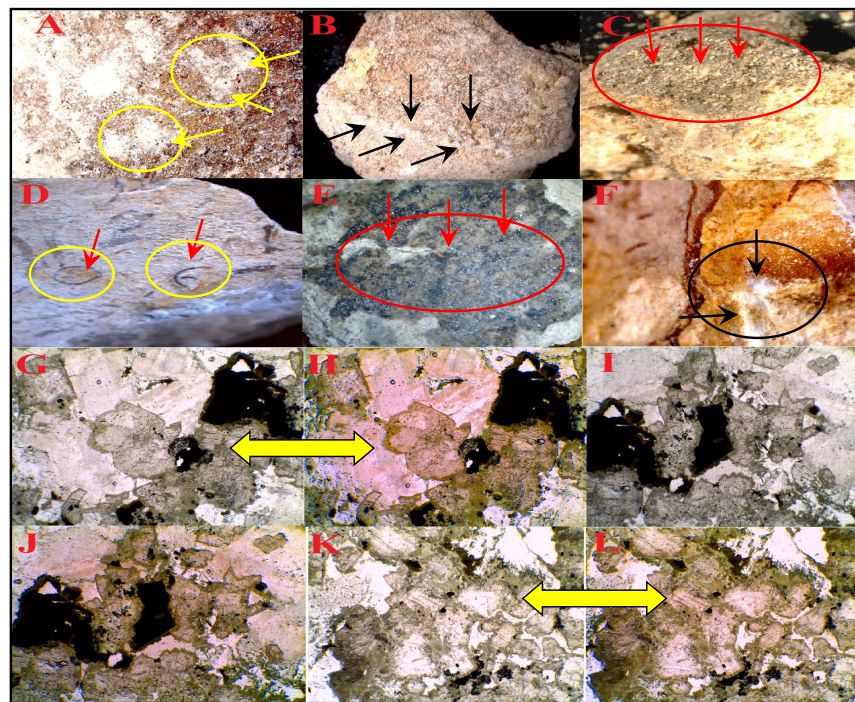
Figure 5. (A-F) Represent the limestone samples that investigated by optical stereo microscope, which show roughening and relief in the stone surfaces, addition to granular disintegration into grains, crystallized salts, soiling and pitting were observed in all samples, fossils shows in D sample. (G-L) Show thin section of the marble samples show compact mosaic texture, coarse grained crystals, cleavage, and micro cracks in the texture.

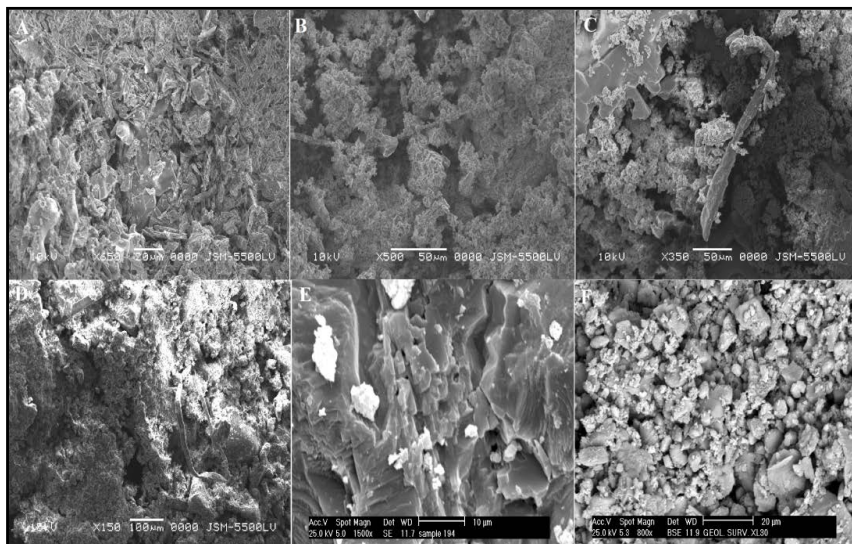
texture of all samples, as well as the presence mosaic texture was in most of marble samples (**Figure 5**). Limestone samples were investigated by SEM, showing micro cracks in internal structure of the stone, disintegration between calcite crystals and dense of halite and gypsum crystals which covers the pores of the stone, in addition to loss of binding materials, and erosion in calcite crystals. Deteriorated marble samples show white marble which consists of combined calcium carbonate with weak porosity, in addition to presence of fungi between grains, compact calcite crystals with a small percentage of salts showed in red marble samples, and heterogeneous calcite crystals with presence crystals of salts showed in green marble samples (**Figure 6**).

Figure 6. (A, B, C) SEM Photographs of deteriorated limestone samples. (A) Shows the deterioration of mineral crystals, and crystalline sulfur salts (650×); (B) Loss of binding materials and crystalline salts (500×); (C) Shows damage of calcite crystals and loss of bonding materials and corrosion of mineral crystals (350×). (D, E, F) SEM Photographs of deteriorated marble samples. (D) Shows white marble that consists of combined calcium carbonate with weak porosity, in addition to presence of fungi between grains (150×); (E) Shows red marble which consists of compact calcite crystals with a small percentage of salts (1500×); (F) Shows green marble which consists of heterogeneous calcite crystals with presence crystals of salts (800×).

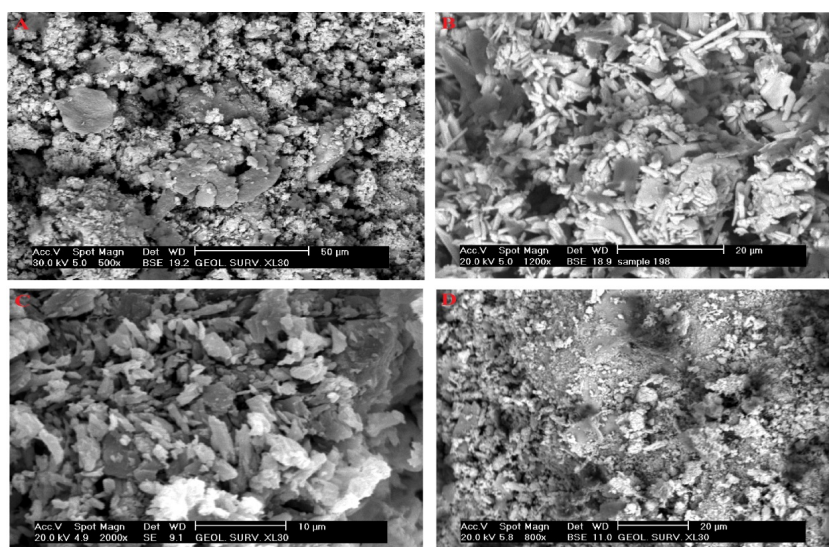
There are two mortars (lime-gypsum) used as binding materials in the joints of stones' courses. Mortars samples were investigated by SEM, the lime mortar samples showed calcium carbonate with an abundance of sand which used as a filler material, the examination shows the presence of fine particles of calcite and quartz, in addition to hematite, feldspar, and gypsum as minor minerals. The second kind of mortars used in case study is gypsum mortar, where it was investigated by SEM, which showed aggregates of gypsum with particles of calcite and quartz. From examination showed disintegration of mortar crystals due to loss of bonding materials, which led to appearance of voids and disassembled particles, this is due to the effect of groundwater on building materials (**Figure 9**).

Figure 9. SEM Photographs of mortars used in Qanibay al-Rammah madrasa. Lime mortar (A, D) show presence crystals of calcite with an abundance of sand, from photographs show disintegration the mineral crystals due to loss of bonding materials. Gypsum mortar (B, C) show crystals of gypsum with aggregats of quartzite, in addition to particales of calite.

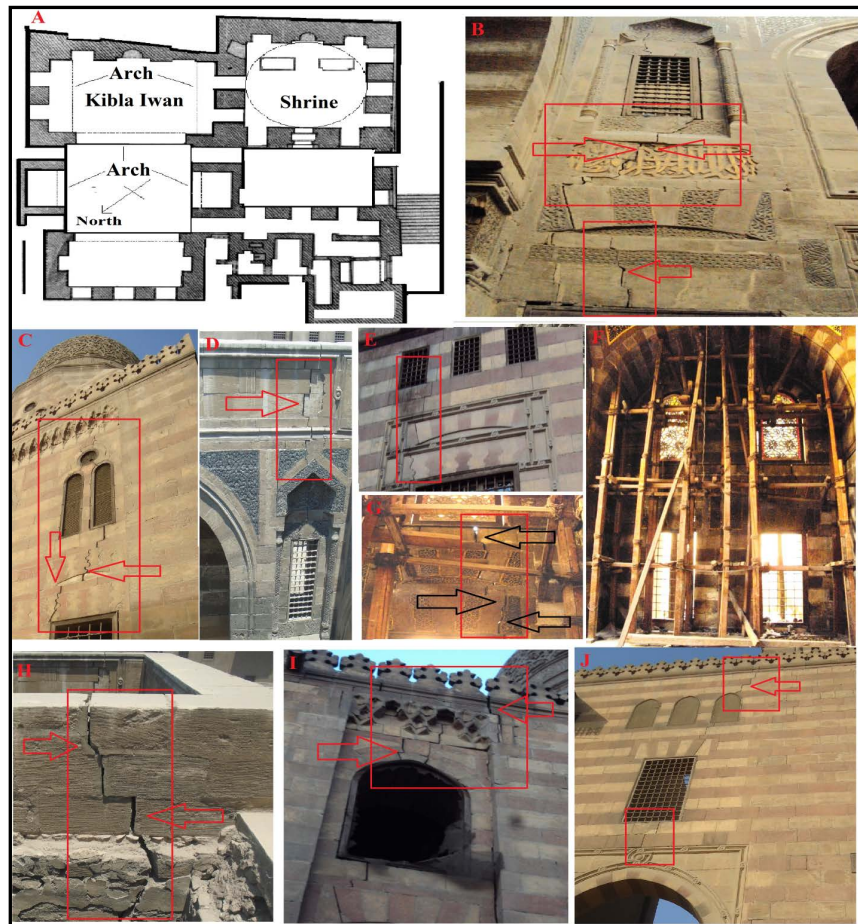
An intermediate earthquake took place near Dahshur, Egypt, about 20 km south of Cairo, on 12 October 1992, the earthquake's strength was between 6 and 7 on the Richter scale. This earthquake combined with other large earthquakes have affected Qanibay al-Rammah madrasa, but the recent earthquake may have caused a large amount of damage because of poor structural conditions of the building (Figure 11) [28].

Figure 11. (A) Horizontal design of Qanibay al-Rammah madrasa; (B) J. showing cracks with different size in different places of the building.

The permissible shear force was calculated according to Egyptian building code, which was 140 N, this means that if the force exceeds this value, the building will be exposed to cracks. From designed model by (F.E.M) was determined the critical places of Qanibay al-Rammah madrasa which is next the east northern arch of the great Iwan, the upper parts of corners, the middle-upper part from the east northern wall of the shrine, the upper parts of corners of the west southern facade of the shrine, and the upper parts of corners of the east northern facade of great Iwan. These places show different cracks with different size, due to effect the shear force of earthquakes (**Figure 11** and **Figure 12**).

The study results give way to us to identify the current state of Qanibay al-Rammah madrasa (as a procedure precedes the restoration) to find the appropriate method to the intervention with improving the building materials properties and reinforcement of structural elements subjected to cracks and supporting the places exposed to a high bending moment and shear force.

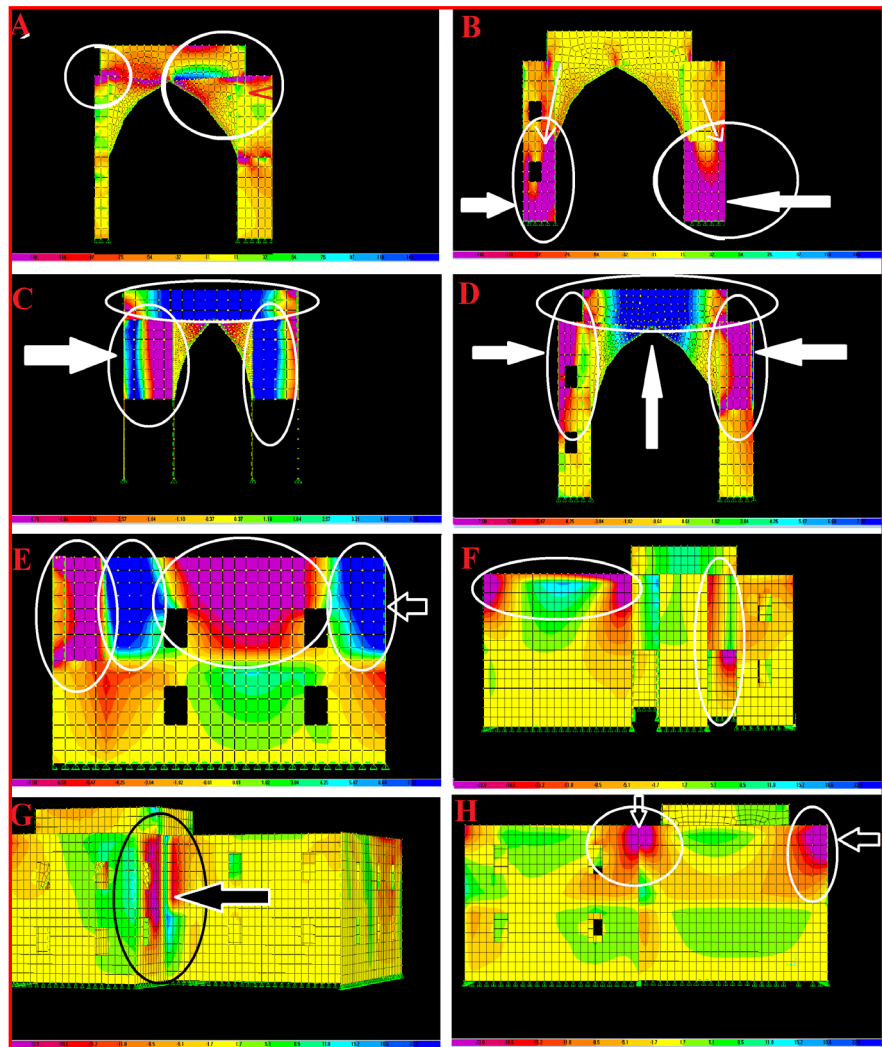
Figure 12. (A) The paralleled shear force to the section due to affected earthquakes force in the direction of (X-X). (B) The effect of the parallel shear force of the section in the direction (Y-Y). (C) (D) The bending moment affecting the section in the direction (X-X) and (Y-Y) (the east Iwan of great Iwan). (E) The bending moment affecting the eastern wall of the shrine. (F) The bending moment affecting the eastern wall of the building in the direction (X-X). (G) The bending moment affecting the east-south facade in the direction (X-X). (H) The bending moment affecting the west-south facade in the direction (X-X).

The bending moment in directions (X and Y) was calculated by PROKON software, the allowable value of bending moment was 4.78 Kn-m in direction (X-X), and 29 Kn-m in direction (Y-Y), this means that if the bending moment exceeds this value, the building will be exposed to cracks and collapse, where determined the critical places of Qanibay al-Rammah madrasa (**Figure 12**).

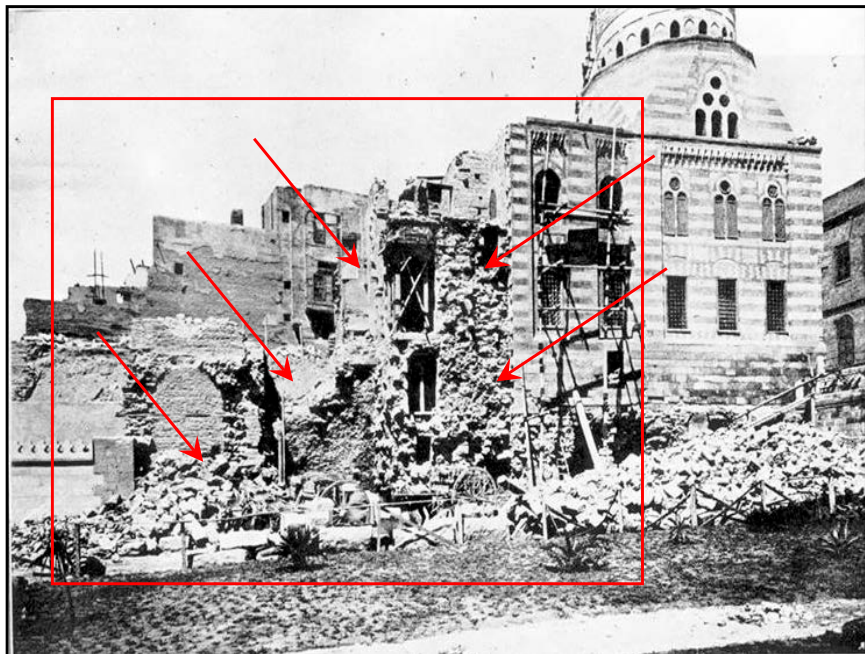
We observed the building materials used in the southern partition of the building such as the southern east façade, the southern east iwan and the shrine contain advanced stages of various deterioration symptoms, due to that this part of the building has been subjected to greater damage factors since the time of construction until at the moment, while rest of the madrasa was reconstructed after that it was ruined (**Figure 13**) [29] [30].

Figure 13. Qanibay al-Rammah complex, the western north iwan, part of the western south iwan and minaret are ruined.
