Slope Stability Analysis of Itakpe Iron Ore Mine, Itakpe, Nigeria

Abstract

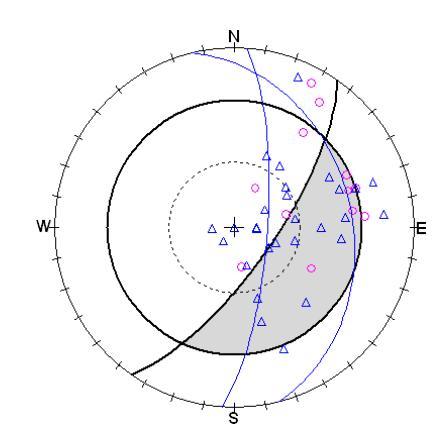
One hundred and twenty three dip and dip direction values were obtained from the Itakpe iron ore deposit. The friction angle obtained for the Itakpe iron ore deposit is 36° which is the minimum dip angle for which sliding will occur along a discontinuity while the cohesion value is 55kN/m² (Table 2). Some of the input data used includes bench height of 10 m, rock density of 3.80 kN/m^2 and inclination of failure plane of 50° (Table 3). The data were plotted using ROCKPACK III. The slope of Itakpe iron ore deposit was divided into four bench levels; 241 -258 m, 263 - 275 m, 276 - 286 m, and 308 - 312 m. The slope on level 241 - 258 m contains discontinuities that are mainly made of small joints. Forty dip and dip direction values were plotted for the 241 - 258 m level. Figure 1 indicates the dip vector plot of the values plotted. The discontinuity dip vectors plotted which fall within the critical zone dip more steeply than the friction angle of 36° while those that are outside the friction circle dip less steeply than the slope face. Figure 1 also shows the Markland's test carried on the dip vectors. Markland test is a valuable tool for identifying those discontinuities that could lead to planar failures in the rockmass and this allow for the elimination of other discontinuities. The discontinuities within the critical zone are potentially unstable and can lead to planar failure. Markland test for wedge failure was also carried out .The great circle of

Figure 1. 241 - 258 m Markland test (Itakpe iron ore mine).

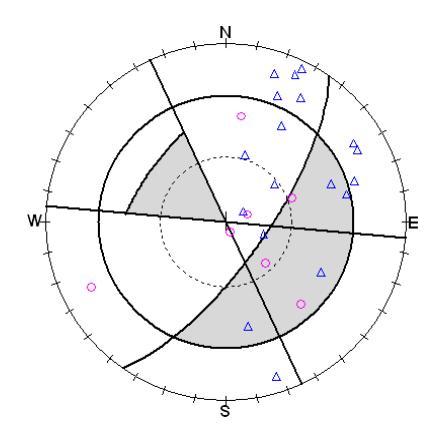
dip and dip direction values 18/023 and 78/074 were plotted at the centre of the two clusters identified. The two great circles represent the discontinuities of each cluster. The intersection of the discontinuities does not fall within the critical zone hence there cannot be any wedge failure at the slope within the level 241 - 258 m bench level (**Figure 1**). The intersection point is the plunge and trend. The kinematic in Markland was carried out for Toppling test. There is no likelihood of toppling failure because the discontinuities do not fall within the toppling zone (**Figure 2**).

Figure 2. 241 - 258 m (Toppling test).

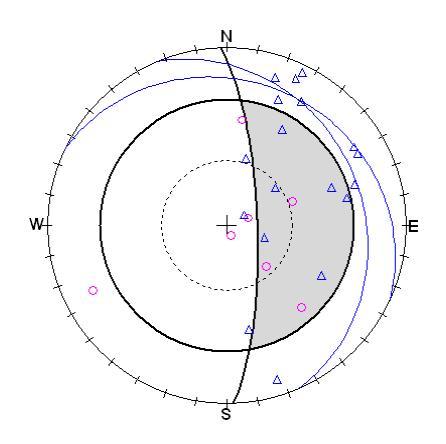
small joints were plotted on the stereonet using ROCK-PACK III. Figure 3 shows the dip vector plot of the discontinuities. Markland's test was carried out for the slope on the 263 - 275 m level. Although there are some discontinuities in the critical zone, the intersection of the two great circles did not occur in the critical zone. The dip and dip direction of the two great circles are 025/20 and 067/25 and their point of intersection is outside the critical zone (Figure 3). Although some discontinuity values fall within the critical zone but the fact that the intersection of the great circle did not occur within the critical zone indicates that there cannot be planar failure on the slope at that level. The wedge failure -analysis in Markland carried out for the slope on 263-275m level indicates the absence of potential wedge failure because the two great circles did not intersect in the critical zone (Figure 3). The toppling failure analyses carried out for the 263-275m level indicates that the absence of any discontinuity in the toppling zone (Figure 4).

Figure 3. 263 - 275 m Markland test.

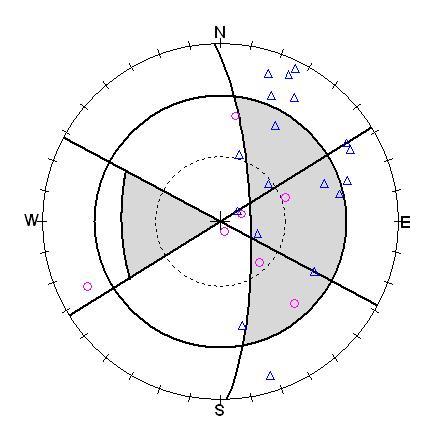
Figure 4. 263 - 275 m Toppling test.

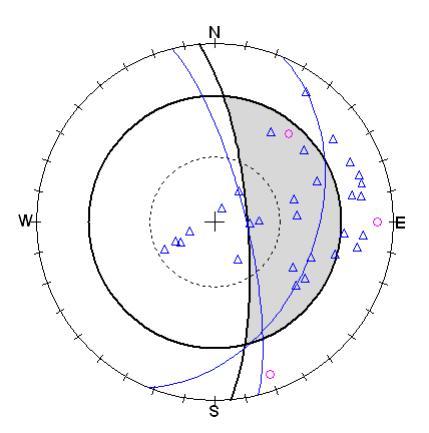
Figure 5 indicates the dip vector plot of discontinuities of slope on 276 - 286 m level. The Markland test carried out shows the presence of discontinuities that plot within the critical zone which indicates the possibility of

planar failure. However wedge failure analysis carried out using two great circles with orientations 076/76 and 112/43 also indicates the possibility of wedge failure, because of the intersection of the two great circles within the critical zone (**Figure 5**). Also the presence of discontinuities that plot within the toppling critical zone indicates that there is potential toppling failure on the slope at the 276-286m level (**Figure 6**).

Figure 5. 276 - 286 m Markland test.

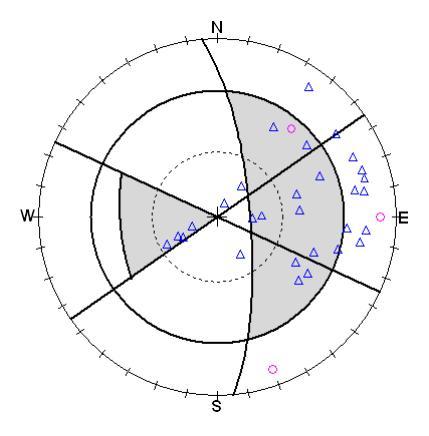
Figure 6. 276 - 286 m Toppling test.

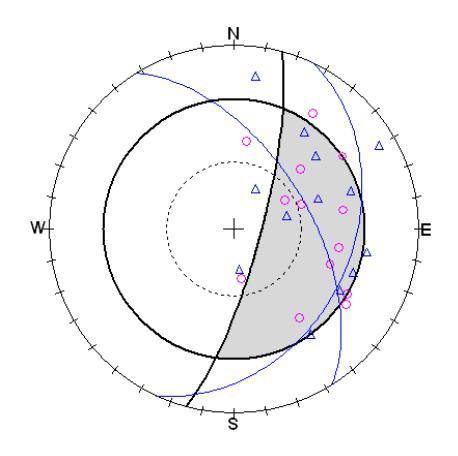
of slope on 308-312m level The Markland test carried out shows the presence of discontinuities that plot within the critical zone which indicates a potential planar failure (**Figure 7**). Also the wedge failure test carried out using two great circles with orientations 115/36 and 058/57 have the intersection of the point within the wedge critical zone which indicates there is possibility of potential wedge failure of slope at the 308 - 312 m level. In addition the toppling failure test shows the absence of discontinuities that plot within the toppling critical zone which indicates the of potential toppling failure of the slope at the 308 - 312 m level (**Figure 8**).

Figure 7. 308 - 312 m Markland test.

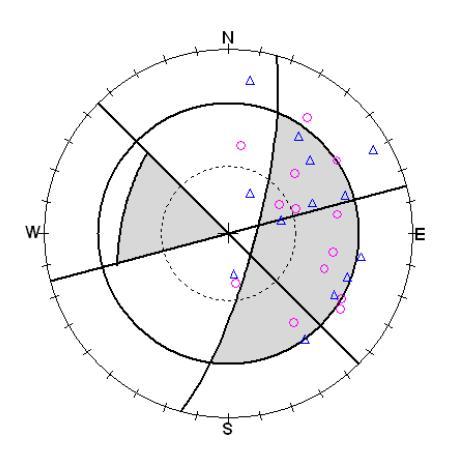
Figure 8. 308 - 312 m Toppling test.

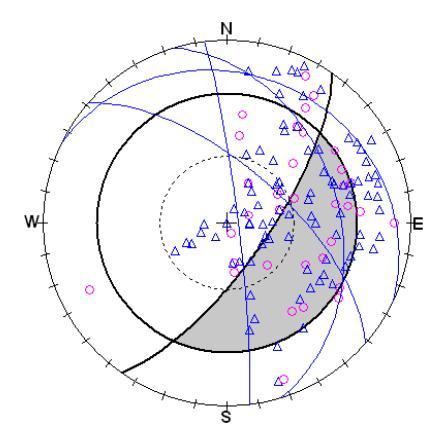
The one hundred and twenty three dip and dip direction values was plotted and the dip vector plot is indicated in **Figure 9**. Markland test was carried out using four great circles of 090/85, 073/39, 041, and 026/20 and the intersections of these great circle indicates possibility of planar failure (**Figure 10**). The toppling test carried out further confirmed that there is no possibility of toppling failure (**Figure 10**). However the result of the analysis carried out using Rockpack III indicates a factor of safety of 0.61 which is below 1 considered as mini-

Figure 9. Total dip vector plot (Markland test).

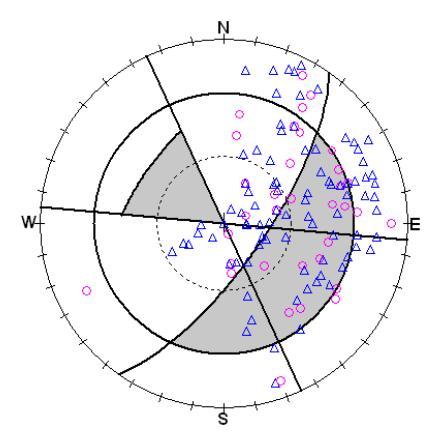
Figure 10. Total dip vector (Toppling test).
