The WW II German Coastal Artillery Battery *H.K.B.1274/StP C342* at Camaret sur Mer (Finistère—FR)

Giancarlo T. Tomezzoli

How to cite this paper: Tomezzoli, G. T. (2017). The WW II German Coastal Artillery Battery *H.K.B.1274/StP C342* at Camaret sur Mer (Finistère—FR). *Archaeological Discovery*, 5, 116-141.

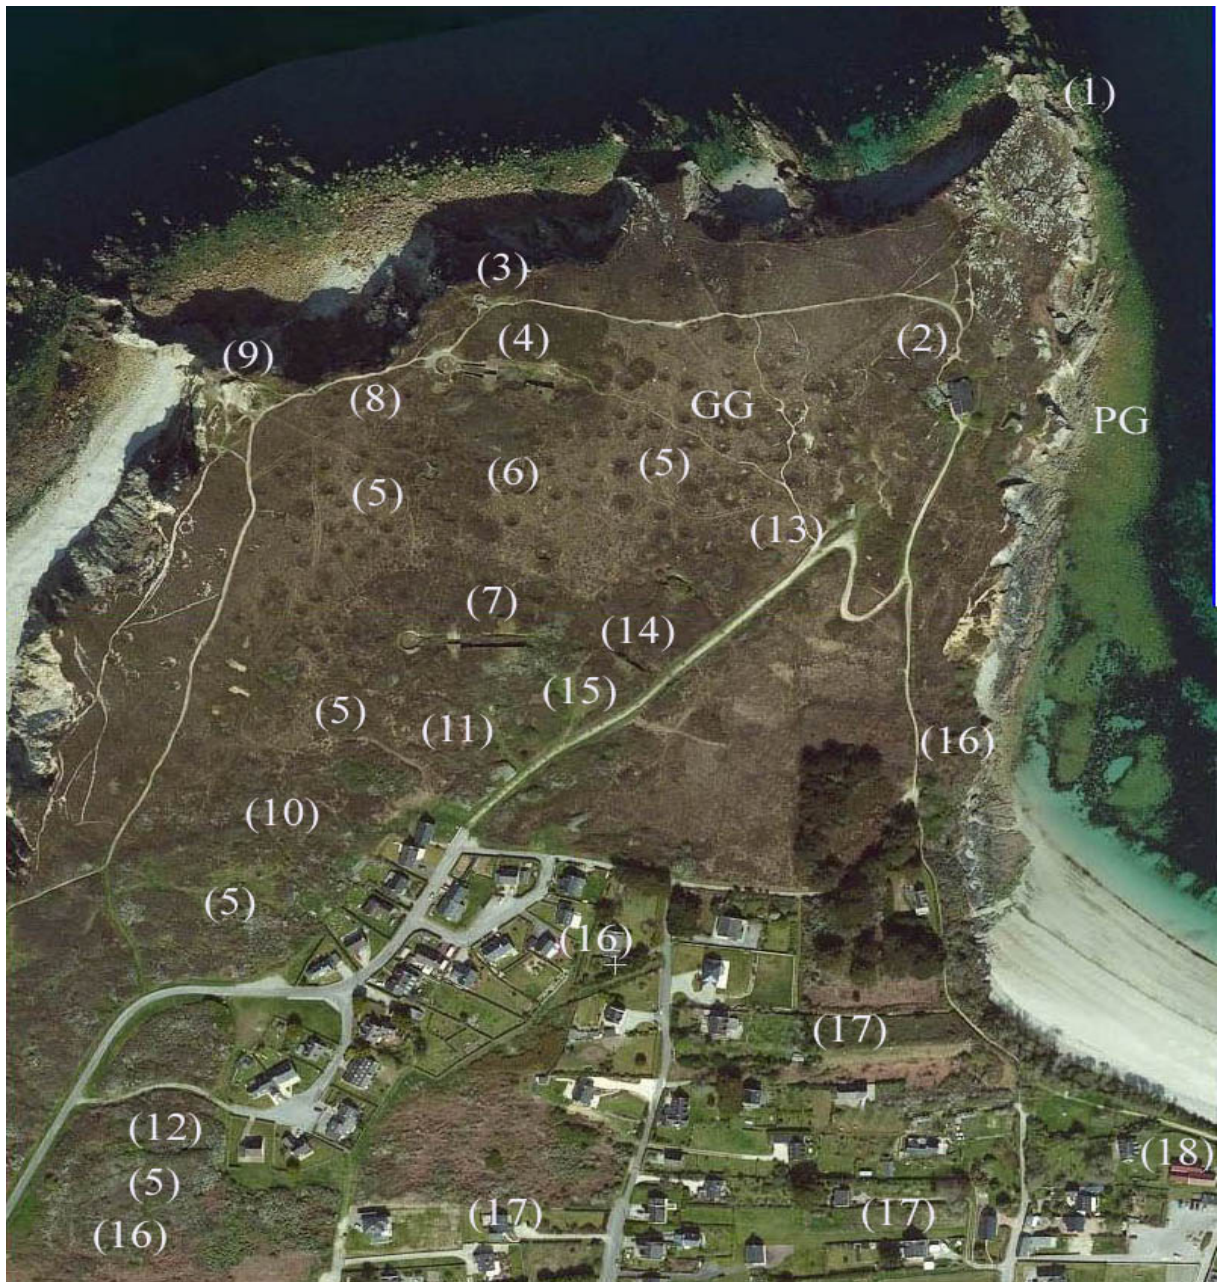
Figure 1. H.K.B. 1274-PG Petit Gouin pointe; GG Grand Gouin pointe; (1) platform and barrack; (2) 2 × 2 cm *Flak* gun 30 emplacements; (3) reflector emplacement; (4) 1st open gun emplacement; (5) bombed areas; (6) square emplacement; (7) 2nd open gun emplacement; (8) latrine; (9) observatory bunker; (10) destroyed 3rd open gun emplacement; (11) destroyed 5 × C9 75 mm gun emplacements; (12) destroyed 4th open gun emplacement; (13) 3 × possible French concrete, joined barracks; (14) *H622* and *H638* bunkers; (15) *H641* bunker; (16) security perimeter: metal barrier and *tobrucks*; (17) minefields; (18) Camaret sur Mer [GeoPortail].

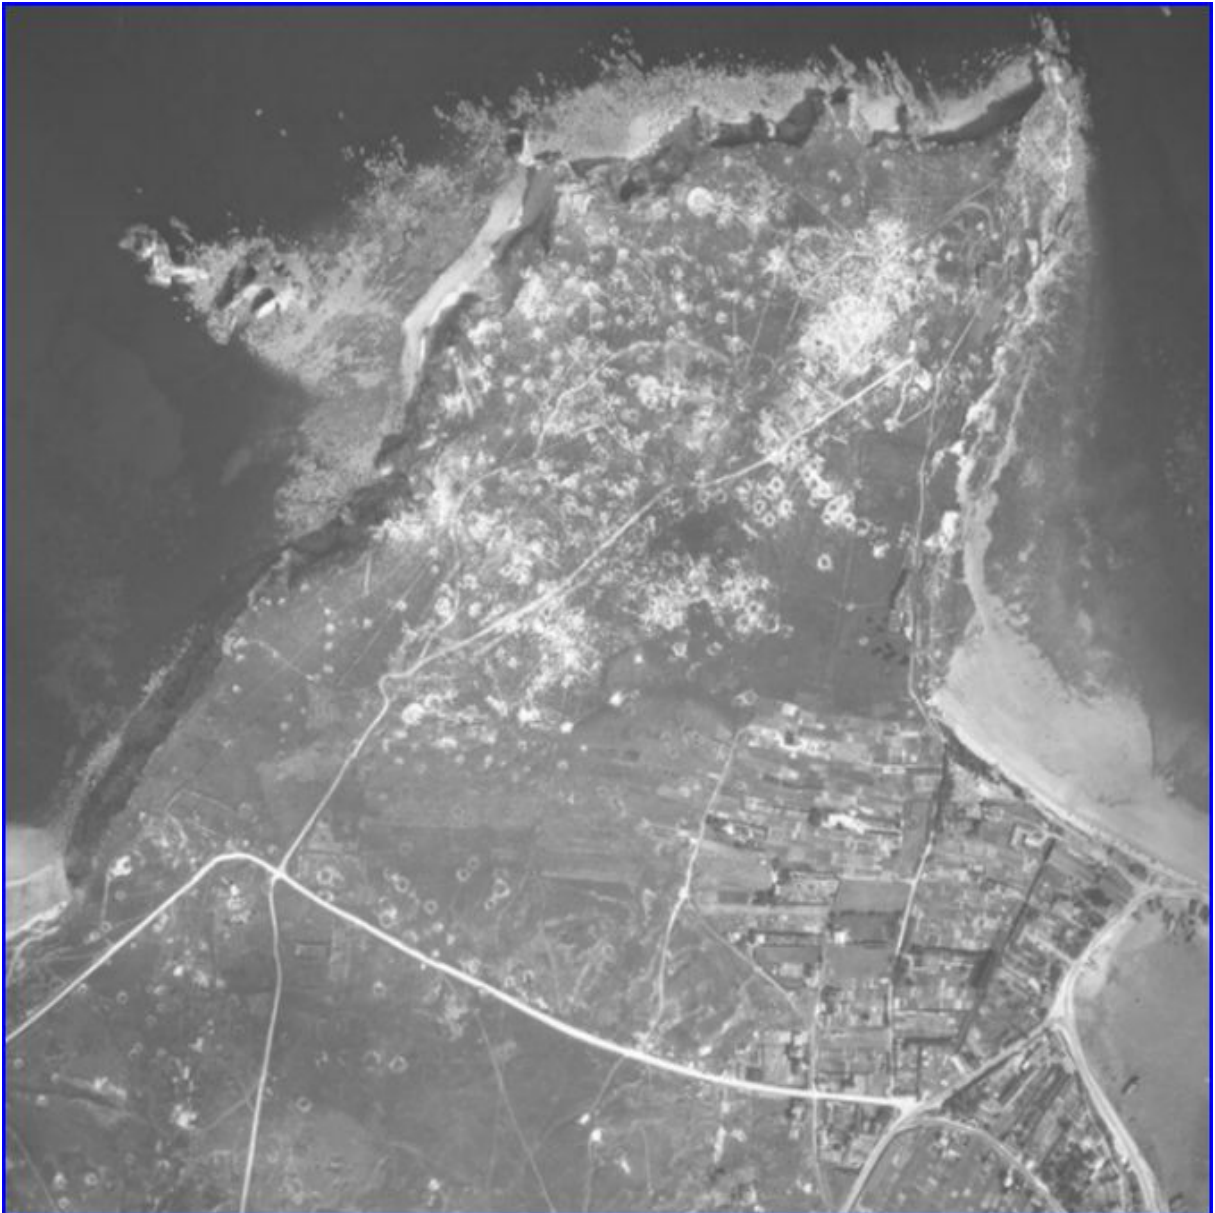
Figure 2. Mission 601 bombardment of *H.K.B.* 1274-C0417-0301_1951_CDP3760_0984, n°984, 1/5154, 27/07/1951 [GeoPortail].

The bombardment of *H.K.B.1274* (Figure 2) was successful. Many of its components on the Grand Gouin pointe were completely destroyed or seriously damaged. The components on the Petit Gouin pointe, protected by a cliff or intentionally left aside, escaped the bombardment.

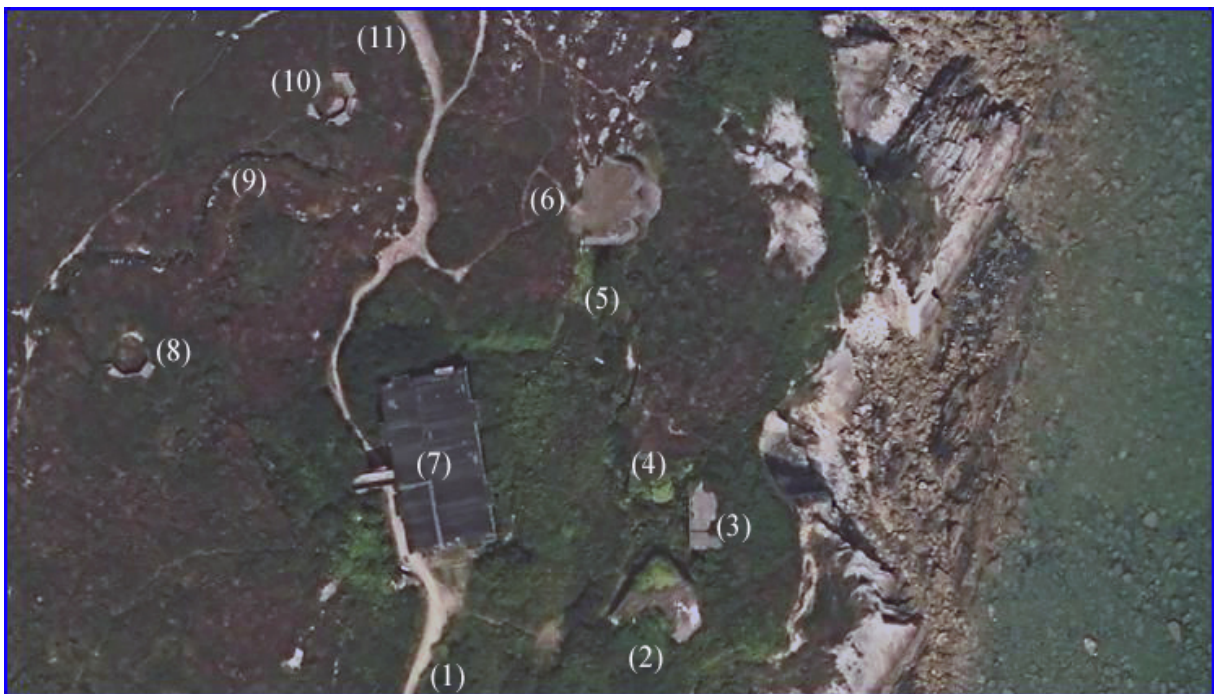
The *H.K.B.1274* components identified on the Petit Gouin (Small White) pointe (Figure 3) were the followings.

Figure 3. Petit Gouin pointe (1) access pathway, (2) 1st *R670*, (3) 1st barrack, (4) 2nd barrack, (5) concrete platform, (6) 2nd *R670*, (7) French crenelated guardhouse, (8) 1st 2cm *Flak* gun 30 emplacement, (9) connection trench (10) 2nd *Flak* gun 30 emplacement, (11) pathway to the Grand Gouin pointe [GeoPortail].

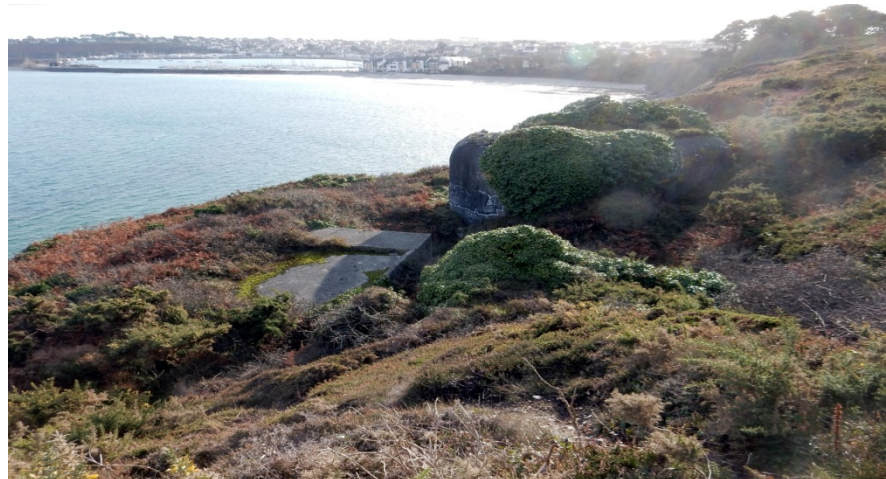
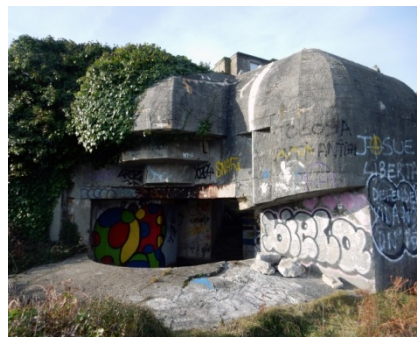
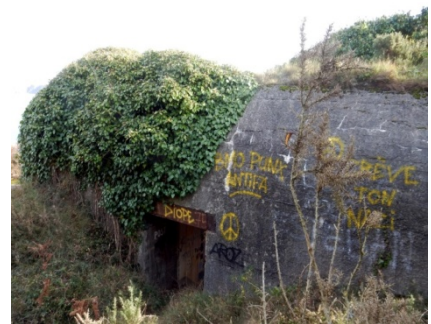
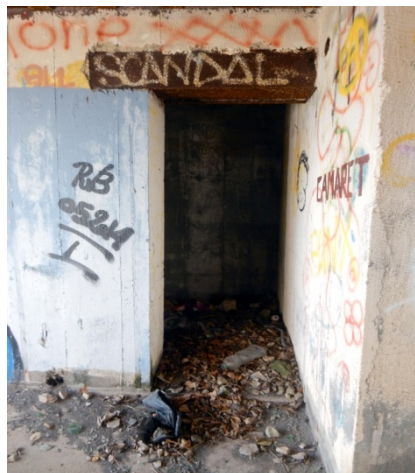
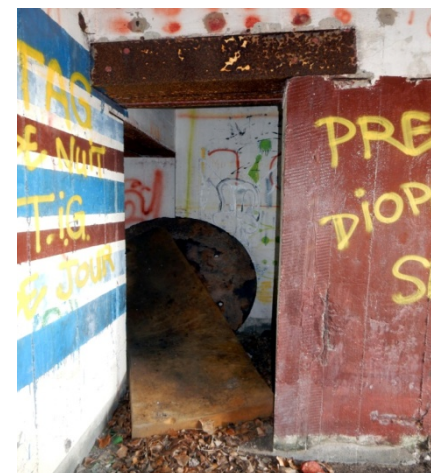
A 1st *R670* (48°17'08.52"N, 04°36'03.76"W) (Figure 4) for 7.5 cm C/97 Schneider gun. It presented a well preserved concrete structure decorated by contemporary, coloured graffiti, without damages due to the bombardment or combats. The narrow rear aperture of the fire room close to the cliff suggested that the hosted gun was detached from its mobile carriage, introduced into the fire room through its front aperture and mounted on a support anchored to fixing bolts in a square aperture on the floor of the room. The fire room was empty,

Figure 4. 1st R670 (a) view from the 2nd R670, on the left 1st barrack, on the foreground Camaret sur Mer; (b) front side with splinter guards, on the top left the French crenelated guardhouse of 1859; (c) rear side with entrance to the fire room close to the cliff; (d) ammunition room; (e) combat gas extraction system room.

deprived of its original furniture and decorated by coloured graffiti. On the walls, no traces of a thermal insulation system. The fire room and the combat gas extraction system room preserved some rusted portion of conduits. The metallic ceiling preserved two joints for the gun lifting and the grids of the combat

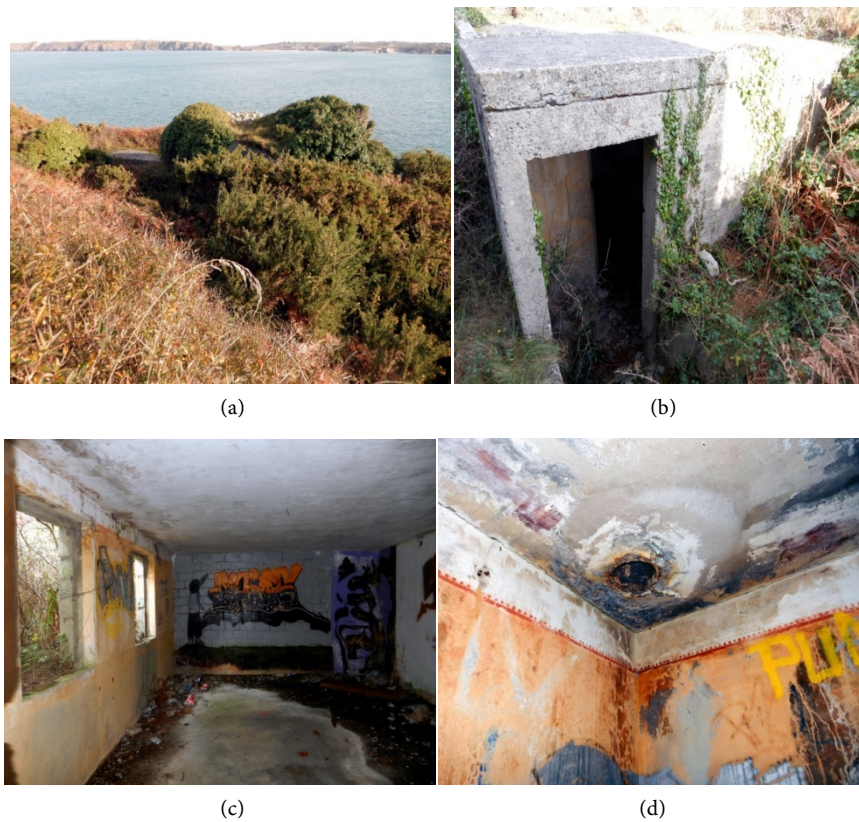
A 1st barrack (48°17' 08.86" N, 04°36' 03.54" W) (**Figure 5**), close to the 1st R670, about 4 × 8 m. It was partially buried in the terrain. Its emerging, concrete structure was well preserved without damages due to the bombardment or combats. Two windows, opened towards the cliff, provided light to an internal, single room preserving its probably original wall pale, ochre painting, covered by contemporary, coloured graffiti, and ceiling white painting. On the ceiling a chimney hole confirmed that it was habitable, notwithstanding the absence of a latrine and traces of electrical elements. Probably it was used as guardhouse. All the original furniture disappeared and the room was partially filled with terrain fell from the cliff through the windows. The traces of the formwork elements visible on the external walls, typical of the German masonry, confirmed that it was of German construction.

Figure 5. 1st barrack (a) coverage, on the top Trez-Rouz beach “British Death”; (b) entrance; (c) lodging room; (d) chimney hole probably for *Festungshofen* (fortress oven) WT80.

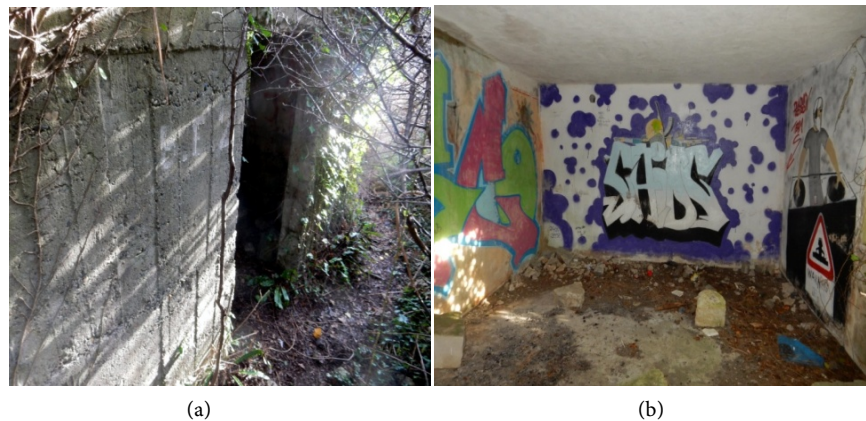
A 2nd barrack (**Figure 6**), close to the 1st one, about 4 × 5 m. It was completely buried in the terrain. Its emerging concrete structure was well preserved without damages due to the bombardment or combats. Two windows, opened towards the cliff, provided light to an internal, single room preserving its probably original wall pale, ochre painting, covered by contemporary, coloured graffiti, and ceiling white painting. The absence of a chimney hole on the ceiling, a kitchen, a latrine and traces of electrical elements confirmed that it was not habitable and probably used as material depot. All the original furniture disappeared and

Figure 6. 2nd barrack (a) entrance; (b) internal, single room.

the room was partially filled with terrain fell from the cliff through the windows. It too was of German construction.

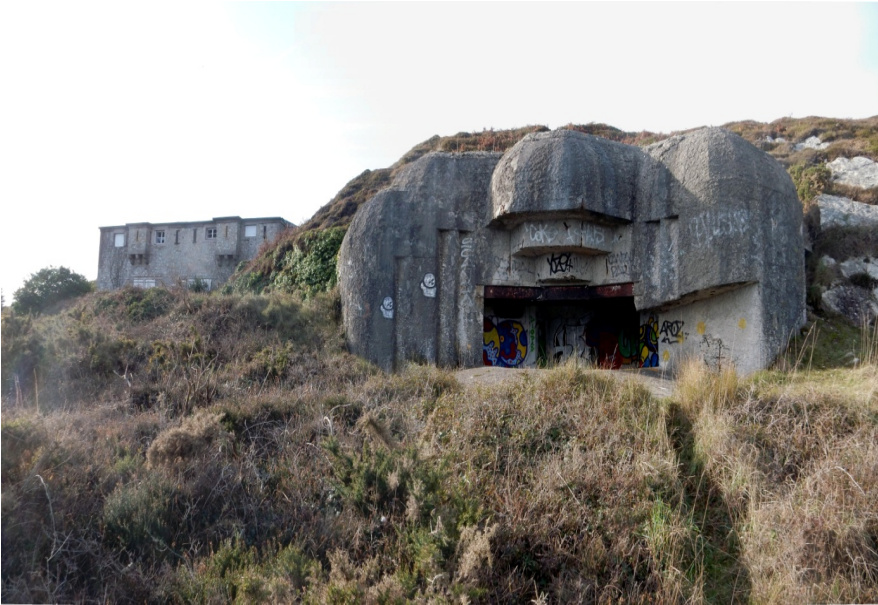
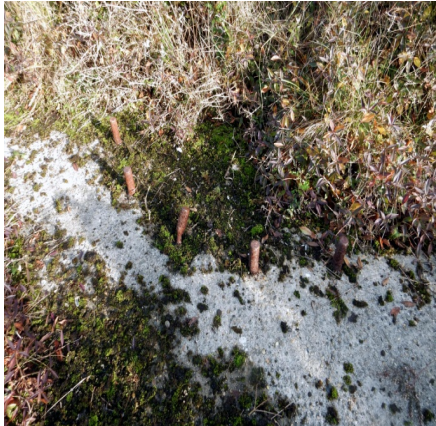
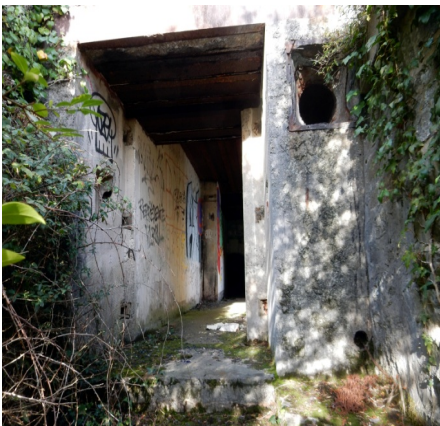
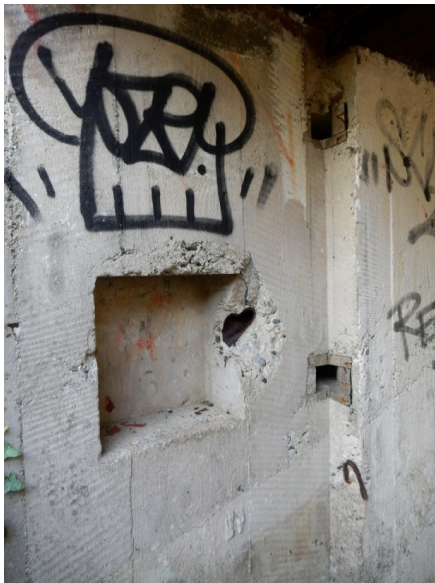
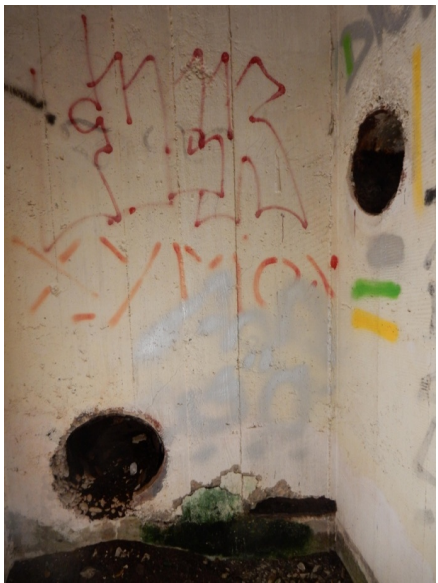
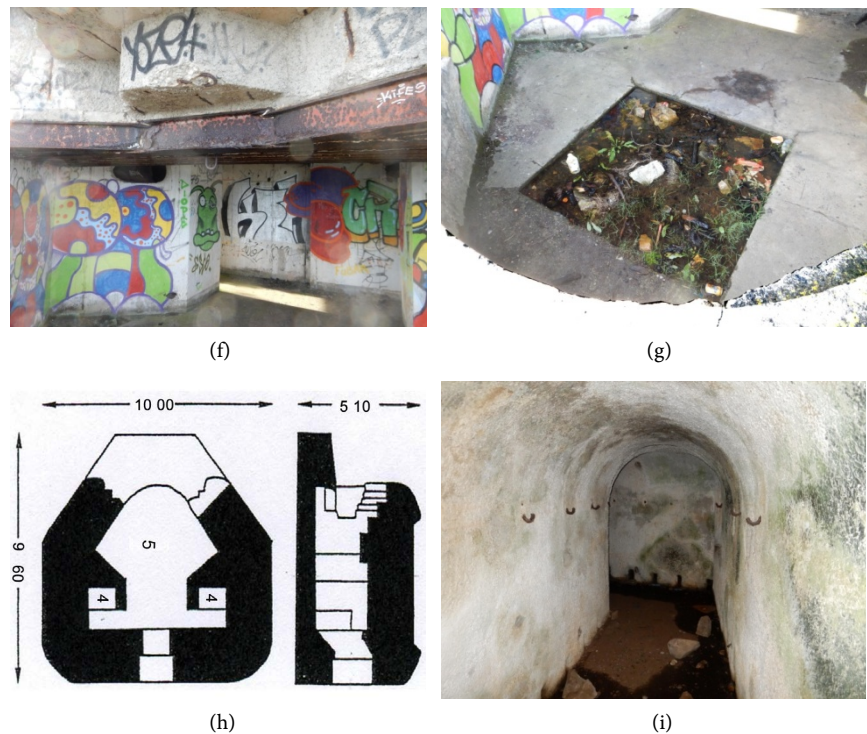
A 2nd R670 (48°17'10.06"N, 04°36'04.07"W) (**Figure 7**) for 7.5 cm C/97 Schneider gun, about 40 m north from the 1st one. It presented a well preserved concrete structure decorated by small, contemporary, coloured graffiti, without damages due to the bombardment or combats. It was accessible from the two barracks through a concrete staircase bringing to a concrete platform provided with two fixation bolts positions for gun or projector supports. At the platform end, a corridor entrance brought to the ammunition room, the combat gas extraction system room and the rear side opening of the fire room of the bunker. The fire room was empty, deprived by its original furniture and decorated by coloured graffiti. On the walls, no trace of a thermal insulation system. The fire room and the combat gas extraction system room preserved some rusted portion of conduits. The metallic ceiling preserved two joints for the gun lifting and the grids of the combat gas extraction system. At its end, the corridor further gave access to another barrel vault corridor, probably of French construction, carved into the cliff, having cable supports on the walls. This corridor, folded at 90°, gave access to an empty room about 5 × 5 m of unknown purpose.

A French crenelated guardhouse (48°17'09.09"N, 04°36'05.08"W) (**Figure 7 (a)**), 10 × 20 m (**Dion, 1996**). It was closed and not accessible to the public. The underground floor hosted a cistern. The first floor, partially protected by the cliff, comprised an access portal, 4 rooms for lodgements and services of the French garrison and 5 smaller rooms for hosting services, ammunitions and artillery materials. The second floor was the artillery terrace and was covered and rendered habitable in the first half of the 20th century. It comprised an access portal connected to the cliff by a bridge and 8 turrets with louvers (**Glad Patrimoine de Bretagne, 2002a**).

Figure 7. 2nd R670 (a) fire room front side aperture with splinter guards, on the upper left the 1859 French crenelated guardhouse; (b) concrete platform with one of the two fixation joints position for a gun or projector support; (c) corridor entrance, on the right exhausted combat gas conduit niche; (d) niches at the bunker entrance; (e) combat gas extraction system room, rusted conduits rests; (f) fire room entrance, metallic ceiling with joint for gun lifting; (g) square gun emplacement with plied fixing bolts; (h) R670 plan. 4 ammunition room and combat gas extraction system room, 5 fire room (Rudi, 1998); (i) barrel vault corridor to an empty room of unknown purpose carved into the cliff.

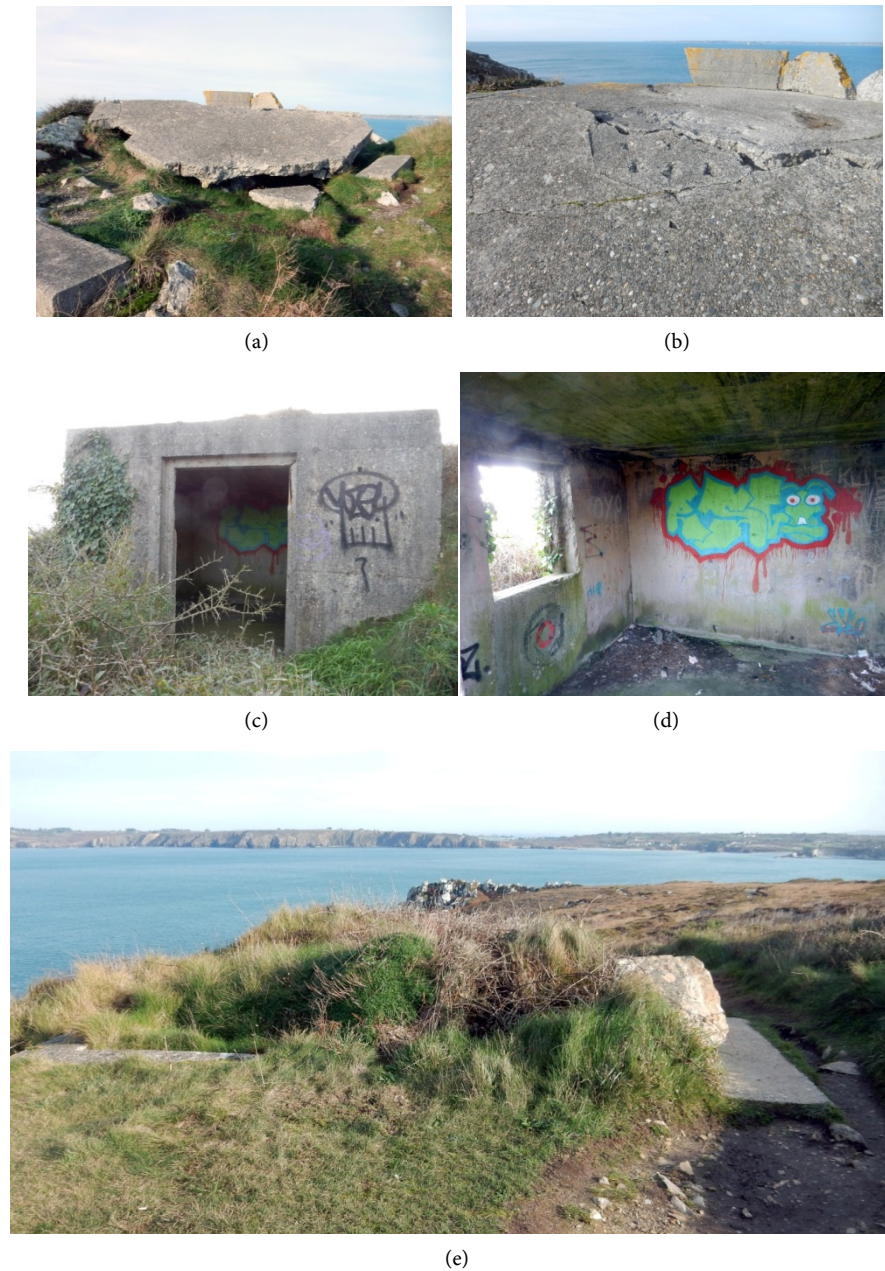
A platform (48°17'13.12"N, 04°36'04.47"W) (**Figure 8**), about 4 m diam. and

20 cm thick. It preserved an erected part, about 50 cm high, of its original parapet. A collapsed portion along a fracture line crossing its center leaned on the ground masking the platform support. The collapse was due either to a structural failure or to the vibrations induced on the platform by the bombardment. An octagonal incision on its surface confined small triangular incisions probably for the adhesion of a concrete coverage. On the platform, mixed in the concrete, the pebbles of the *Ero Vili* (Tomezzoli & Marzin, 2015) were clearly visible.

A barrack ($48^{\circ}17'12.15''N$, $04^{\circ}36'04.32''W$) (Figure 8), about 8×4 m. It presented a well preserved concrete without damages due to the bombardment (Figure 9) or combats. A window provided light to an internal, unpainted, single room, covered by contemporary coloured graffiti. Although a chimney hole in the ceiling, a kitchen, a latrine and of traces of electrical elements were absent, its position near the platform suggests that it was used for lodging the personnel in service at the platform. The traces of the formwork elements visible on the external walls confirmed that it was of German construction.

A rectangular component ($48^{\circ}17'12.36''N$, $04^{\circ}36'12.45''W$) (Figure 8), about 5×3 m emerged at the ground level. It presented well preserved concrete sides 50 cm thick and its interior was filled by a concrete blocks and terrain. Its purpose is unknown.

Figure 8. Grand Gouin pointe (a) platform, collapsed portion; (b) platform, fracture line and incisions; (c) barrack near the platform; (d) interior single room; (e) rectangular component of unknown purpose, on the left the Goulet mound, in the middle the Grand Gouin pointe.

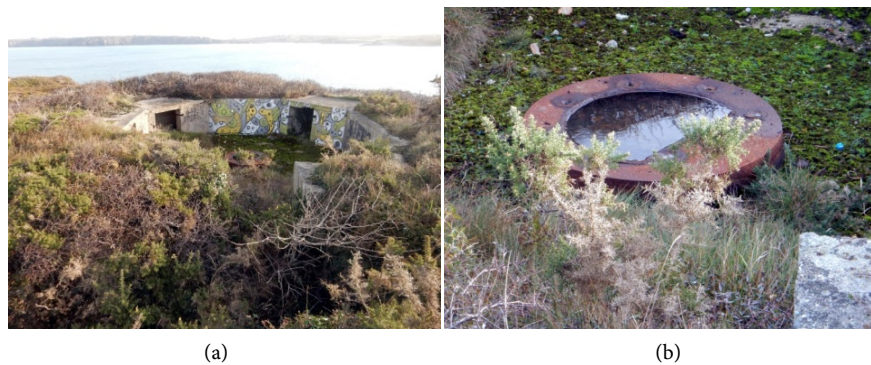
A 1st 2cm Flak gun 30 emplacement ($48^{\circ}17'09.46''\text{N}$, $4^{\circ}36'06.92''\text{W}$) (**Figure 10**), 4 m internal diameter, buried in the terrain. It presented an emerging, concrete structure well preserved without damages due to the bombardment or combats. Octagonal in shape, it hosted the entrance on one side and ammunition stores on other four sides. At the centre, well preserved, the ground metallic support for the gun, provided bolt fixation screwed holes.

Figure 10. 1st 2 cm *Flak* gun 30 emplacement (a) entrance and ammunition stores; (b) ground metallic support for the gun.

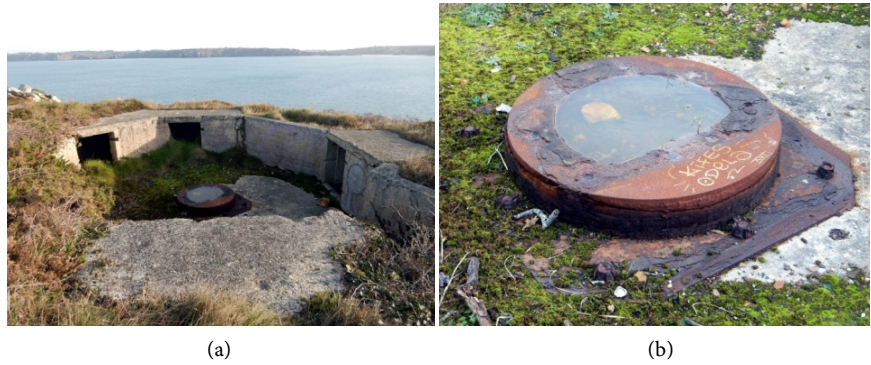
A 2nd Flak gun 30 emplacement ($48^{\circ}17'10.44''\text{N}$, $04^{\circ}36'05.71''\text{W}$) (**Figure 11**), similar to the 1st Flak gun 30 emplacement. It presented an emerging, concrete structure well preserved without damages due to the bombardment or combats.

At the centre, well preserved, was the ground metallic support for the gun, equal to that of the 1st gun 30 emplacement.

Figure 11. 2nd 2cm *Flak* gun 30 emplacement (a) entrance and ammunition stores; (b) ground metallic support for the gun.

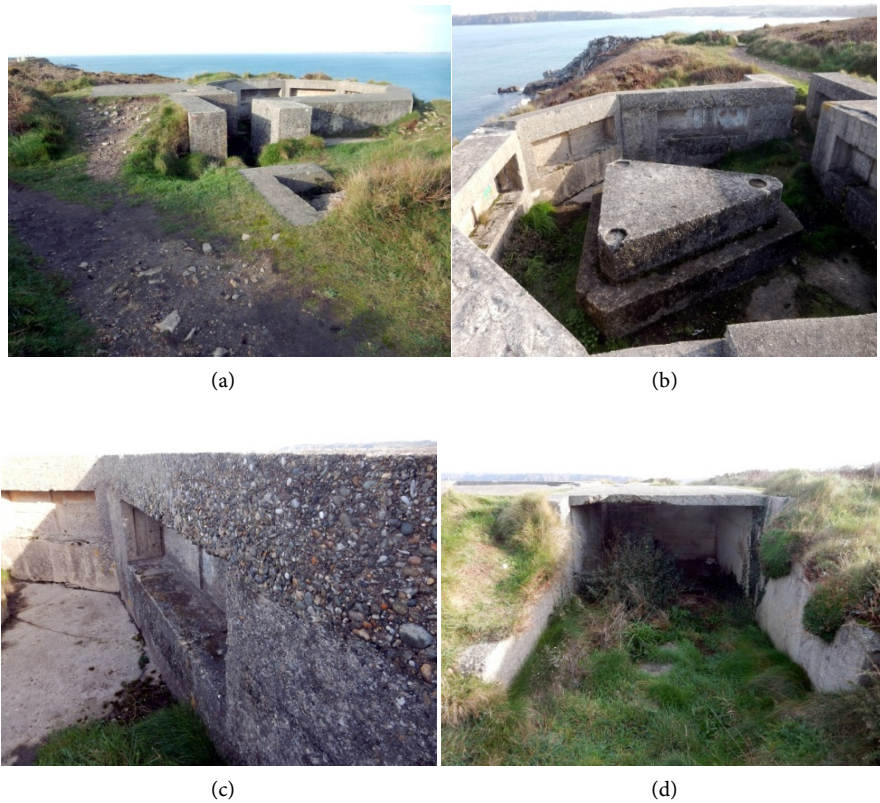
A 150 cm parabolic searchlight emplacement ($48^{\circ}17'11.01''\text{N}$, $04^{\circ}36'17.4''\text{W}$) (**Figure 12**) (*Atlantikwall Co UK., 2016*), about 5 m internal diameter. It was partially buried in the terrain and presented a well preserved emerging, concrete structure without damages due to the bombardment or combats. Octagonal in shape, it hosted a labyrinth entrance on one side and niches on each other internal sides. In the centre, well preserved, a triangular concrete base with three vertices recesses for the fixation of the projector support legs. Near its entrance a rectangular, concrete emplacement, about 1.5×2.5 m, emerged from the terrain, possible access to lodging rooms under the emplacement. Leaning against an external side, a garage, 3.50×2.50 m, hosted a searchlight electrical generator

Figure 12. 150 cm search light emplacement (a) labyrinth entrance, on the left electric generator garage, on the right rectangular, concrete emplacement (b) interior with triangular concrete base with three recesses; (c) side niche; (d) electric generator garage.

mounted on a trailer, probably a standard diesel 8 cylinders engine delivering 200 A at 110 V. The search on the terrain for other searchlight emplacements provided no result.

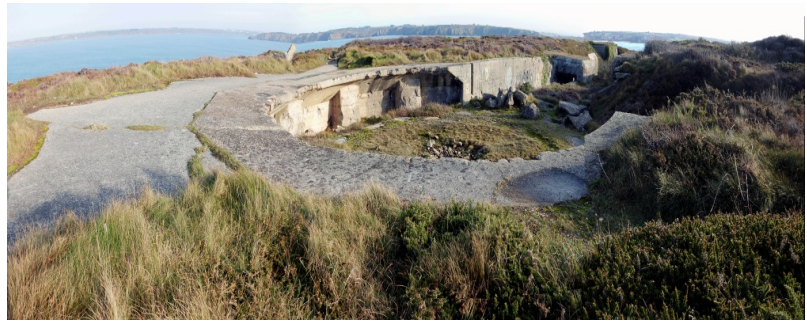
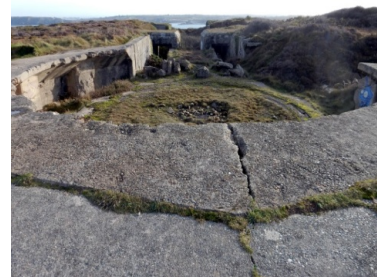
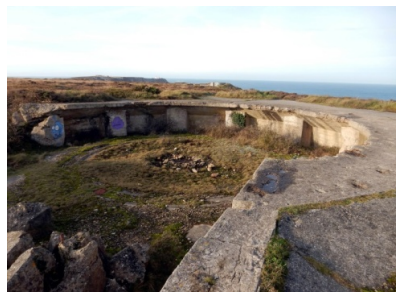
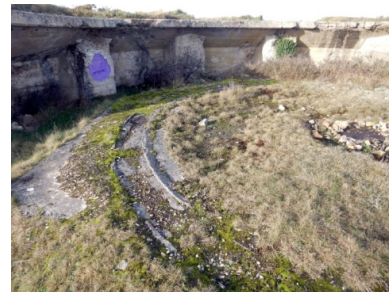
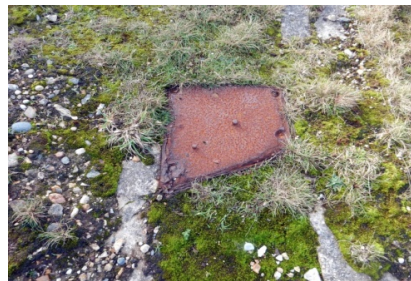
A 1st gun open emplacement (48° 17'09.56"N, 04° 36'16.86"W) (**Figure 13**), about 65 m long and 22 m bright. It was an *SK* construction formed by a concrete, circular gun emplacement, about 10 m diam., emerging at the terrain level, followed by two opposed right and left *Vf 51a* ammunition bunkers, and two opposed right and left *H502 SK* and *H501 SK* crew bunkers. A concrete access way ran along its sides to connect together all these constructions. The gun em-

Figure 13. 1st open gun emplacement (a) general view; (b) emplacement structure . 1 circular gun emplacement, 2 emplacement entrance, 3 right *V51a*, 4 left *V51a*, 5 *H502SK*, 6 *H501SK*, 7 right branch of the access way, 8 left branch of the access way, 9 central rampart ([Rapport Pinczon du Sel, 1947-1948](#)); (c) circular gun emplacement and left and right *V51a*; (d) circular gun emplacement, ammunition niches and rests of the ground gun support, in the middle a bunker *R636a*; (e) trace of the fixation plates of the rail for turning the gun; (f) fixation plate of the circular rail; (g) central rampart and left and right *V51a*, on the concrete walls impact hits of bomb splinters; (h) right *V51a*, corridor and opening of the ammunition room; (i) right *V51a*, ammunition room; (j) right *V51a*, ammunition room; (k) left *V51a*; (l) *H501SK* escape conduit; (m) *H502SK*, disintegrated facade; (n) emplacement entrance and internal court, on the left *H502SK*, on the right *H501SK*.

placement preserved eight niches on its internal wall for storing ammunitions and materials and on the floor the trace of the fixation plates of the rail for turning the gun. A trapezoidal fixation plate provided with a bolt at each vertex and two protruding mounting pins was still at its place in the trace. The gun support at the centre of the gun emplacement disappeared. Two broken, concrete, square columns at the entrance of the gun emplacement, each provided with a deep vertical groove on two opposed sides in correspondence with two other vertical grooves on the internal wall of the gun emplacement suggested the gun em-

placement could be isolated from the rest of the emplacement by inserting wooden planks in the grooves. A central rampart separated and protected the two *V51a* and the *H501 SK* and *H502 SK*, and the branches of the access way.

The right *V51a* was crossed by the access way through its corridor. An entrance in the corridor gave access to a single ammunition room preserving on the walls the original white painting, traces of metallic joints and on the ceiling a rusty metallic cover in some parts detached. A rectangular wall aperture near the entrance allowed the rapid exchange of the ammunitions. All the original room furniture disappeared. The left *V51a* was in all similar to the right *V51a* and both the two presented a well preserved concrete structure, without damages due to the bombardment or combats. Only the walls protecting the access way branches showed impact hits of bomb splinters. The *H501 SK* had its entrances obstructed by the vegetation; therefore its interior was not accessible. On its exterior structure, a damaged escape conduit was still recognizable. The *H502 SK* was hit by a bomb which perforated its coerture by a hole of 2 m diam., devastated its interior, killed the occupants and disintegrated the front facade.

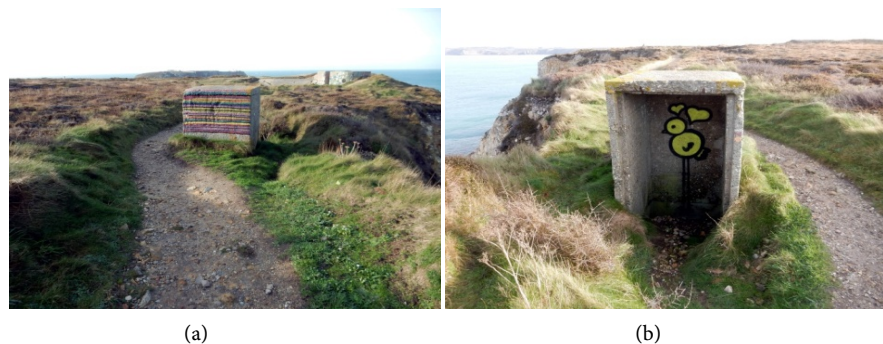
A latrine (48°17'09.21"N, 04°36'21.61"W) (**Figure 14**), near the cliff, 1.50 x 1.50 m. It presented a well preserved concrete structure, decorated by contemporary, coloured graffiti, without damages due to the bombardment or combats. It served the personnel in service at a nearby observatory and fire direction bunker.

Figure 14. Latrine (a) rear side with *R636a* in the foreground; (b) front side.

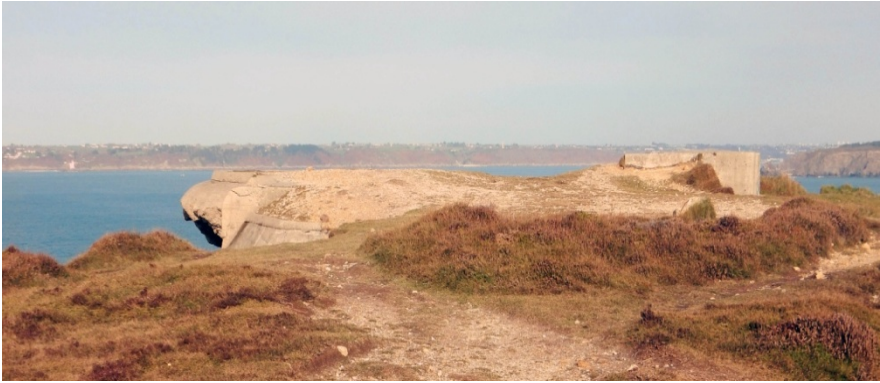
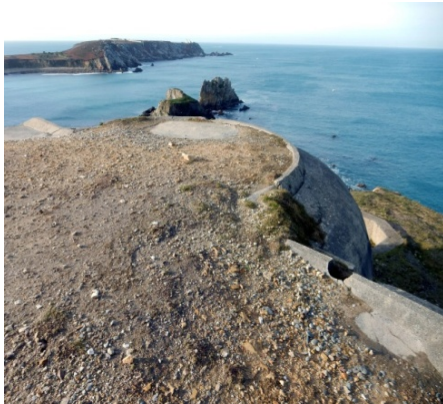
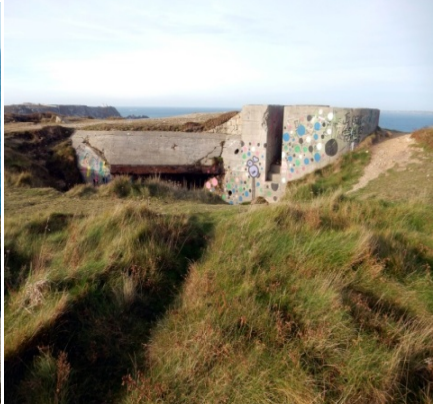
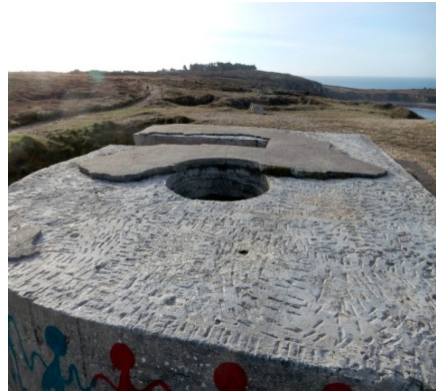
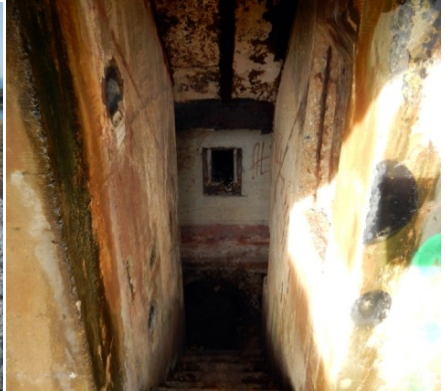
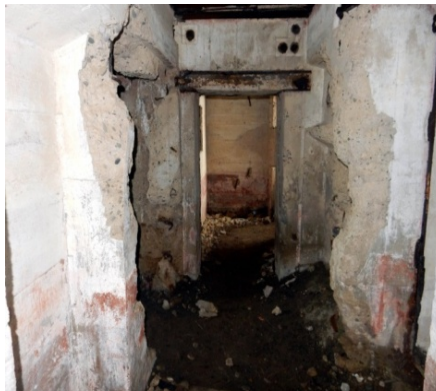
A coastal battery observatory and fire direction bunker (48°17'09.19"N, 04°36'23.54"W) (**Figure 15**). It presented, with respect to the corresponding standard models *R636*, *R636a* (**Figure 15(m)**), the presence of a concrete, uncovered observation post for one soldier armed with a machine gun at the rear side near its entrance and the absence of an upper covered rangefinder observatory on its coverage. The uncovered, observation post presented a sub-stantially well preserved concrete structure, only part of which lost by a possible constructional failure or by vibrations induced on the post by the bombardment. The upper covered observatory was probably judged not necessary in view of the unobstructed field of view toward the sea of its observation room or the possible attempt of simplify the architecture and saving material. A bomb hit the dome coverage of the observation room. The dome coverage, although damaged (**Figure 15(k)**), sustained the explosion without however avoiding damages to

Figure 15. Coastal battery observatory and fire direction bunker (a) concrete coverage, on the right uncovered lookout post for one soldier; (b) dome coverage of the observation room; (c) rear side, on the right uncovered observation post; (d) uncovered observation post, disappeared concrete coverage; (e) entrance; (f) damaged gas lock, on the left entrance to the computing room, on the right entrance to the close fire room; (g) crew room with painted window probably of origin and contemporary, coloured graffiti; (h) gas lock; (i) damaged computing room; (j) bunker front side; (k) damaged dome coverage of the observation room; (l) external observation post; (m) *R636a* standard model. 1 gas lock, 2 close fire room, 3 crew room, 20 radio room, 21 heating room, 26 observation room, 27 computing room, 28 communication room, 39 officers room, 66 rangefinder observatory (Rudi, 1998).

the interior of the bunker (**Figure 15(f)** & **Figure 15(i)**) and the possible killing of the occupants. The observation room and the computing room were invaded by concrete debris and terrain entered from the elongated aperture of the obser-

vation room. All the internal rooms were empty, deprived of all their original furniture, sometime decorated by contemporary, coloured graffiti. On the walls no traces of a thermal insulation system. The rooms preserved their rusted metallic ceiling and portions of aeration conduits. Outside the bunker, near the observation room, was an external, octagonal observation post for one soldier.

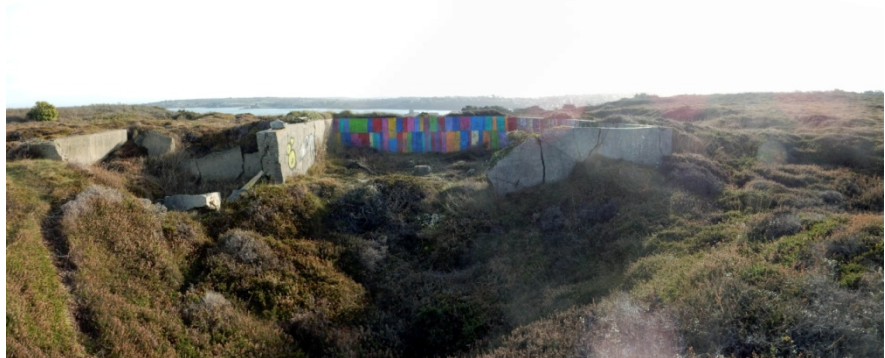
A square emplacement ($48^{\circ}17'07.59''\text{N}$, $04^{\circ}36'18.63''\text{W}$) (**Figure 16**), about 10×10 m. It was surrounded by 2m high side walls. It presented a damaged concrete structure decorated by contemporary, coloured graffiti. The bombardment demolished part of the wall hosting the entrance and opened deep cracks on the other walls. Leaning against one of its walls, a rectangular emplacement, about 6×5 m, presented part of the wall hosting its entrance demolished and the other walls deformed and broken in pieces.

Figure 16. Square emplacement, on the left leaning rectangular emplacement.

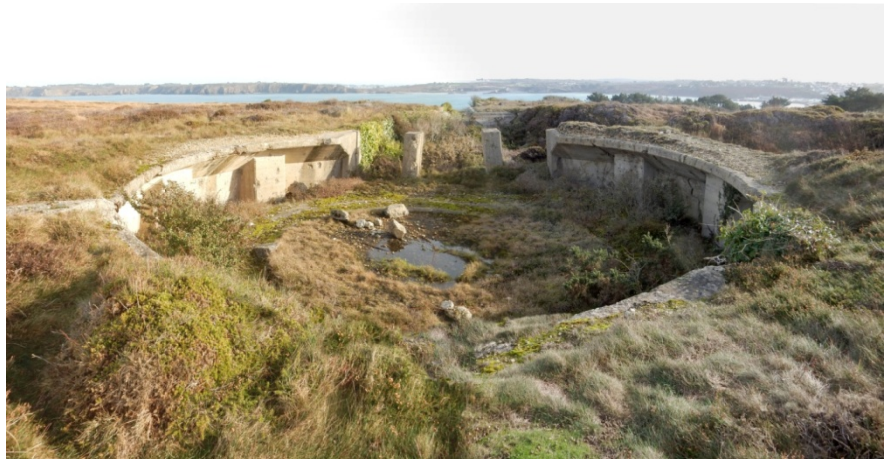
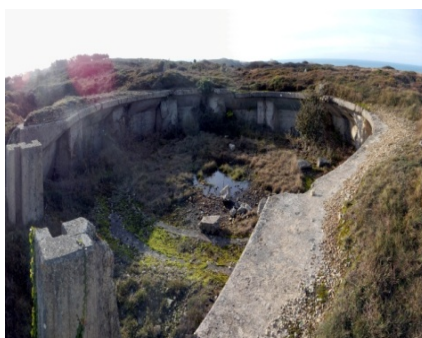
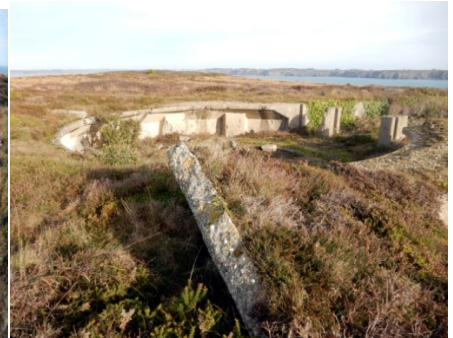
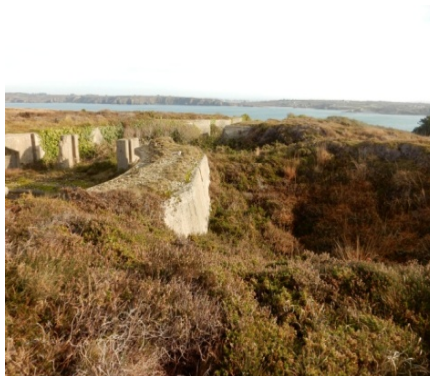
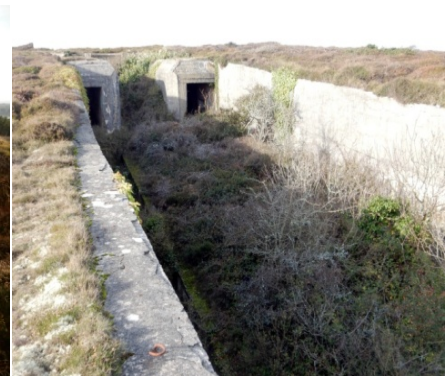
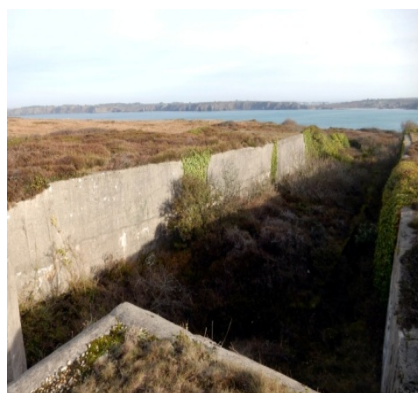
A 2nd open gun emplacement ($48^{\circ}17'04.35''\text{N}$, $04^{\circ}36'17.47''\text{W}$) (**Figure 17**), about 65 m long and 28 m bright, similar to the 1st open gun emplacement. It was an *SK* construction formed by a concrete, circular gun emplacement, about 10 m diam., emerging at the terrain level, two opposed right and left *Vf 51a* ammunition bunkers and two opposed right and left *H502 SK* and *H501 SK* crew bunkers. A concrete access way ran along its sides to connect together these constructions. The gun emplacement preserved eight niches on its internal wall for storing ammunitions and materials and on the floor the trace of the fixation plates of the rail for turning the gun. No fixation plate remained in place. The gun support at the centre of the gun emplacement disappeared. Two concrete, square columns still in place at the entrance of the gun emplacement, each provided with a deep vertical groove on two opposed sides in correspondence with two other vertical grooves on the internal wall of the gun emplacement suggested that the gun emplacement could be isolated from the rest of the emplacement by inserting wooden planks in the grooves. A central rampart separated and protected the two *Vf 51a* and the *H501 SK* and *H502 SK*, and the branches of the access way. The right and left *Vf 51a* were crossed by the access way through their corridors. An entrance in their corridors gave access to a single ammunition room preserving on the walls the original white painting, traces of metallic joints and on the ceiling a rusty metallic cover. A rectangular wall aperture near the entrance allowed the rapid exchange of the ammunitions.

Figure 17. 2nd open gun emplacement (a) general view; (b) circular gun emplacement with two concrete, square, columns; (c) circular gun emplacement; (d) bomb craters near the circular gun emplacement; (e) left and right *Vf 51a*; (f) emplacement entrance; (g) right *R501SK* with a bomb crater on the upper left (h) *R501SK* plan. 1 gaslock, 3 crew room (Rudi, 1998); (i) *R502SK* plan. 1 gaslock, 3 crew room (Rudi, 1998).

All the original room furniture disappeared. Only the walls protecting the access way branches showed impact hits of bomb splinters. The *H501SK* and *H502SK* had their entrances obstructed by the vegetation; therefore their interiors were not accessible. The 2nd open gun emplacement substantially escaped the bombardment and presented a well preserved concrete structure decorated by contemporary, coloured graffiti.

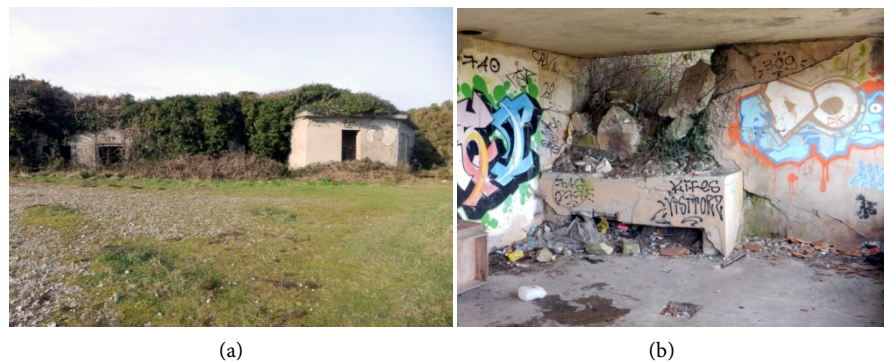
Three concrete, joined barracks ($48^{\circ}17'06.85''\text{N}$, $04^{\circ}36'07.91''\text{W}$) (Figure 19). They were probably of French construction judging on the accurate finishing of their walls. They hosted, respectively, personnel lodgments and a canteen. They presented well preserved concrete structures with the exception, in one of them, of a wall damaged by the bombardment, through which debris and terrain fell on the rests of a possible kitchen. All the original furniture disappeared. The search on the ground for possible mortar or gun emplacements provided no results.

Figure 19. Three concrete barracks, probably of French construction (a) entrances of the west and east barrack; (b) east barrack interior, possible canteen.

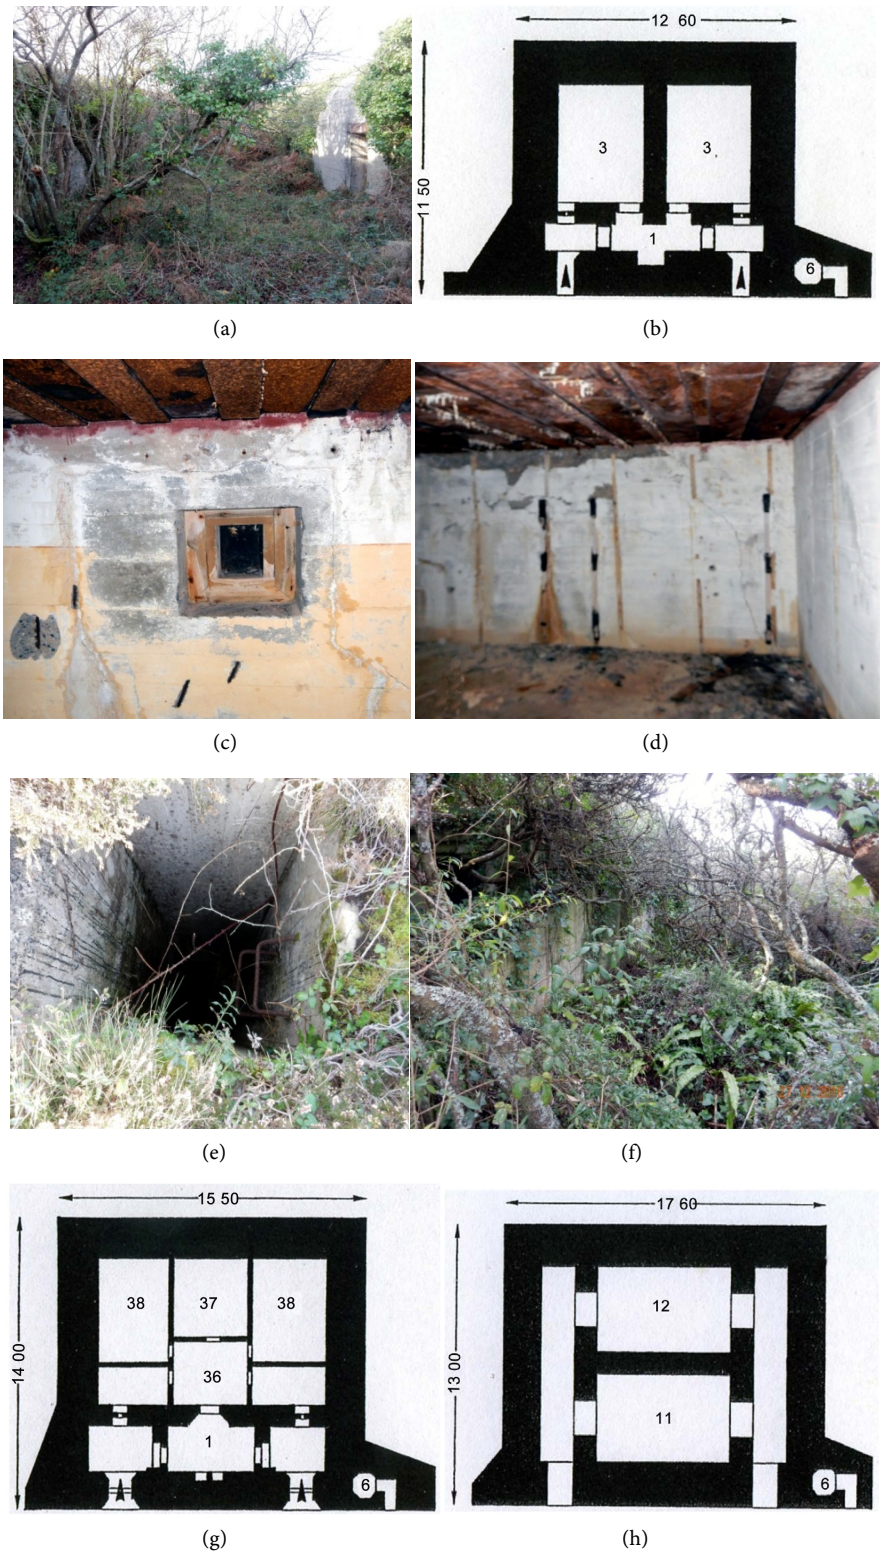
A *H622* and a *H638* bunker ($48^{\circ}17'05.45''\text{N}$, $04^{\circ}36'12.38''\text{W}$) (Figure 20) facing each other. The *H622*, two crew bunker, was buried in the terrain. It presented a facade without damages due to the bombardment or combats. It was accessible. On the walls, no trace of a thermal insulation system. The two crew rooms were empty, deprived by their original furniture. They preserved a rusted metallic ceiling and cot support joints on the walls. The *H638*, small dressing bunker, was buried in the terrain and not accessible because of the vegetation that covered its facade and obstructed its entrances. Therefore, it was not possi-

ble to determine its preservation state. It comprised an admission room, a treatment room and two sickrooms/wards.

A H641, ammunition bunker type III ($48^{\circ}17'03.96''\text{N}$, $04^{\circ}36'13.85''\text{W}$) (**Figure 20**), was buried in the terrain and only a small portion of it emerged. It was not accessible; therefore, it was not possible to determine its preservation state. For security reasons the shells and the cartridges of the ammunitions were stocked in separated rooms.

Figure 20. Facing H622 and H638 (a) on the left H638 on the right H622; (b) H622 plan. 1 gas lock, 3 crew room, 6 observation post (Rudi, 1998); (c) H622 entrance; (c) H622 crew room (d) crew room, on the wall cot support joints; (e) H622 escape conduit; (f) H638 covered by the vegetation; (g) H638 plan. 1 gas lock, 6 observation post, 36 admission room, 37 treatment room, 38 sickroom/ward (Rudi, 1998); (h) H641 plan. 6 observation post, 11 shells room, 12 cartridge room.
