The WW II German Coastal Artillery Battery *H.K.B.1274/StP C342* at Camaret sur Mer (Finistère—FR)

Giancarlo T. Tomezzoli

How to cite this paper: Tomezzoli, G. T. (2017). The WW II German Coastal Artillery Battery *H.K.B.1274/StP C342* at Camaret sur Mer (Finistère—FR). *Archaeological Discovery*, 5, 116-141.

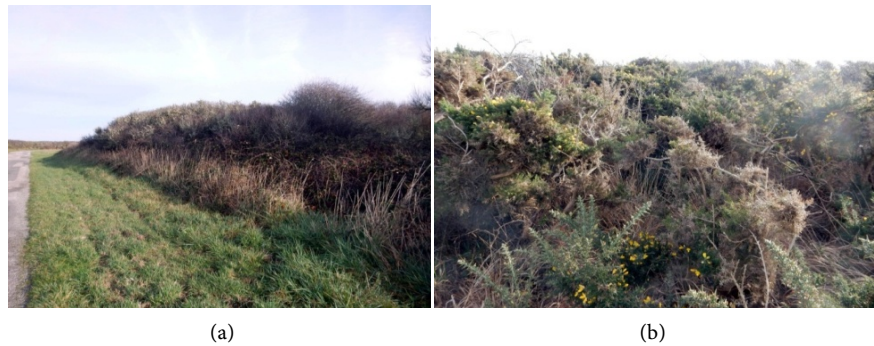
A 4th open gun emplacement ($48^{\circ}16'54.37''\text{N}$, $04^{\circ}36'25.86''\text{W}$) (**Figure 21**), of the same design of the 1st and 2nd open gun emplacements, was completely destroyed. Its ruins were covered by terrain and thick vegetation which prevented

Figure 21. 4th open gun emplacement (a)-(b) ruins covered by terrain and thick vegetation.

any recognition.
