The WW II Saint-Pabu German Radar Camp and the *Stützpunkte Re 03, Re 04*

How to cite this paper: Tomezzoli, G. T., & Colliou, S. (2017). The WW II Saint-Pabu German Radar Camp and the *Stützpunkte Re 03, Re 04*. *Archaeological Discovery*, 5, 142-162.

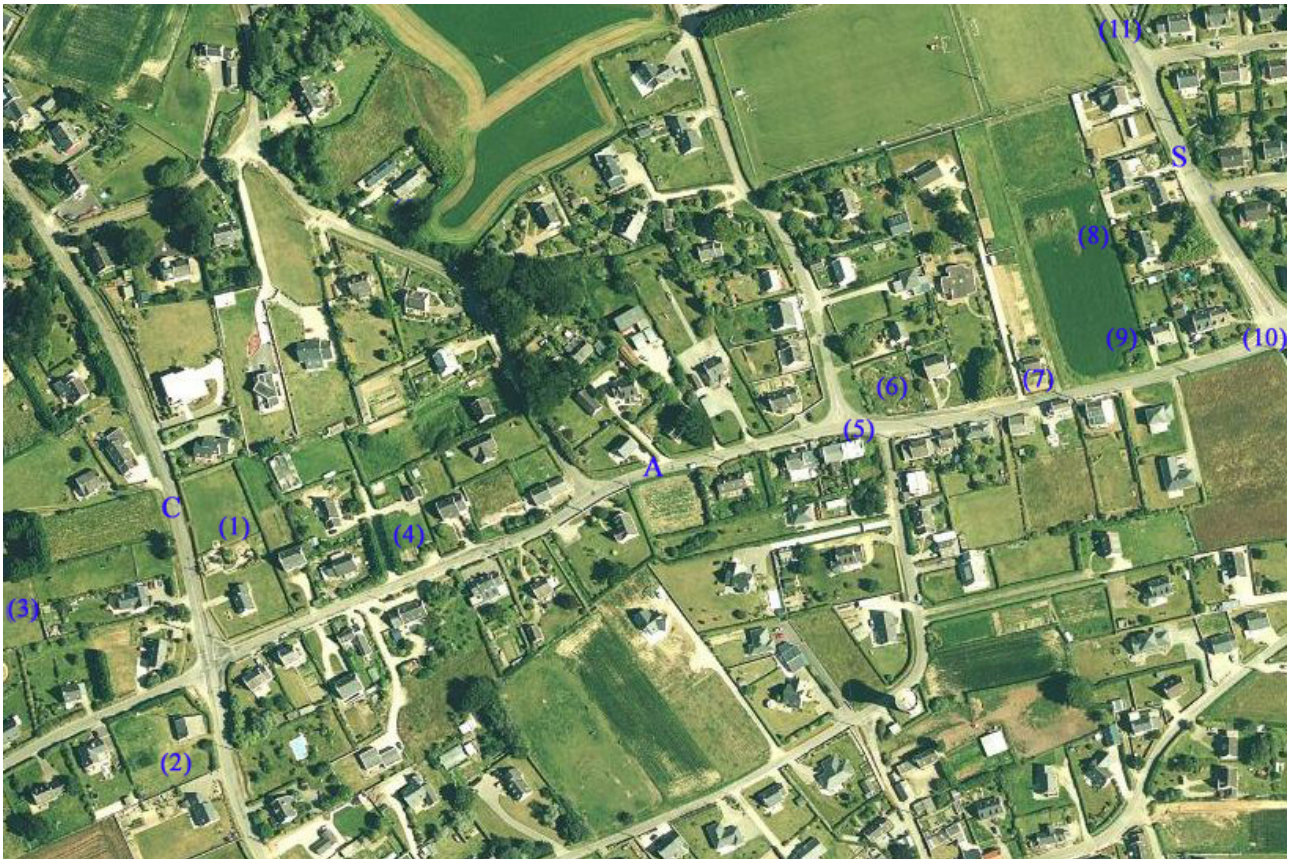
Figure 1. Saint-Pabu radar camp components: (1) 1st *V2a* and *L410A*, (2) 1st *Freya* radar emplacement, (3) 1st *Würzburg-Riese* radar emplacement, (4) *L479 Anton*, (5) bunker *Vf* integrated in a modern house, (6) area hosting camp components, (7) 2nd *Freya* radar emplacement, (8) *Vf* bunker covered with terrain and tobruck, (9) 2nd *V2a*, (10) East camp entrance, (12) 2nd *Würzburg-Riese* radar emplacement, A rue Avel Vor, C rue Corn ar Gazel, S rue du stade [Geoportail].

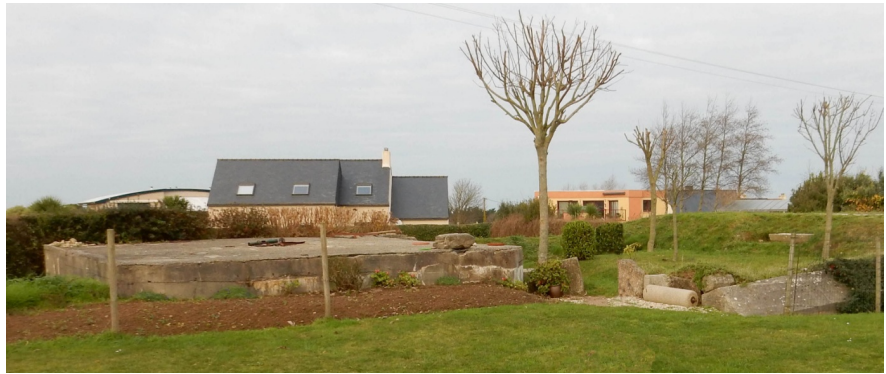
Figure 2. On the left the 1st V2a, on the right the I410A

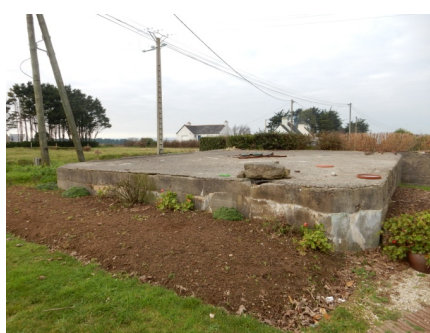
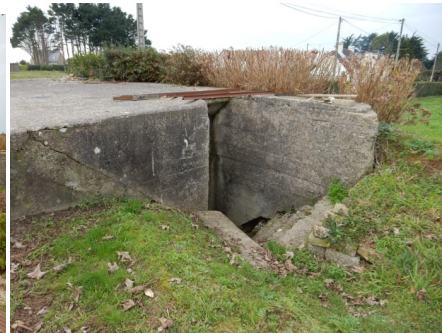
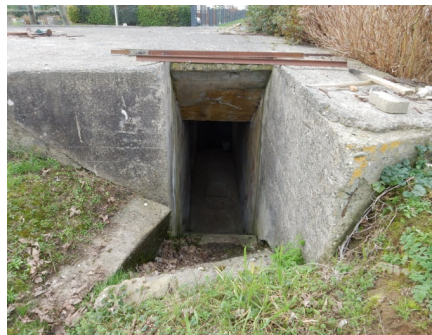
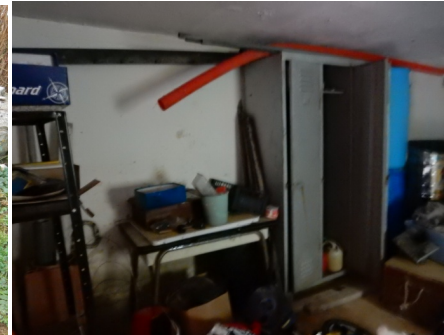
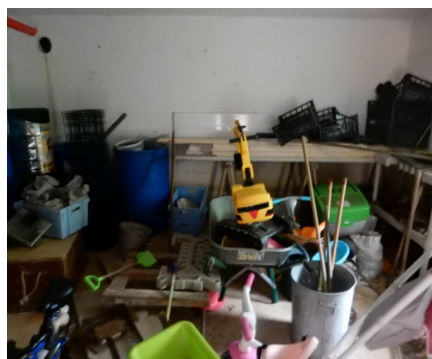
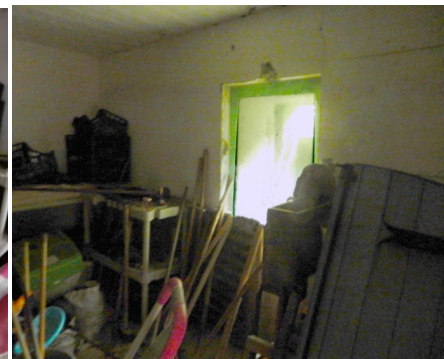
A 1st *V2a* (48°33'59.01"N, 4°37'19.07"W) (**Figure 2**, **Figure 3**) about 8 × 8 m, emerging about 1.5 m from the ground. Its emerging concrete structure was in a good preservation state without damages due to combats. The presence on the coverage of a chimney conduit for a *Festungsofen WT80* (fortress gas-secured oven), covered by a stone, suggested that it was heated if necessary and therefore intended for hosting one or two groups of soldiers. The proprietor explained that, an inclined trace on the external concrete structure, near the entrance indicated a disappeared stair. It was in connection with an entrance stair, now clumsy, for permitting to the soldiers exiting the *V2a* interior a rapid access to the coverage which probably hosted a single or double 2cm *Flak* gun. A protection wall on one side flanked the entrance stair which gave access to an interior corridor provided, on one side, with the entrance to a single room. The room preserved a wall and ceiling white painting and was cluttered by materials. On the walls, no traces of a thermal insulation system. A wall preserved the emergency exit and another adjacent one hole indicating a connection with the chimney conduit on the coverage. All the original room furniture and electrical

Figure 3. 1st V2a (a) coverage, near one side a chimney conduit covered by a stone (b) entrance with protection wall, on the left, trace of the stair to access the coverage; (c) entrance stair; (d) internal room; (e) internal room, cluttered by materials, on the upper left of the wall a chimney hole (f) side wall with emergency exit.

connections and devices disappeared.

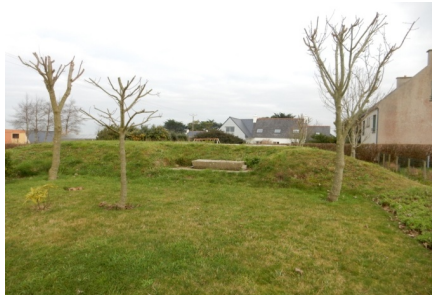
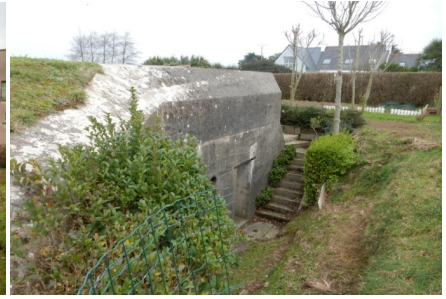
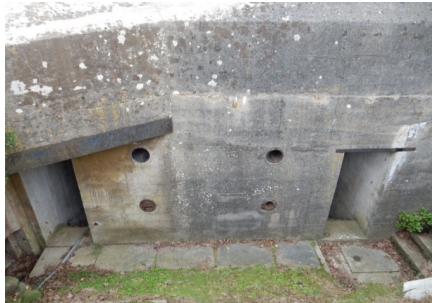
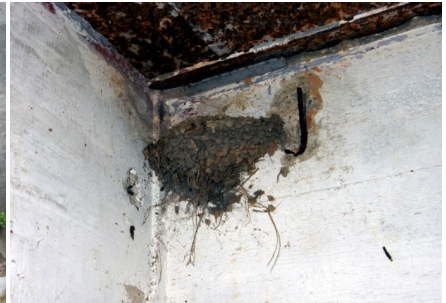
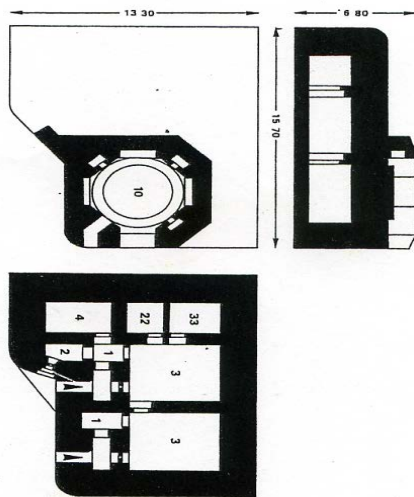
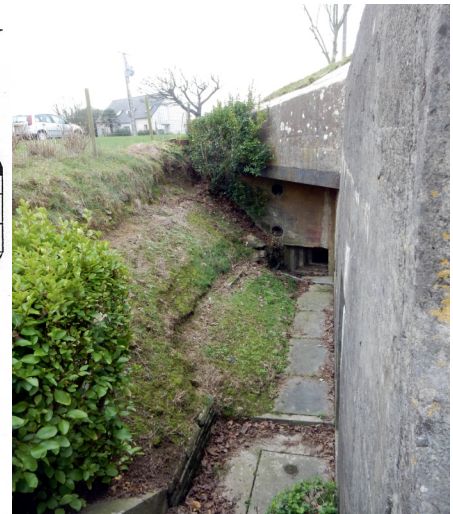
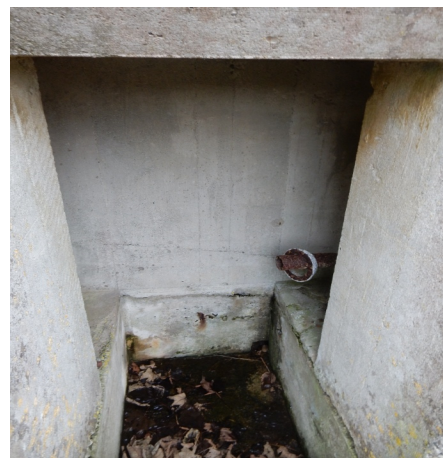
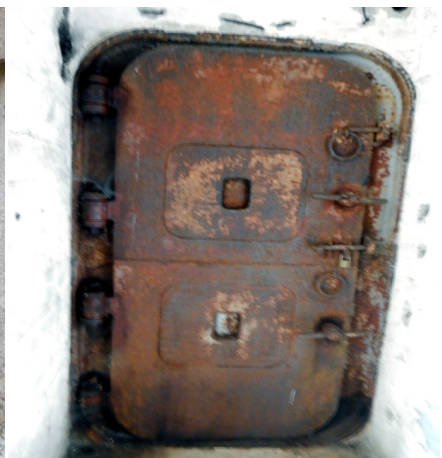
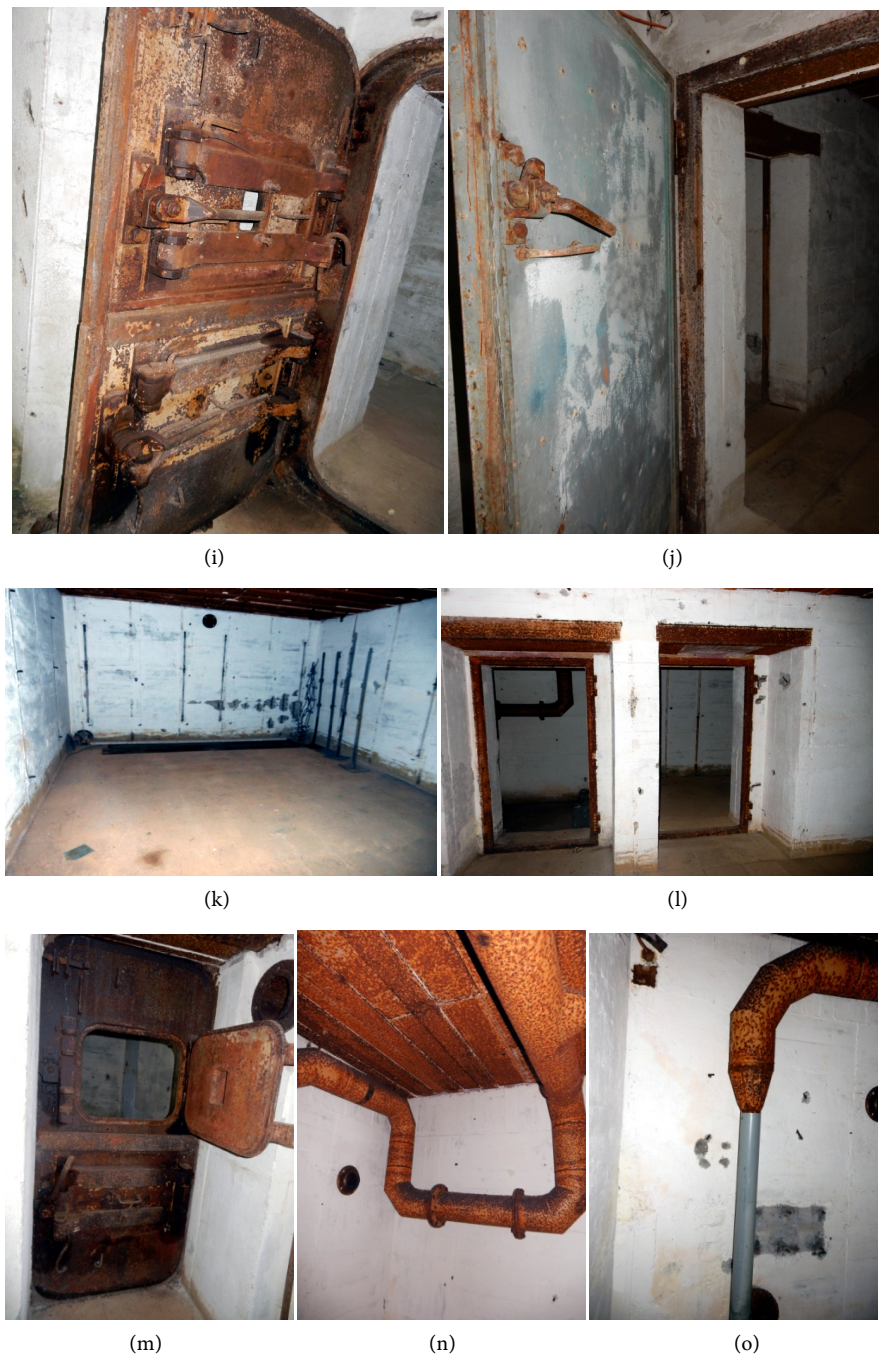
A *L410A* ($48^{\circ}33'59.16''\text{N}$, $4^{\circ}37'18.32''\text{W}$) (**Figure 2, Figures 4-6**), about 5 m far from the 1st *V2a*, partially buried in the ground. Its emerging concrete structure was in a good preservation state without damages due to combats. A stairs descending under the terrain level gave access to two entrances defended by a close combat room. The proprietor explained that the rectangular slabs at the base of the entrances covered the still operating bunker drainage system and that a 40×50 cm niche on one side of one of the entrances hosted a radio post. An original, rusted, armored door was at its place at the entrance of each respective gasloch. Another original, rusted, armored door was at its place at the exit of the each respective gasloch. Each gasloch gave access to a crew room preserving on the walls the traces of the supports for tilting beds. A single door allowed communication between the two crew rooms. One crew room gave access to the non-commissioned officer room and the ventilation room which preserved conduits of the original ventilation system. An original, rusted, armored door was at its place at the entrance of the close combat room. All the rooms were empty, deprived of all their original furniture and electrical connections and devices. The rooms preserved their rusted metallic ceiling and on the walls, no traces of a thermal insulation system and electrical connections. The octagonal gun emplacement on the *L410A* coverage, hosted an entrance on one side and ammunitions niches on each other internal sides. At its centre, well preserved, a circular, concrete base for the *Flak* gun. The kind of *Flak* gun placed on the base is unknown, but probably it was a single or double, 2 or 3 cm *Flak* gun. The pebbles of the Ero Vili (**Tomezzoli & Marzin 2015**) were clearly visible on the base. The proprietor explained that the niche provided with a 30 cm high wall, functioned as water cistern for cooling the barrel of the gun. He also declared that during the bunker restoration many *Flak* gun ammunitions were found near the entrances.

Figure 4. *L410A* (a) vision from the 1st *VZa*; (b) access stair to the entrances; (c) entrances with circular, armored air intakes and rectangular slabs covering the drainage system, on the left metallic coverage of the close combat room; (d) metallic coverage of the close combat room, details; (e) *L410A* plan: 1. gasloch, 2. close combat room, 3. crew room, 4. ammunition room, 10. *Flak* gun emplacement, 22. ventilation room, 33. non-commissioned officer room (Rudi, 1998); (f) gun embrasure of the close combat room; (g) drainage system at the interior; (h) gas loch entrance armored door; (i) other gas loch entrance armored door; (j) other gas loch exit armored door, crew room and single communication door between the crew rooms; (k) crew room, on the upper side of the wall hole for a *Festungssofen WT80* conduit; (l) on the left ventilation room, on the right non-commissioned officer room; (m) armored door of the close combat room; (n)-(o) ventilation room with portions of the original ventilation system conduits.

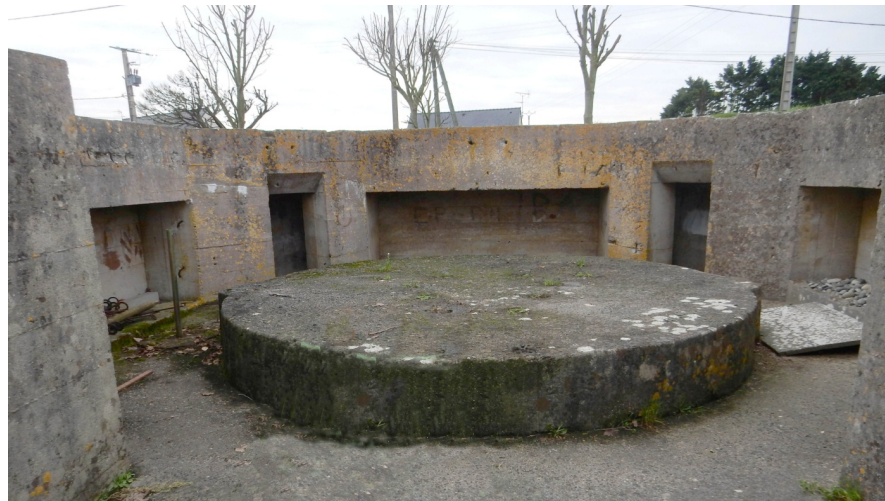
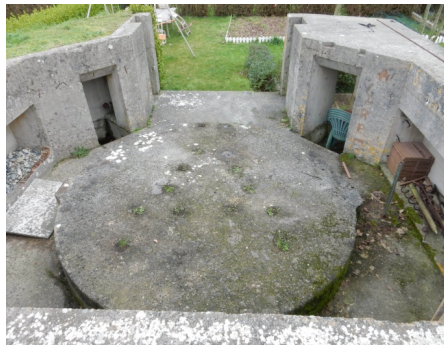
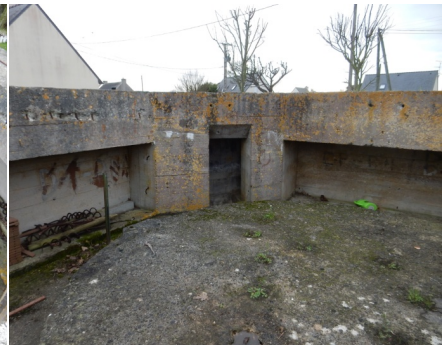
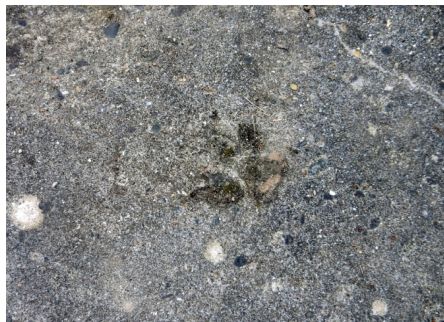
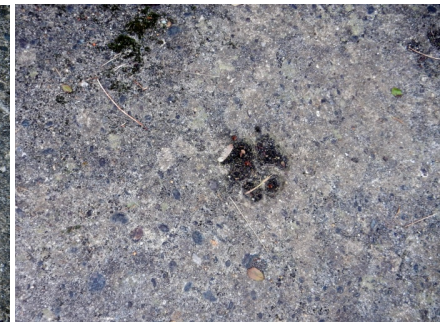
Figure 5. L410A gun emplacement (a) circular, concrete base for the *Flak* gun; (b) emplacement entrance and ammunition niches; (c) ammunition niches; (d)-(e) dog footprints on the circular, concrete base.

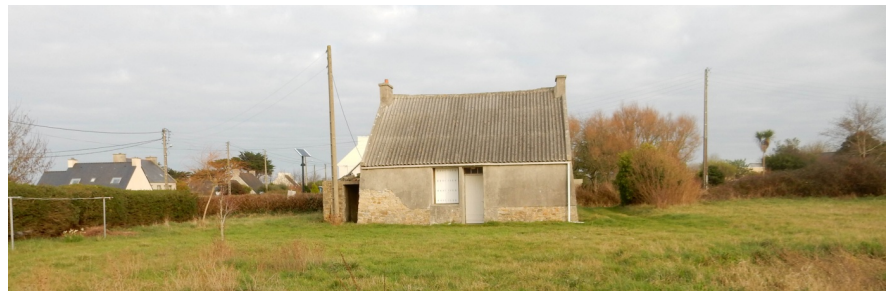
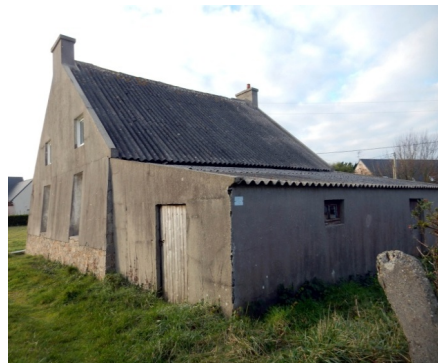
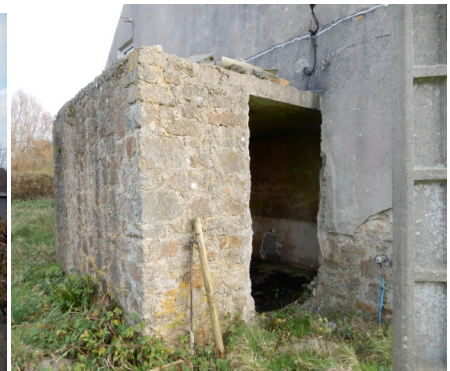
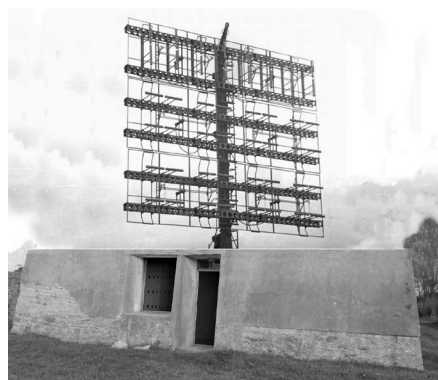
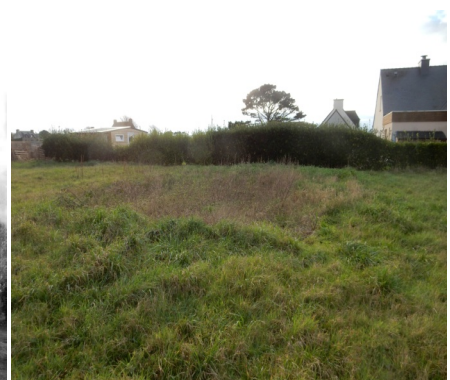
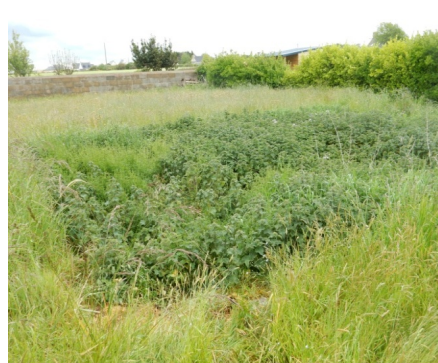
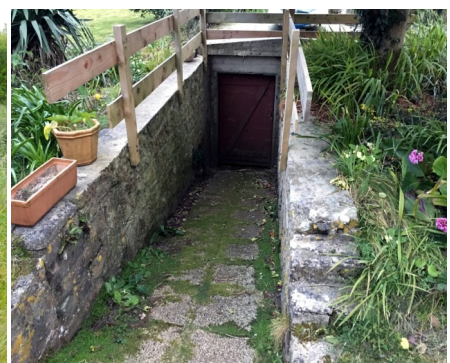
A 1st *Freya* radar emplacement ($48^{\circ}33'56.31''\text{N}$, $4^{\circ}37'19.72''\text{W}$) (**Figure 6**) about $10 \times 10 \times 3$ m, identified thanks to the indications of the proprietor. It was unrecognizably integrated in a modern house, of which it formed the lower portion, under the roof. Its concrete structure was in a good preservation state without damages due to combats. The external walls presented a slight inclination of few degrees towards the interior and a thickness of about 1 m. The emplacement appeared to conform to a Type 5 square splitter wall for radar *Freya*, lacking labyrinth entrances. It was built with local stone bricks covered by a concrete layer. The proprietor declared that, at the interior, nothing remained of the original emplacement. A small shed on one side was built with the same brick stones as the emplacement and its interior penetrated in the corresponding emplacement side without entering the emplacement. After the war, a shed was added on one other adjacent emplacement side.

A 1st pool ($48^{\circ}33'55.74''\text{N}$, $4^{\circ}37'20.74''\text{W}$) (**Figure 6(h)**) about 9×15 m, in the garden, near the 1st *Freya* radar emplacement. Its sides were formed by concrete and its interior was invaded by the vegetation. At a side of the pool, about 6 m

A bunker ($48^{\circ}33'55.58''\text{N}$, $4^{\circ}37'21.64''\text{W}$) (**Figure 6(g)**) about 7×4 m, in a garden adjacent to the 1st *Freya* radar emplacement garden, about 10 m away from the 1st pool. It emerged about 30 cm from the terrain and was provided with an about 5×1.5 m concrete, access ramp with protecting walls in stone bricks, extending in the direction of the 1st pool.

Figure 6. 1st Freya radar emplacement (a) emplacement integrated in a modern house, on the left possible barrack area, on the right the 1st pool; (b) after war shed on a side of the emplacement; (c) small shed on the adjacent side; (d) emplacement reconstruction - Freya radar starting image (von Kroge 1998); (e) possible barrack area; (f) 1st pool invaded by the vegetation; (g) bunker near the 1st pool, concrete access ramp.

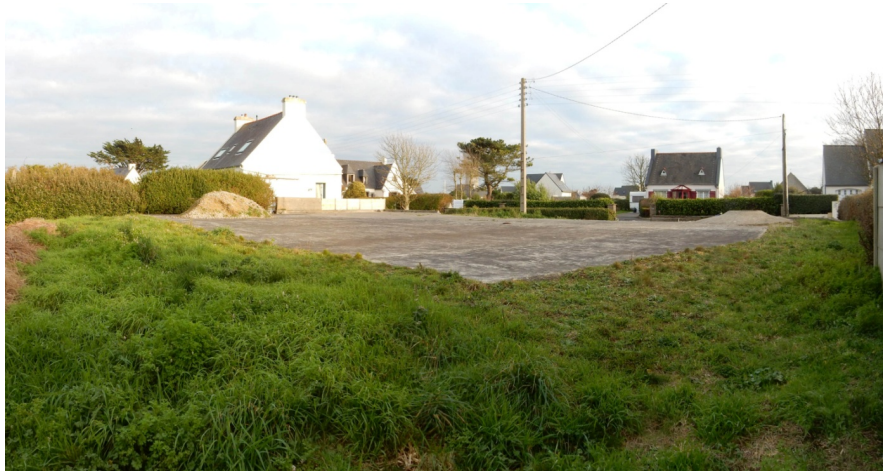
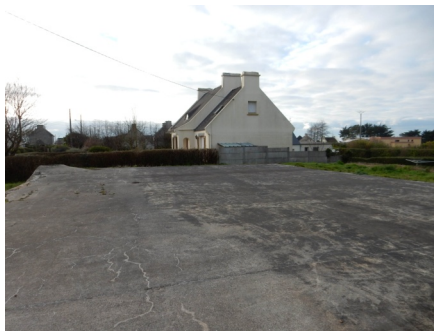
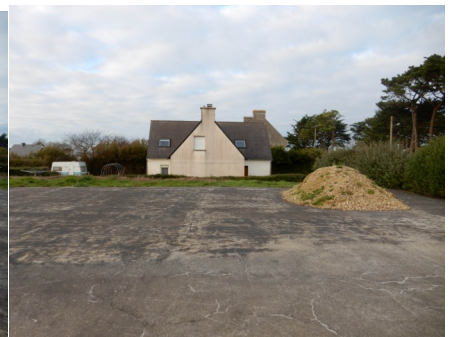
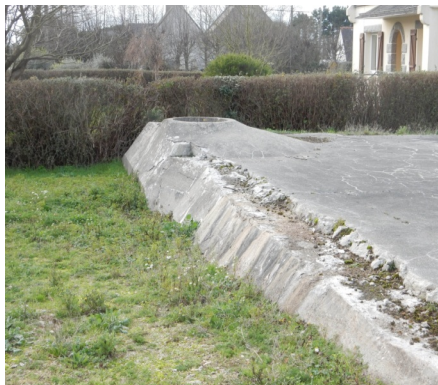
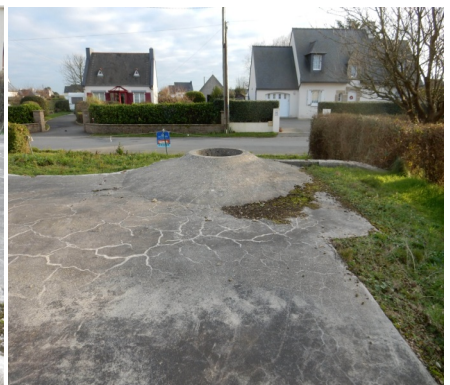
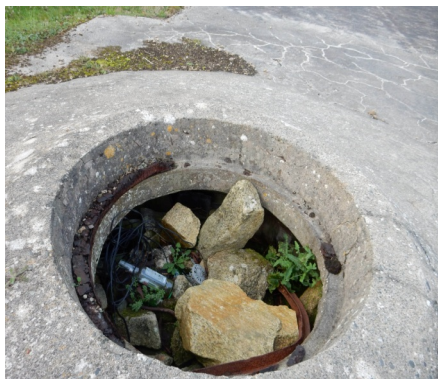
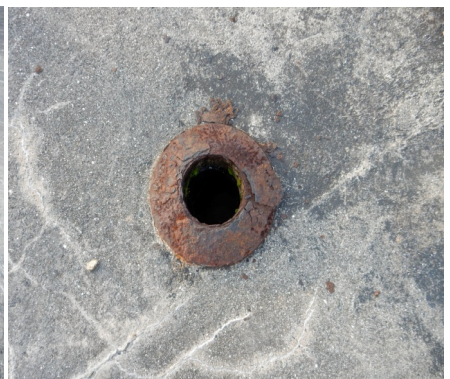
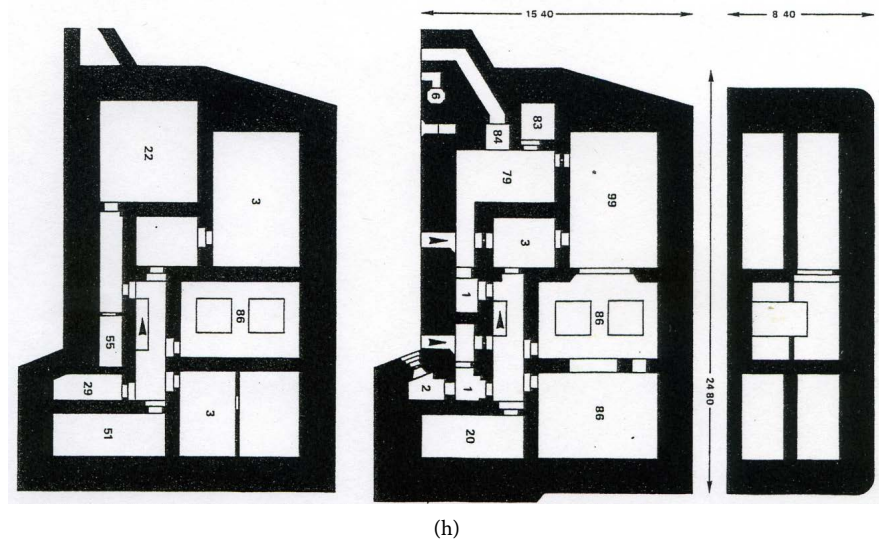
An *L479 Anton* ($48^{\circ}33'58.48''\text{N}$, $4^{\circ}37'15.97''\text{W}$) (**Figure 7**) for day and night fighter control buried in the terrain, of which only the concrete coverage

Figure 7. *L479 Anton* (a) general view; (b) view to the East; (c) view to the West; (d) concrete structural damage on one side; (e)-(f) external observation post cluttered by materials; (g) periscope conduit; (h) *L479* plan: 1. gasloch, 2. close combat room, 3. crew room, 6. observation post, 20. radio room, 22. ventilation room, 29. store room, 51. telephone room, 55. store room, 79. emergency generator room, 83. transformer room, 84. recooling room, 86. command post, 99. fuzes room (Rudi, 1998).

emerged. The coverage was in a good preservation state with a minor concrete structural damage on one side, not due to combats or bombardments. It hosted an external observation post cluttered by materials and a periscope conduit. The entrances were buried in the terrain, so that an inspection of the interior was not possible.

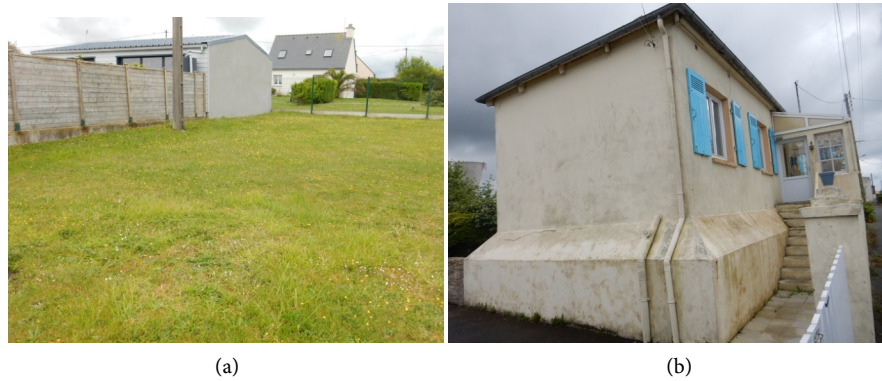
The position of a disappeared 1st *Würzburg-Riese* radar emplacement ($48^{\circ}33'58.25''\text{N}$, $4^{\circ}37'23.69''\text{W}$) (Figures 8(a), 18) about 100 m North - West from the 1st *Freya* radar emplacement, on a private terrain. It was demolished after the war and only a difference in the grass betrayed its past presence.

A 14×6 m *Vf* surmounted by a modern house ($48^{\circ}34'1.07''\text{N}$, $4^{\circ}37'0.3''\text{W}$) (Figure 8(b)). It was similar to the 1st *Vf2a* and provided with a stair for rapid access to the coverage, now for accessing the house entrance, on which was probably placed a single or double, 2 or 3 cm *Flak* gun.

Figure 8. (a) position of the 1st Würzburg-Riese radar emplacement on a private terrain; (b) *Vfi* integrated in a modern house.

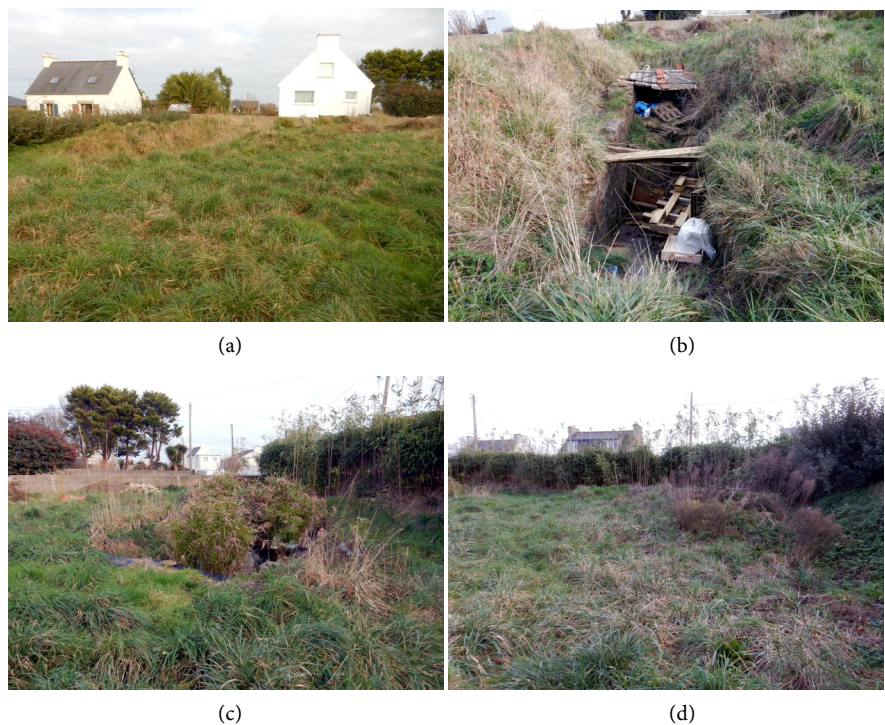
An area ($48^{\circ}34'2.06''\text{N}$, $4^{\circ}37'2.55''\text{W}$) (Figure 9) about 26×30 m which hosted several camp components. An inclined access ramp ($48^{\circ}34'2.06''\text{N}$, $4^{\circ}37'2.55''\text{W}$) about 6×2 m, provided with protection walls in bricks possible access to a tunnel or to one or more underground rooms. It was cluttered by materials and inaccessible. A possible 2nd pool ($48^{\circ}34'1.52''\text{N}$, $4^{\circ}37'2.06''\text{W}$) about 3×5 m, partially covered by the terrain and invaded by water. A possible small bunker or tobruck ($48^{\circ}34'2.55''\text{N}$, $4^{\circ}37'1.97''\text{W}$) completely buried in the terrain.

Figure 9. Area with camp components (a) North side vision; (b) inclined access ramp; (c) possible 2nd pool covered by terrain and invaded by water; (d) South side vision with a possible small bunker or tobruck covered by the terrain.

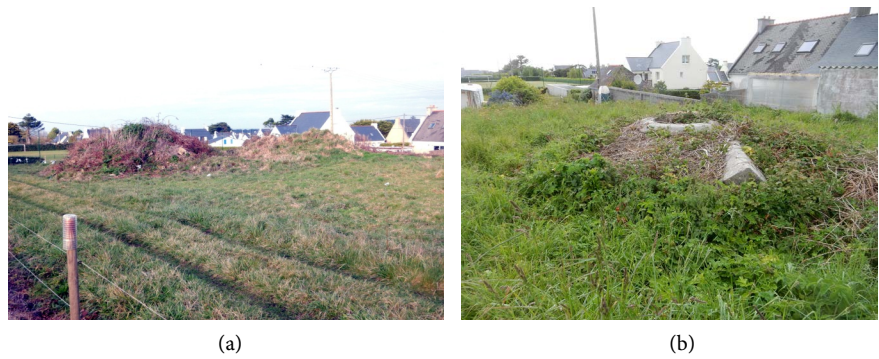
A *Vf* ($48^{\circ}34'4.49''\text{N}$, $4^{\circ}36'58.44''\text{W}$) (Figure 10(a)) covered by terrain. Its type and purpose are unknown. It is possible that on its coverage too was placed a single or double, 2 or 3 cm *Flak* gun.

A tobruck ($48^{\circ}34'4.7''\text{N}$, $4^{\circ}36'57.43''\text{W}$) (**Figure 10(b)**) near the *Vfi*. It was partially buried in the ground. The aperture of its combat room and its entrance were obstructed by terrain, so that the inspection of its entrance room and combat room was not possible.

Figure 10. (a) Vf covered by terrain, (b) tobruck near the Vf, partially covered by terrain.

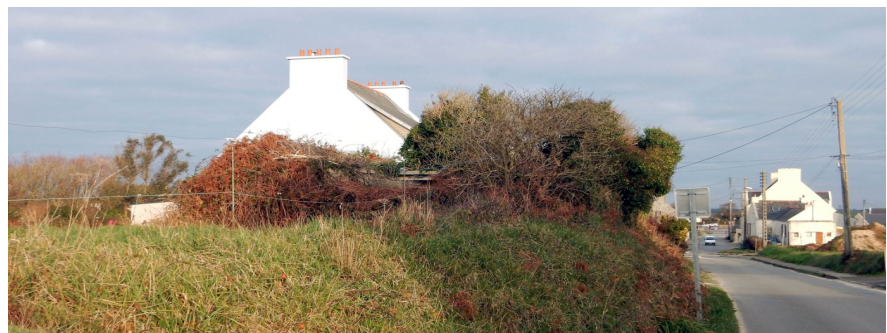
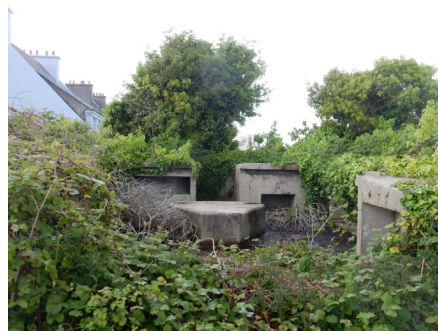
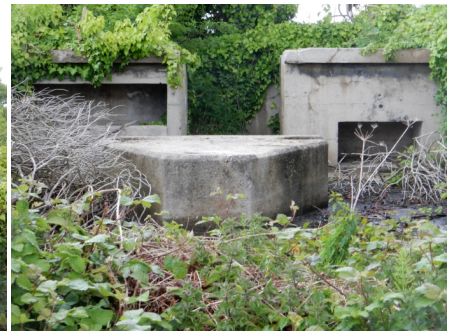
A 2nd *VZa* ($48^{\circ}34'2.25''\text{N}$, $4^{\circ}36'56.37''\text{W}$) (**Figure 11**) about 8×8 m, buried in the terrain, having a square gun emplacement on its coverage, partially invaded by vegetation. Its entrances were buried in the terrain, so that an inspection of the interior was not possible. The gun emplacement, hosted a labyrinth entrance on one side and ammunitions niches on each other internal sides. At the centre, well preserved, a triangular, concrete base with a circular niche on two adjacent

Figure 11. 2nd *Vf2a* (a) *Vf2a* general vision, on the right the rue Avel Vor; (b) square *Flak* gun emplacement with concrete triangular base and ammunition niches; (c) concrete triangular base with two niches for *Flak* gun support legs.

vertexes for a single or double, 2 or 3 cm *Flak* gun support legs.

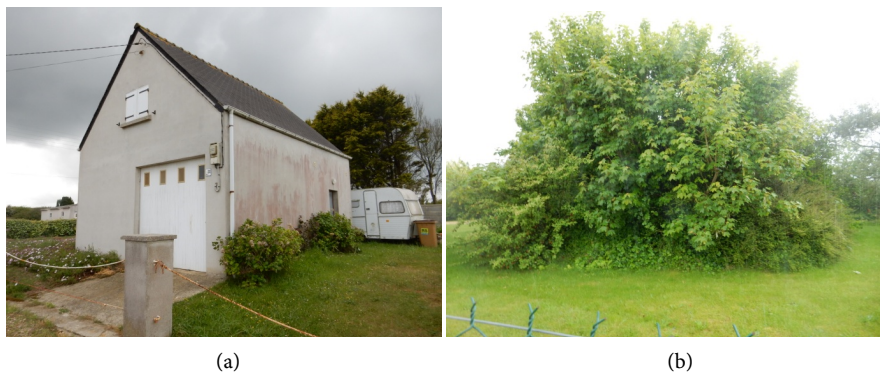
The position of the 2nd *Freya* radar emplacement (48°34'2.15"N, 4°36'58.98"W) (**Figure 12(a)**), on the rue Avel Vor. It was occupied by a modern house. Nothing of the original 2nd *Freya* emplacement remained visible.

The 2nd *Würzburg-Riese* radar emplacement (48°34'2.15"N, 4°36'58.98"W) (**Figure 12(b)**), on the rue du stade. It was completely covered by vegetation and slightly visible.

Figure 12. (a) 2nd Freya radar emplacement occupied by a modern house; (b) 2nd Würzburg-Riese radar emplacement.

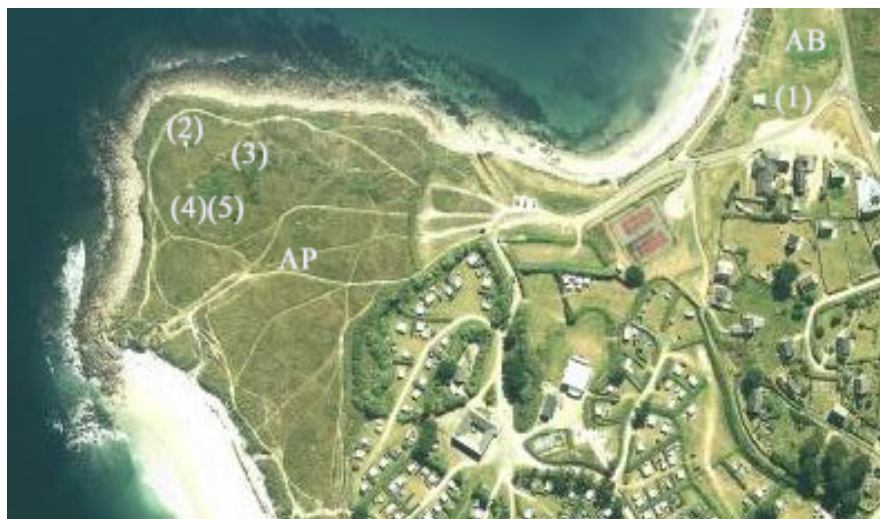
Figure 13. *Re 03* and *Re 04*: AB. Ar Gazel beach (*Re 03*), AP. Ar Gazel point (*Re 04*), 1. *V2d*, 2. 1st tobruck, 3. 2nd tobruck, 4. 3rd tobruck, 5. position of the demolished *V2d*.

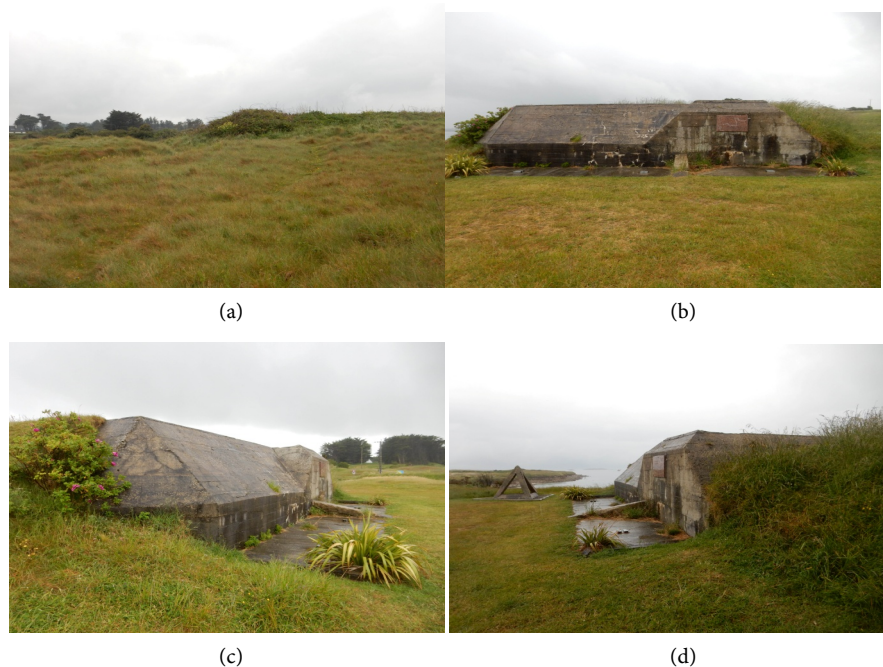
A *V2d* ($48^{\circ}34'32.13''\text{N}$, $4^{\circ}37'37.46''\text{W}$) (**Figure 14**) about 8×10 m, the only *Re 03* component identified on the Corn ar Gazel beach. It was partially covered by the terrain and its emerging concrete structure was in a good preservation state without damages due to combats. It is possible that a stair, buried in the terrain, allowed a rapid access to the coverage on which was probably placed a single or double, 2 or 3 cm *Flak* gun. The entrances were buried in the terrain, so that an inspection of the interior was not possible.

One of the thousand concrete tetrahedrons positioned, during the war, on the beach for counteracting allied landings, placed near the *V2d* during rehashing works of the beach.

Figure 14. *V2d* at Corn ar Gazel beach (a) connection trench; (b) front vision; (c) side vision; (d) side vision, on the left concrete tetrahedron.

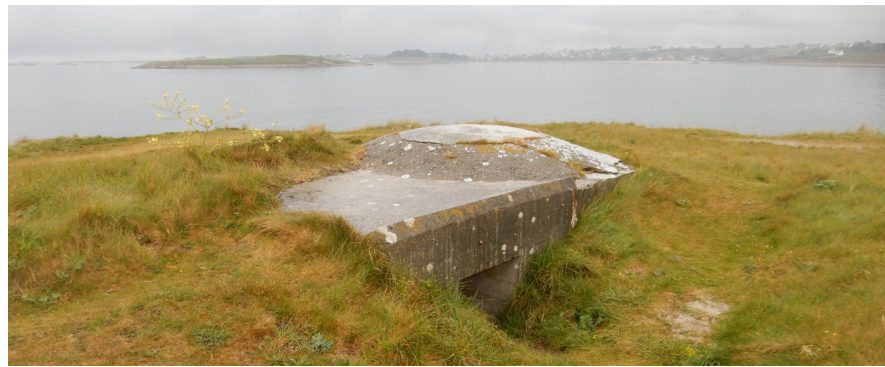
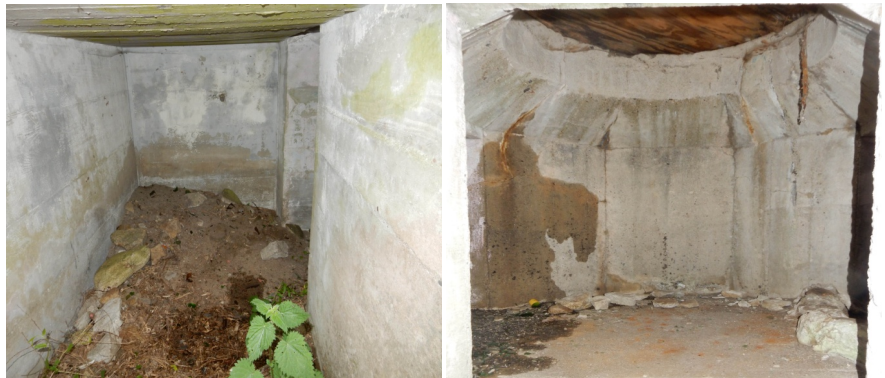
A 1st tobruck ($48^{\circ}34'42.38''\text{N}$, $4^{\circ}37'33.37''\text{W}$) (**Figure 15**), probably for a mortar, partially emerging from the sandy ground. The circular aperture of its combat room was closed by wooden boards covered by a concrete layer. Its emerging concrete structure was in a good preservation state without damages due to combats. The unobstructed entrance allowed ascertaining that entrance room and combat room were in a good preservation state, although the first was partially invaded by sand and debris arrived through the entrance.

Figure 15. 1st tobruck (a) entrance and aperture of the combat room covered by a concrete layer; (b) entrance room partially invaded by sand and debris; (c) combat room, on the upper side aperture closed by wooden boards.

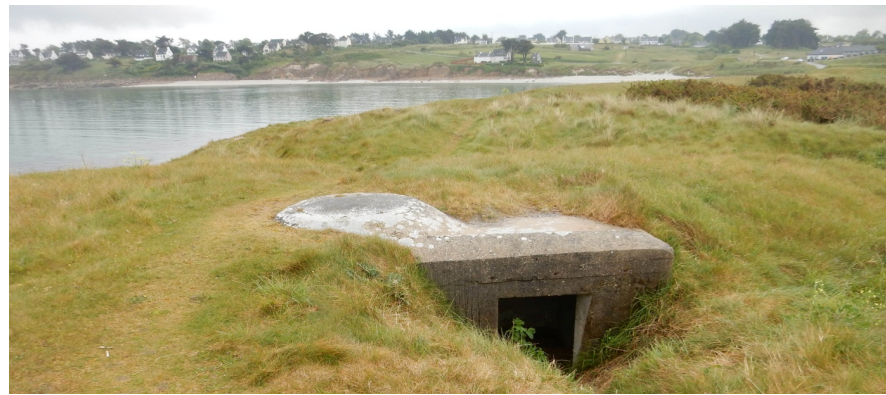
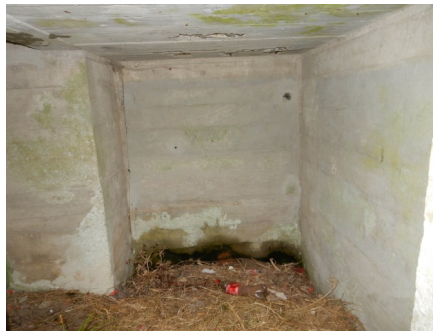
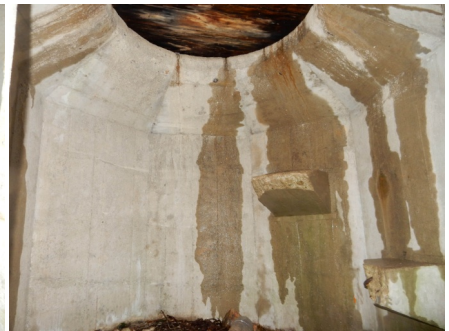
A 2nd tobruck ($48^{\circ}34'41.50''\text{N}$, $4^{\circ}37'33.78''\text{W}$) (**Figure 16**) partially emerging from the sandy ground. The circular aperture of its combat room was closed by wooden boards covered by a concrete layer. Its emerging concrete structure was in a good preservation state without damages due to combats. The unobstructed entrance allowed ascertaining that entrance room and combat room were in a good preservation state, although the first was partially invaded by sand and debris arrived through the entrance. In the combat room two steps protruded from the wall.

Figure 16. 2nd tobruck (a) entrance and aperture of the combat room covered by a concrete layer; (b) entrance room partially invaded by sand and debris; (c) combat room, on the right steps protruding from the wall, on the upper side aperture closed by wooden boards.

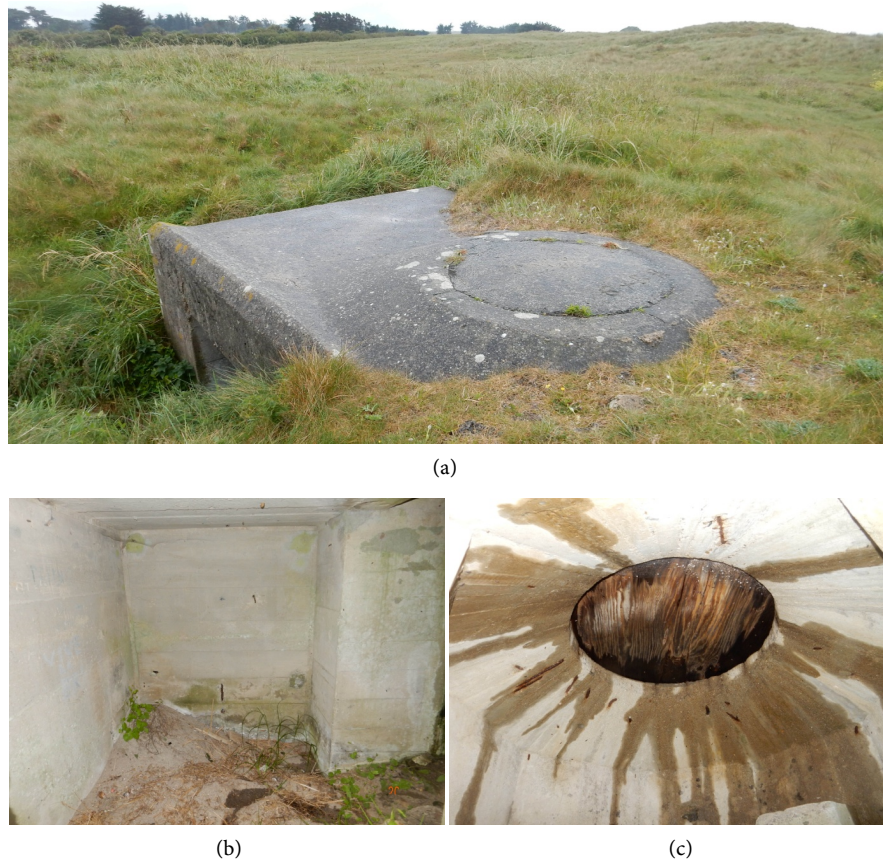
A 3rd tobruck ($48^{\circ}34'42.26''\text{N}$, $4^{\circ}37'34.79''\text{W}$) (**Figure 17**) partially emerging from the sandy ground. The circular aperture of its combat room was closed by wooden boards covered by a concrete layer. Its emerging concrete structure was in a good preservation state without damages due to combats. The unobstructed entrance allowed ascertaining that entrance room and combat room were in a good preservation state, although the first was partially invaded by sand and debris arrived through the entrance. In the combat room two steps protruded from the wall.

Figure 17. 3rd tobruck (a) entrance and aperture of the combat room covered by a concrete layer; (b) entrance room partially invaded by sand and debris; (c) combat room, on the right step protruding from the wall, on the upper side aperture closed by wooden boards.

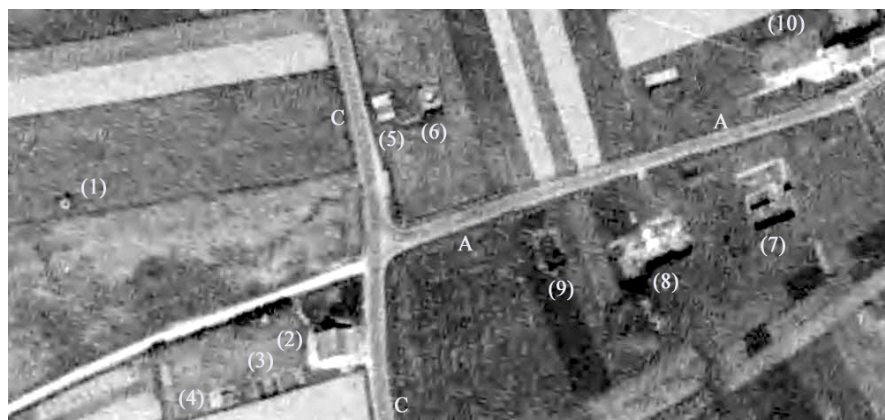
Works for camp improvement were in progress towards the end of the Occupation period as witnessed by a terminated 1st square excavation (48°33'58.57"N, 4°37'12.34"W) about 18 × 13 m, provided with a further central, rectangular excavation about 2 × 5 m, an elongated 2nd excavation (48°33'58.17"N, 4°37'14.30"W) about 26 × 14 m, in advanced state of completion and a 3rd excavation (48°33'57.35"N, 4°37'15.45"W) about 7 × 5 m provided with access ramp, all near the *L479* on the opposed side of the actual rue Arvel Vor (**Figure 18**). The dimensions of the 1st excavation did not fit with the dimensions 18.20 × 20.50 m of a bunker *V143* for *Mammut* radar (**Figure 19(a)**), which ruled out the hypothesis of the foreseen construction of such a bunker. The 2nd excavation, because of its shape and dimensions, appeared to conform well to a *L486* bunker (**Figure 19(b)**) for a permanent radar station, which confirmed the hypothesis of the foreseen construction of such a bunker. Said *L486* was probably foreseen for undertaking part of the operations performed at the *L479*. The 3rd excavation would be suitable for the construction of a small bunker of unknown type or for hosting a partially buried barrack. The excavations were still visible in the years 70th before to be filled by material and their area let free for modern houses construction.

Figure 18. Area of the excavations: (1) 1st *Würzburg-Riese* radar emplacement, (2) 1st *Freya* radar emplacement, (3) 1st pool, (4) small bunker near the 1st pool, (5) 1st *Vf2a*, (6) *L410A*, (7) 1st excavation, (8) 2nd excavation, (9) 3rd excavation, (10) *L479*, A rue Arvel Vor, C rue Corn ar Gazel [Geoportail] C0416-0181_1962_CDP1916_8220, cliché n°8220, 01/09/1962.

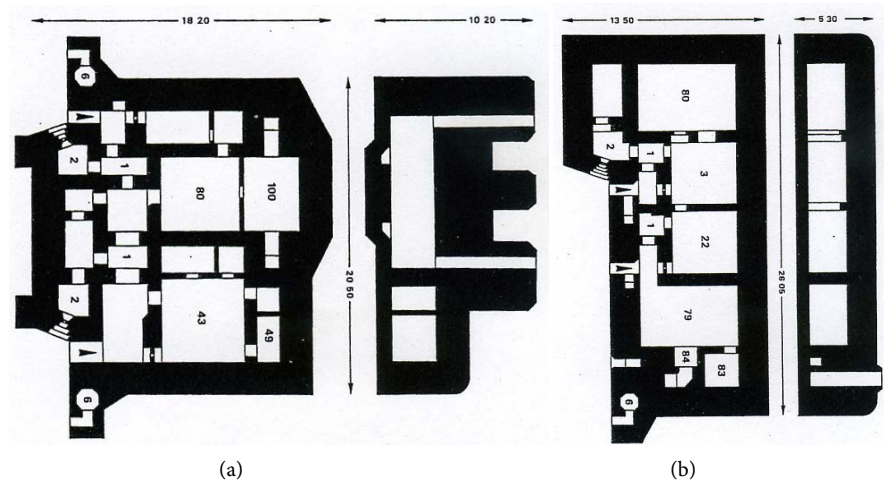
Figure 19. (a) Bunker V143 plan: 1. gasloch, 2. close combat room, 6. observation post, 43. engine room, 49. cooling water room, 80. operation room, 100. compensator room (Rudi, 1998); (b) bunker L486 plan: 1. gasloch, 2. close combat room, 3. crew room, 6. observation post, 22. ventilation room, 79. emergency generator room, 80. operation room, 83. transformer room, 84. re-cooling room (Rudi, 1998).
