The BDU West between WWII and Cold War

Giancarlo T. Tomezzoli

How to cite this paper: Tomezzoli, G. T. (2019). The BDU West between WWII and Cold War. *Archaeological Discovery*, 7, 1-19. <https://doi.org/10.4236/ad.2019.71001>

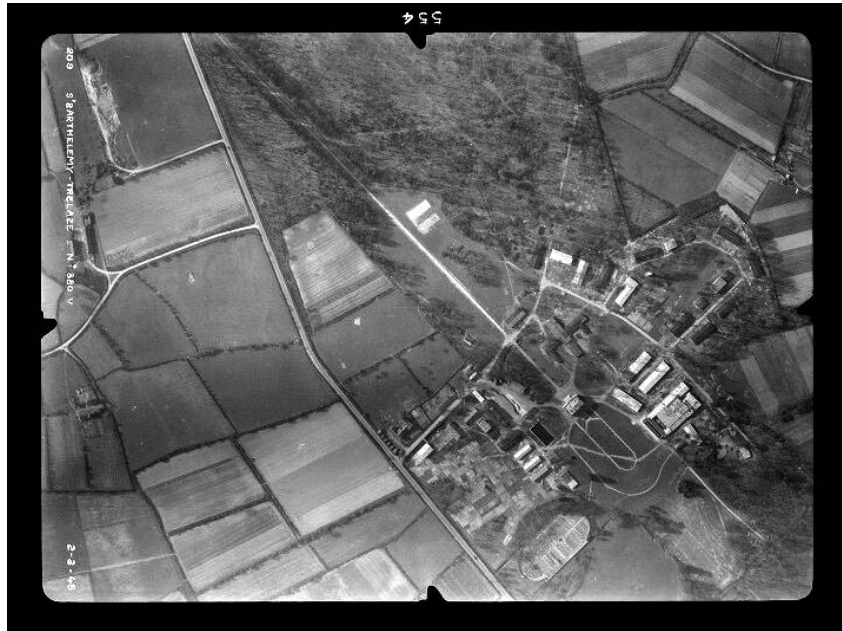
Figure 1. Domaine of Pignerolle: general view of the BDU: on the lower right, the castle and the BDU barracks and bunkers. C1522.0501_1948_CDP2928_0380, n°380, 1/4866, Argentique, 02/03/1948.

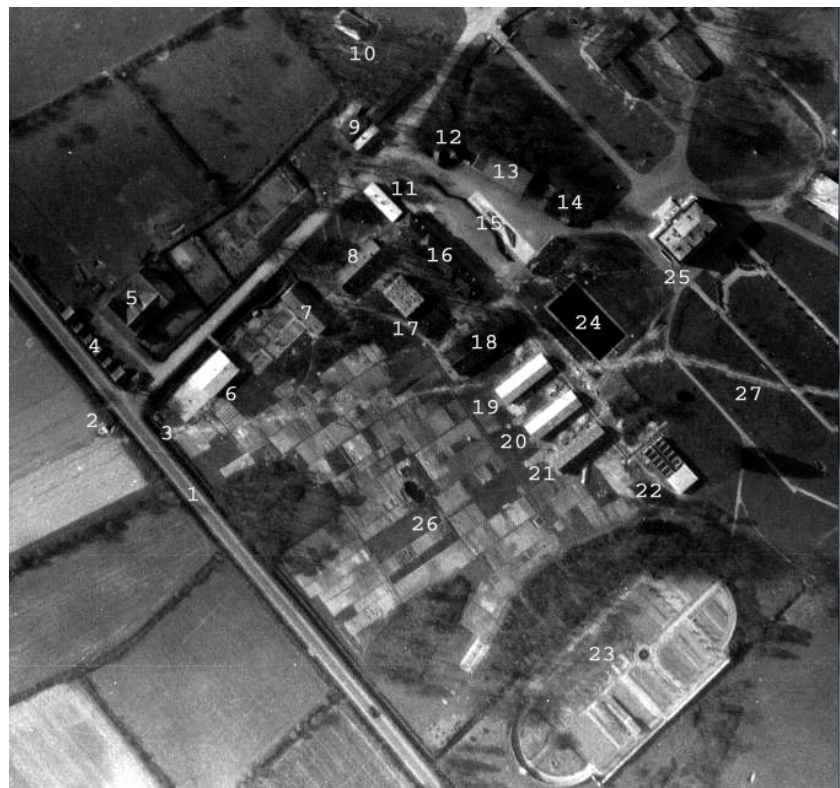
Figure 2. BDU organization—South part: (1) route de Beaufort; (2) external guard post; (3) internal guard post; (4) six small barracks; (5) two corps barrack; (6) - (8) barrack; (9) three corps barrack; (10) bunker; (11) barrack; (12) pigeon house; (13) - (15) barrack; 16 castle dependence; (17) bunker; (18) - (22) barrack; (23) vegetable garden; (24) pool; (25) castle; (26) cultivated area; (27) internal path.

The barracks (4) - (6), (9) - (11), (13) - (16), (18) - (22), (28) - (30), (32) - (34), (36), (38) - (39), (41) - (46), (49), (51) - (53), (55) (57) - (61) disappeared and only different grass growths here and there on the meadows betrayed their past presence. Rests of the concrete base of the barrack (34) were visible near the *Admiral* bunker (37). The water tower (48) disappeared. The concrete barracks (7) (8) were perfectly restored with no damage due of the population looting and hosted offices of the *Domaine* garden service.

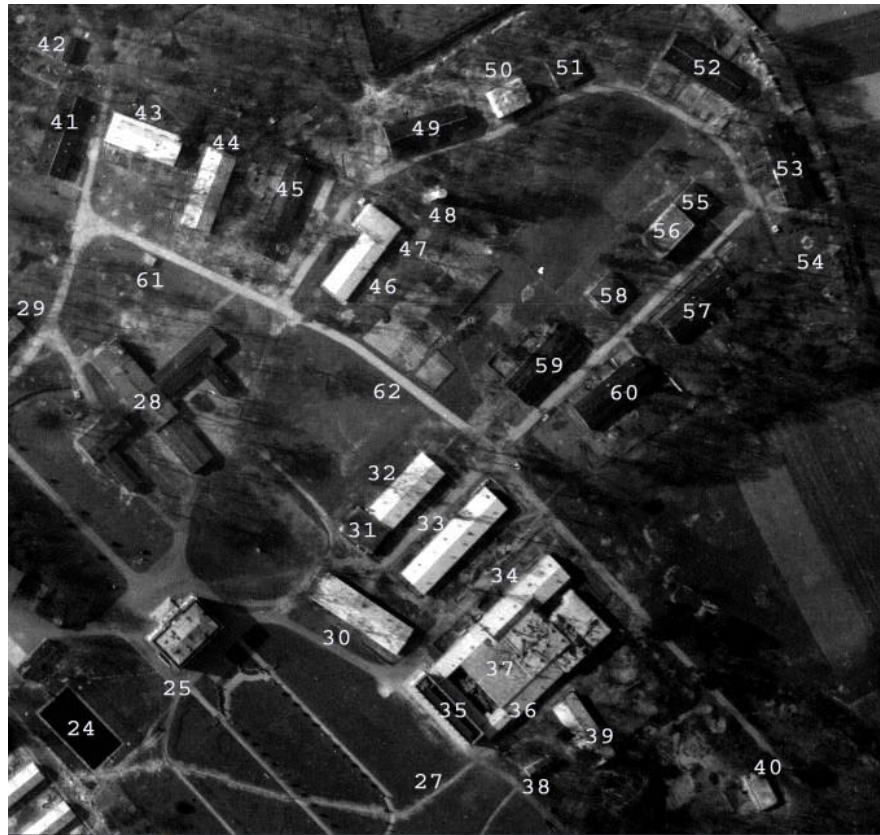
Figure 3. BDU organization—North part: (24) pool; (25) castle; (27) internal path; (28) administrative building; (29) - (30) barrack; (31) bunker; (32) (33) barrack; (34) barrack leaning to the *Admiral* bunker, (35) orangery, (36) barrack leaning to the *Admiral* bunker, (37) *Admiral* bunker, (38) (39) barrack; (40) bunker, (41) - (46) barrack; (47) bunker; (48) water tower; (49) barrack; (50) bunker; (51) - (53) barrack; (54) possible Flak position; (55) barrack leaning to the bunker (56); (56) bunker; (57) - (61) barrack, (62) internal path.

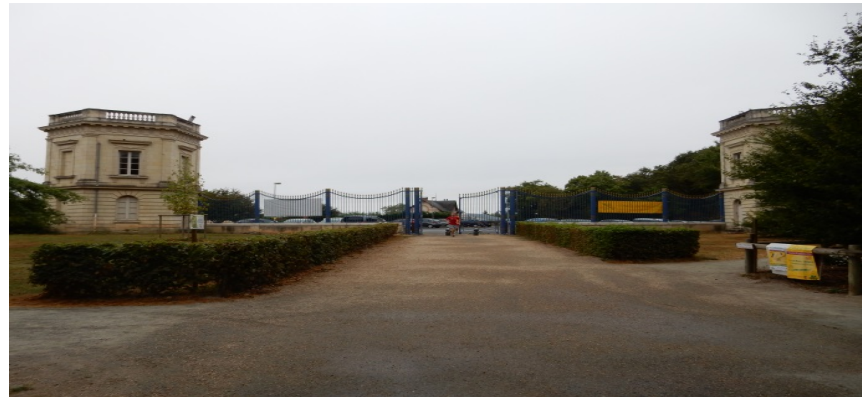
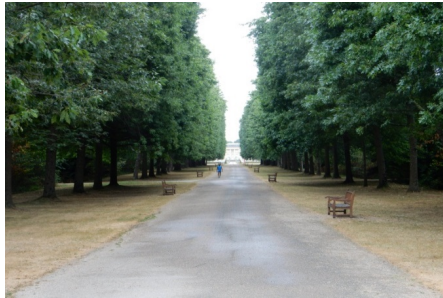
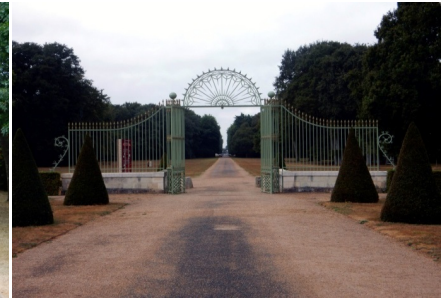
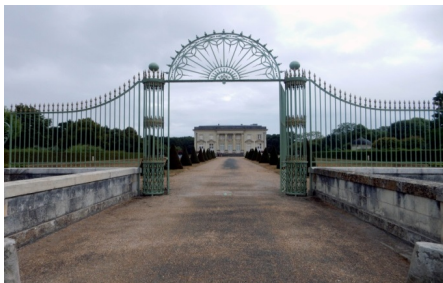
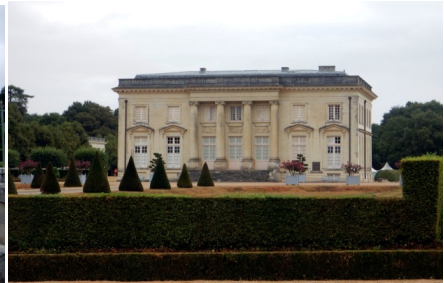
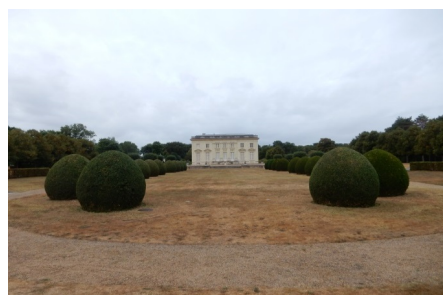
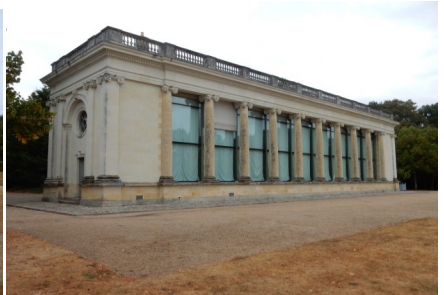
Figure 4. BDU site surviving components—(a) pavilion tours and grids at the Domaine entrance; (b) access lane; (c) entrance gate; (d) castle gate; (e) castle (25) front facade; (f) castle (25) rear facade, (g) orangery (35).

The visits of the BDU site took place on 22nd August 2011 and 16th September 2016. They showed that the pavilion tours and grids at the *Domaine* entrance, the entrance gate, the pigeon house (12), the pool (24), the castle (23) (47°28'11.48"N, 0°28'25.26"W, 42.29 m), the castle dependence (16), the vegetable garden (23) and the orangery (47°28'14.48"N, 0°28'21.98W, 42.52 m) (**Figure 4**) were perfectly restored with no damage due to the population looting. A museum dedicated to the communication was open in the castle, but was closed at the time of the second visit (**Tomezzoli et al., 2013**).

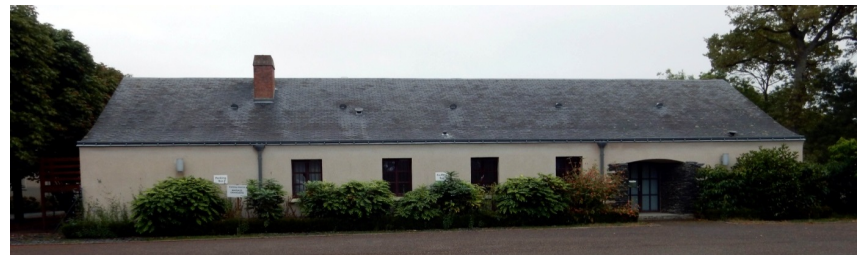
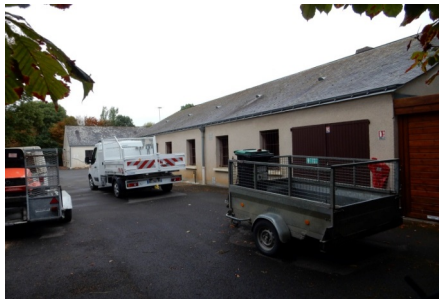
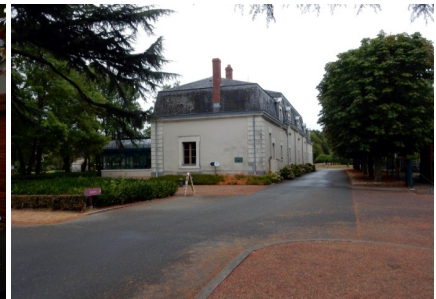
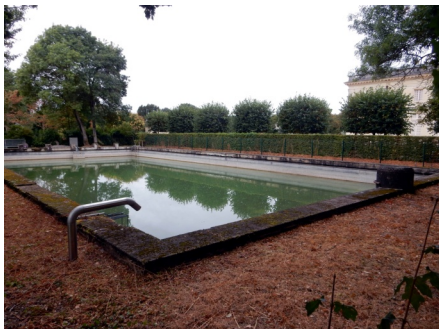
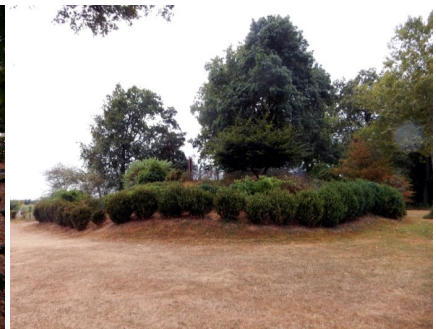
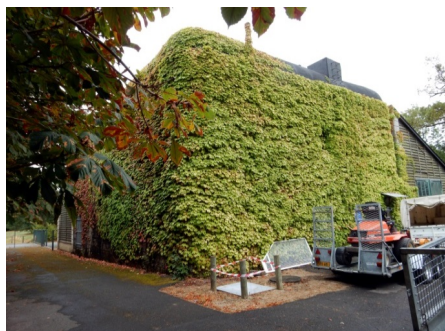
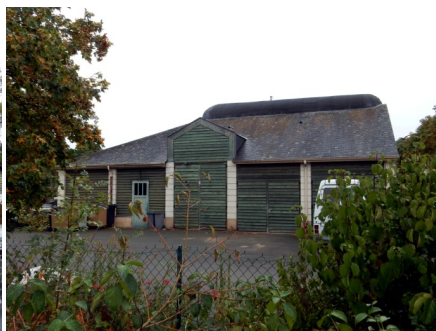
in the terrain; so that its type and internal and external preservation states have not been ascertained. The bunker (17) was accessible and used by the Domaine garden service. Its entrance side was covered by vegetation and a recent wood

Figure 5. BDU site surviving components—(a) barrack (8) front side; (b) barrack (8) rear side—on the far left barrack (7); (c) castle dependence (16); (d) pool (24); (e) mound covering bunker (10); (f) bunker (17) entrance side; (g) barrack hanging on bunker (17).

barrack, used as garage and store of garden materials, was leaning on the opposite bunker side. The interior was in good preservation state with original armoured doors still in place. Bunkers (31), (47), (56) closed during the first were accessible during the second visit. Their interiors were in good preservation state with armoured doors still in place. All the original furniture and components of

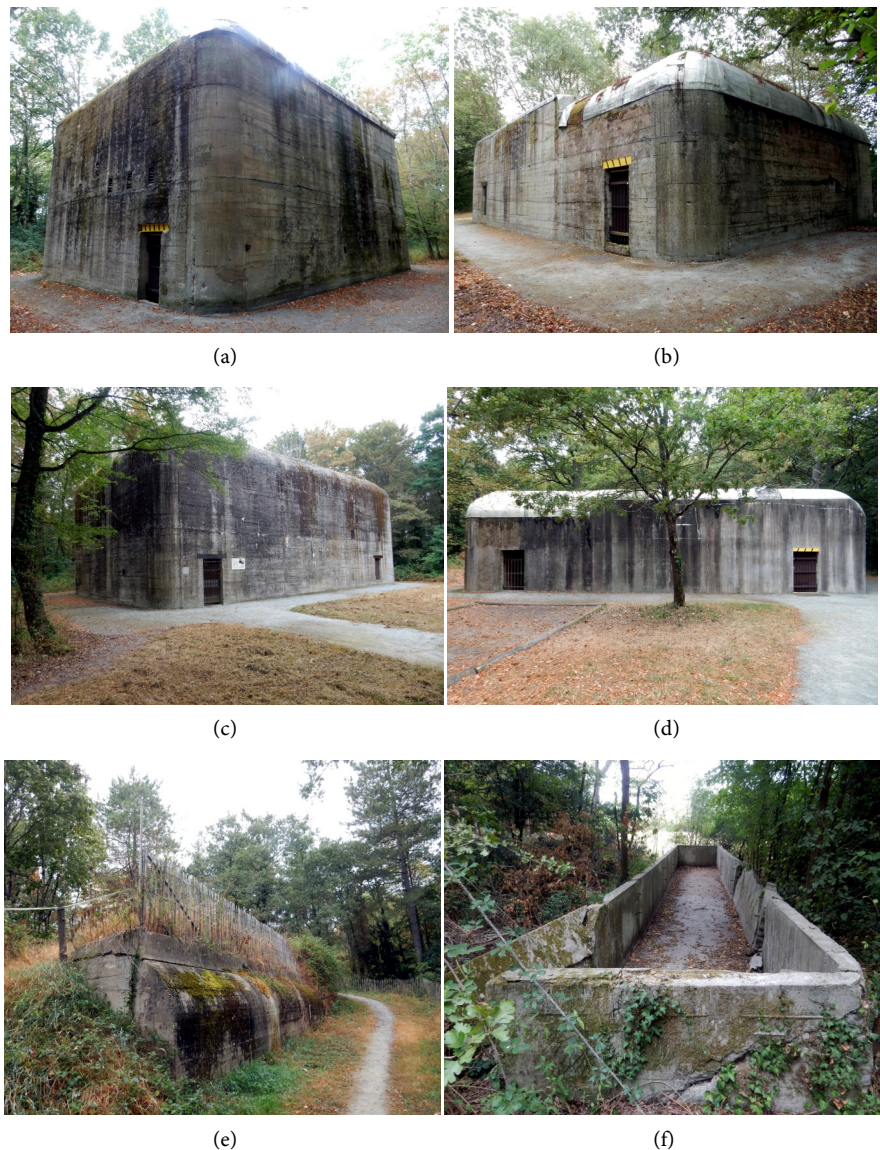
Figure 6. BDU site surviving components—(a) bunker (47); (b) bunker (50); (c) bunker (56); (d) bunker (31); (e) bunker (40); (f) concrete cistern.

its heating and aeration system disappeared. Only aeration conduit portions were in place on the walls. Their external concrete structures were in good preservation state. The coverage of bunker (31) was further covered by a recent metal sheet. Bunker (50) was accessible during the first visit. Its interior was in good preservation state with armoured doors still in place. All the original furniture disappeared and only aeration conduit portions were in place on the walls. Its external concrete structure was in good preservation state and the coverage was further covered by a recent metal sheet.

Bunker (40) was partially buried in the terrain, which obstructed its entrance. Therefore, its type and interior preservation state has not been ascertained. The emerging portion of its external structure was in good preservation state. A concrete cistern and two other bunkers ($47^{\circ}28'9.34''\text{N}$, $0^{\circ}28'8.35''\text{W}$, 43.6 m) (Figure 6 & Figure 7), outside Figure 2, were about 150 m east from the vegetable garden (23). The concrete cistern (2.5×10 m) was invaded by the vegetation at the time of the first visit but emptied and cleaned up at the time of the second visit. The bottom was in good preservation state, but the side walls were marked by large and deep cracks and some wall portions were displaced. One of the bunkers was of a special type (*Sonderkonstruktion*) partially buried in the terrain, which obstructed its entrance. Therefore, its interior organization and preservation state has not been ascertained.

The bunker (31) was an infirmary bunker. Bunkers (47), (50), (56) were shelters for the BDU seamen in case of attack. The purpose of bunker (40) is unknown. The R611 was a bunker for a 150 mm gun; the R621 was a shelter for personnel. In case of R611, this bunker protected the east side of the BDU and it is surprising that no other such bunker was built for protecting the other sides of the BDU. The square support bases on the *Sonderkonstruktion* coverage probably supported a *Flak* guns platform. The thirteen concrete aligned supports probably supported another *Flak* guns platform. The cistern was probably the first constructed near the R611 or R621 and the *Sonderkonstruktion*. It stored water necessary on the construction yard of said bunkers, and not easily available on the yard. It provided water for knead the concrete, to quench thirst of working animals and against possible fires of the wood stocks for formworks.

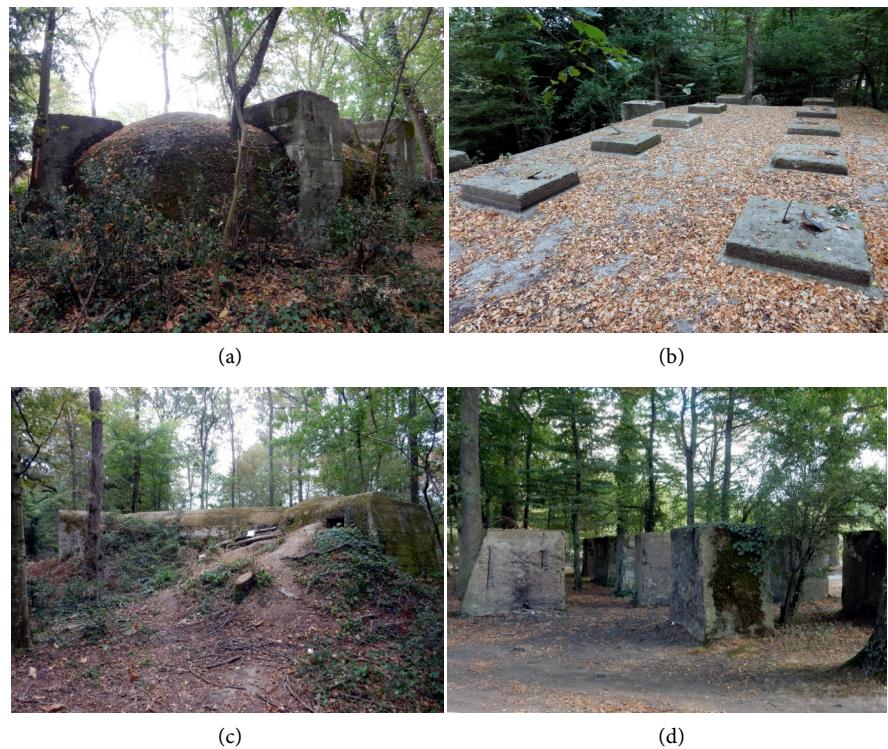
Figure 7. BDU site surviving components—(a) *Sonderkonstruktion*—side view; (b) *Sonderkonstruktion*—coverage with square supports bases; (c) R 611 or R 621—entrance side; (d) concrete aligned supports.

Its emerging structure was in good preservation state with an obstructed emergency exit and eighteen square, support bases on its coverage. The other was an R611 or R621 partially buried in the terrain, which obstructed its fire room openings. Therefore, its interior preservation state has not been ascer-

tained. Its emerging structure was in good preservation state, with the circular aperture of the external observation post (*tobruck*) obstructed by a concrete layer.

Thirteen concrete aligned supports (47°28'28.02"N, 0°28'23.21"W, 31.85 m) (**Figure 7(d)**), outside **Figure 3**, were about 380 m from the *Admiral* bunker beyond the state road 347 but still on the *Domaine*. Their external structure was in good preservation state with metallic joints still in place (Tomezzoli et al., 2013).

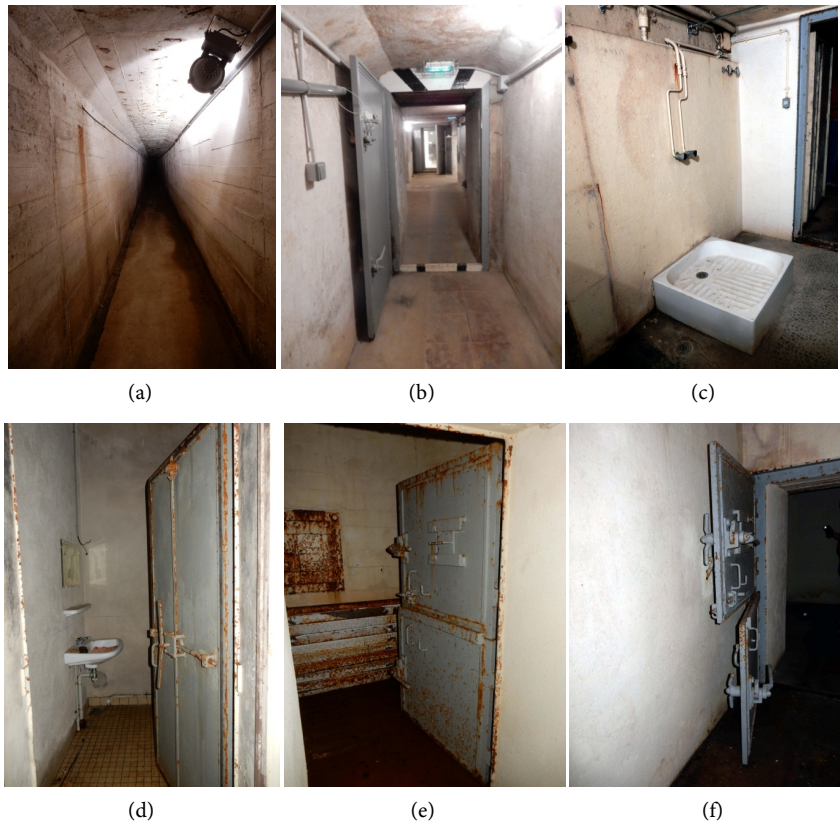
Both were in good preservation state with traces of construction formworks on the walls typical of the German masonry. The bunker anti-atomic transformation works were immediately evident.

A recent shower system was in place at the entrance, complete with its white rectangular base, hot and cold water mixing taps, but no splash guard. Recent toilets were in good preservation state. All the original armored doors were in

Figure 9. *Admiral* bunker (37)—(a) tunnel towards the castle; (b) bunker entrance, original light armored door 19P7; (c) shower system; (d) toilet in good preservation state; (e) original heavy armored door 434PO1 of a close combat defence room (2), on the wall defence original plate 483P2; (f) original armored port 434PO1.

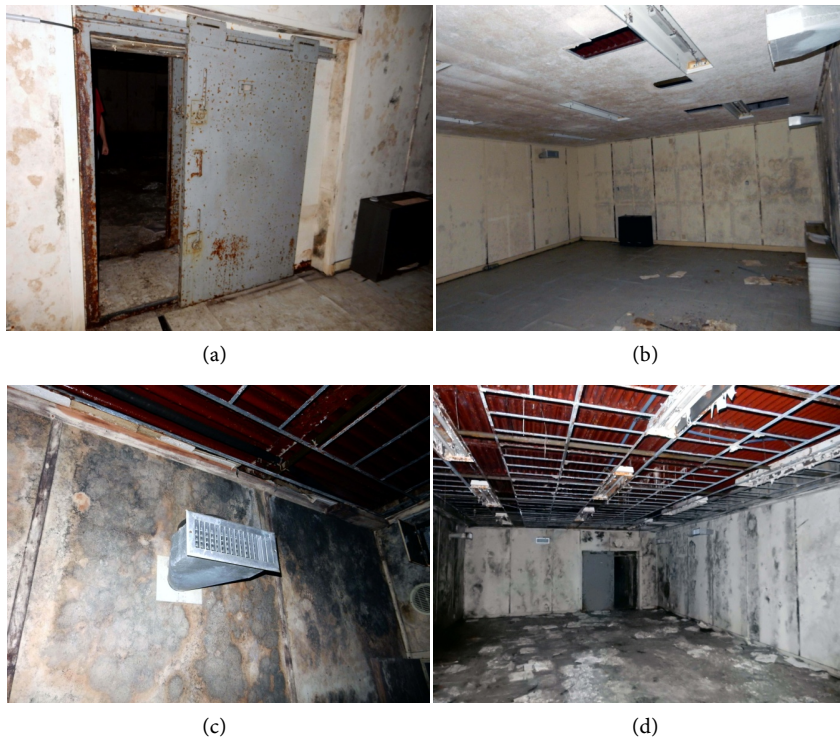
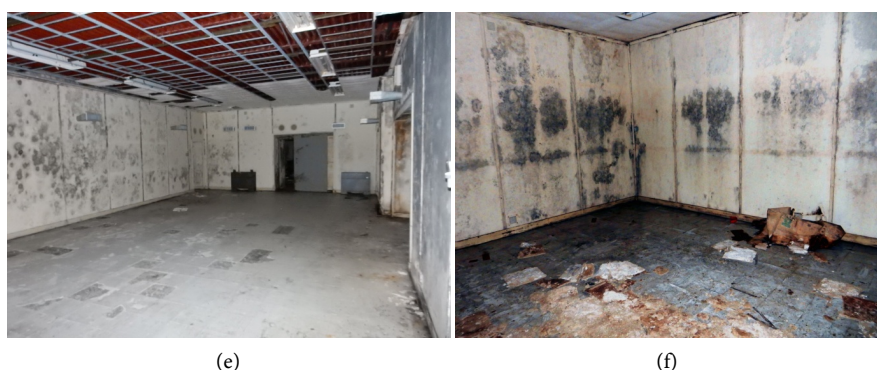
Figure 10. *Admiral* bunker (37)—(a) armored sliding door, on the right electrical, heating element; (b) internal room, suspended ceiling with white coverage panels in place; (c) modern galvanized aerator; (d) internal room, metallic suspension frame in place and white panels fallen on the floor; (e) internal room with metallic suspension frame and no white coverage panels; (f) internal room, white painted walls with marked traces of moisture.

place, sometime gray re-painted, sometime rusted but preserving their original blue painting.

The rooms (27), (32), (57), (85) were in a degraded state. The walls preserved the original white painting with marked stains of moisture. Original vertical wooden supports for a possible insulation system were in place. Modern galvanized sheet aerators on the walls replaced the original aerators. Original white tiles were in place on the floors. Somewhere, water puddles invaded the room floors. Modern suspended ceilings formed by white painted metallic suspension frames supported white coverage panels and casings of the lighting system each containing two neon tubes. The lighting system installation appeared completed. The panels fallen on the floor in one room let visible the suspension frame and the original, rusted bunker metal ceiling. One room was provided with suspension frame and casings but the panel installation was not terminated.

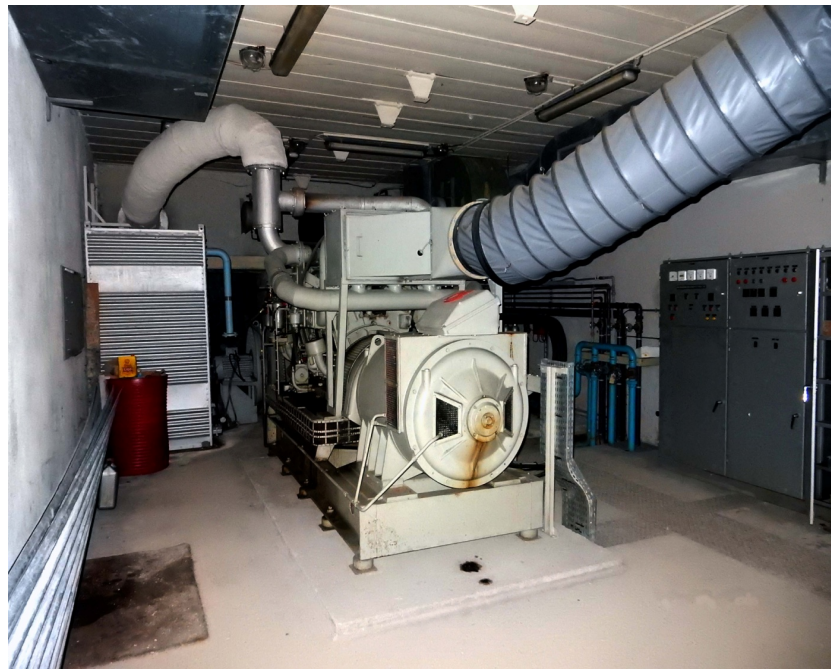
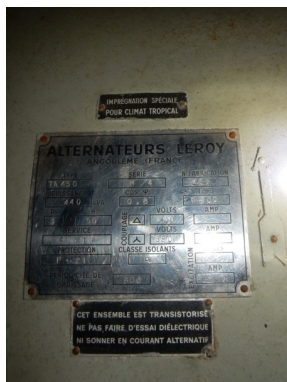
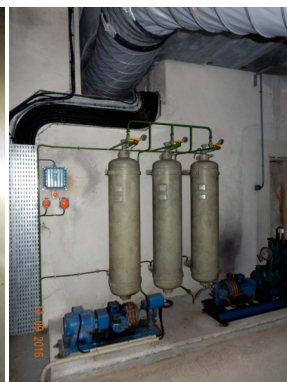
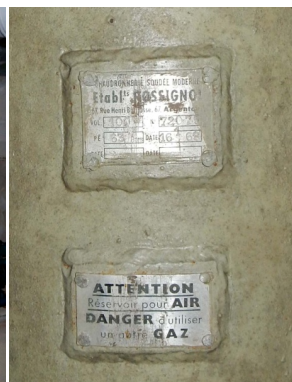
Figure 12. *Admiral* bunker (37): (a) alternator Leroy TA 450, on the right grey painted control cabinets, on the ceiling, joints for the generator lifting; (b) alternator data plates; (c) cylindrical bottles and two air compressors on the floor; (d) two metallic labels on one bottle.

the white painted floor. On the room ceiling, white metal joints for the generator lifting were in place. The alternator grey and blue painted control cabinets were in good preservation state. A white arrow near two metallic black data plates and a silver data plate on the alternator indicated the rotation direction. The data plates (Figure 11(b)) informed:

Three well preserved cylindrical, metal bottles of pressurized air were suspended to a room wall. Green tubes departed from them to the diesel motor and to two blue painted air compressors on the room floor. Two metallic data plates on one of the bottles (**Figure 11(d)**) informed:

submarine base of La Pallice or that of the French diesel-electric locomotive 262 AD.1 or 262 BD.1 of the degaussing station at the Bouvet basin of Saint-Malo port (Tomezzoli & Pottier, 2016). The original radiators, visible in vintage images, were replaced by electrical, heating elements. The black pumps and the insulated, white tubes circulated hot water of the heating system. The grey pumps, the galvanized tubes and aerators circulated air of the ventilation system. The blue tube distributed diesel fuel to the diesel motor. The bottles and the green tubes circulated compressed air to the diesel motor. The dates 16 1 68 on a metallic label of an air bottle and the 16 JANV 1968 on the technical sheet of the Leroy alternator permit to date the transformation works of the *Admiral* bunker between the 1964, year of the closure of the BDU as provisory accommodation centre and the year 1968.
