# Effects of Syngas Particulate Fly Ash Deposition on the Mechanical Properties of Thermal Barrier Coatings on Simulated Film-Cooled Turbine Vane Components

Kevin Luo<sup>1</sup>, Andrew C. Nix<sup>1</sup>, Bruce S. Kang<sup>2</sup>, Dumbi A. Otunyo<sup>2</sup>

IGCC Gas Turbine Thermal Barrier Coatings, Coal Syngas, Fly Ash Deposition, Micro-Indentation, Strain Tolerance

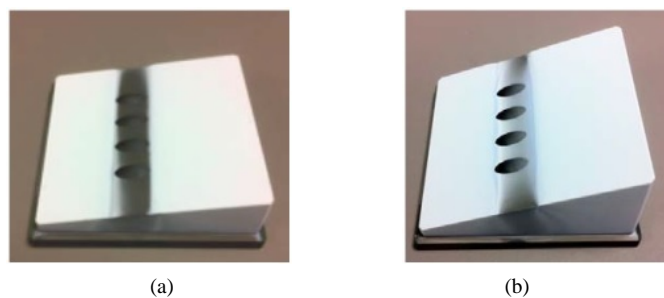
**Figure 1.** Photographs of the (a)  $10^\circ$  and (b)  $20^\circ$  test articles with TBC before deposition testing.

The thermal barrier coatings were applied to each test article using a directed vapor deposition (DVD) process [10]. The DVD process produces coatings similar to those of the EB-PVD but has a more efficient deposition process. It features non line-of-sight deposition and controlled intermixing during multiple source evaporation which allows for novel coating architectures and deposition on complex engine components. Approximately 400  $\mu\text{m}$  of ceramic top coat layer was applied as 7% Yttrium Stabilized Zirconia (7YSZ). A  $\gamma$ - $\gamma'$  platinum aluminide (PtAl) bond coat, developed by Brian Gleeson at the University of Pittsburgh [11], was applied with an approximate thickness of 15 - 20  $\mu\text{m}$ . The cooling holes were masked during the coating process, which created a shallow trench, a configuration used in modern gas turbine components [12]. **Figure 1** contains images of two angled test articles after TBC application [6].

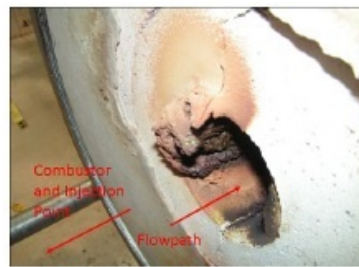
**Figure 2.** Image of large deposit formation on the left size of the transition piece [12].

The study by Murphy, Nix, Lawson, Straub, and Beer [6] found that deposition formed on only one side of the test articles. The one sided deposit formation was due to a large deposit structure forming on the transition piece of the test section. **Figure 2** shows the transition piece with a deposit structure on the left side of the piece [14] [15]. The structure on the test section transition piece created a swirl effect leading to an uneven distribution of fly ash into the test section. This limited the areas of heavy deposition and created a “stratified” amount of deposition on the test articles. The swirl effect would be unrealistic in an actual gas turbine first stage vane flow.

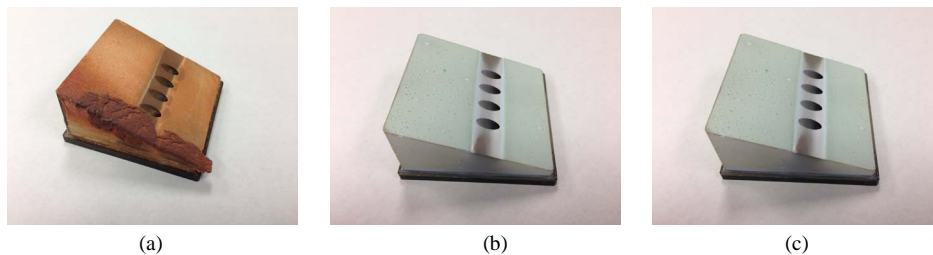
**Figure 3.** Labels of (a) Test Article 1° - 20° with deposition; (b) unexposed Test Article 2° - 20°; and (c) Test Article 3° - 10° with deposition. (a) Test Article 1; (b) Test Article 2; (c) Test Article 3.

The test articles used in this study are labeled and shown in **Figure 3**. Heavy deposition can be observed on the left side of the face on test article 1 (see **Figure 3(a)**). The roughness results were computed for the deposition on test article 1 using an Olympus LEXT OLS 3100 laser confocal microscope [14]. A detailed view of the roughness characteristics is shown in **Figure 4(a)** [14]. The blue line represents the mean average roughness of the article when unexposed to testing. The measurements to the peaks and valleys are represented by  $y_i$ , which is used to calculate the centerline averaged roughness ( $SR_a$ ) and the root-mean-square (RMS) roughness ( $SR_q$ ).  $SR_p$  and  $SR_v$  are defined as highest peak and lowest valley measure by  $y_i$  respectively. Adding  $SR_p$  and  $SR_v$  gives the maximum peak-to-valley distance value,  $SR_z$ . **Figure 4(b)** contains the image of where the surface roughness scan of the deposition was taken on test article 1. The roughness values for test article 1 prior to sectioning are given in **Table 3** [14].

In order to perform micro-indentation and SEM analysis, the test articles required prepping which included sectioning and trimming of the angle. The location of angle trimming can be seen in **Figure 3(a)**. Flat samples were required to produce accurate results from the micro-indentation procedure. The samples have a substrate thickness of 1/4 inches after the angle cut. Once the angle was removed, a grid for further sectioning was created to produce the test samples from flat test articles. **Figure 5** details the sample labels for each test sample. The

heavy deposition on test article 1 in **Figure 3(a)** is outlined in **Figure 5(a)**. Most of the deposition falls off during the sectioning, leaving only strongly adhered deposition that has reacted with the YSZ coating. After completion of the sectioning, samples devoid of defects (delamination, cracking, etc.) were used for micro-indentation tests on selected areas of varying deposition quantity.

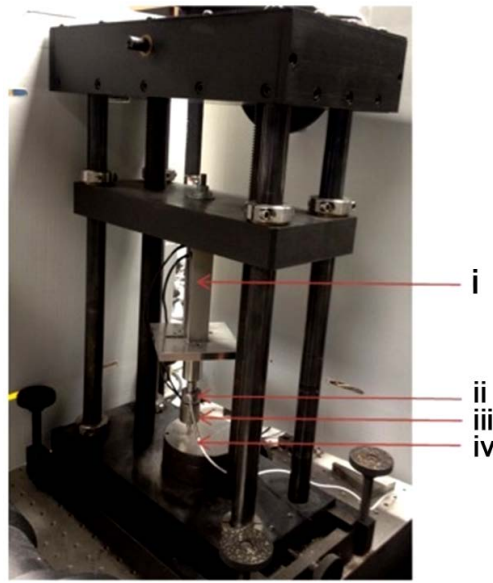
**Figure 6.** Table top micro-indentation setup: (i) 3.6 nm Resolution, Physik Instrumente, P-239.9S, 180  $\mu\text{m}$  piezoelectric actuator; (ii)  $\pm 0.15\%$  Accuracy, Honeywell, Model 31, 100 lb. load cell; (iii) spherical tungsten carbide (WC) 793.5  $\mu\text{m}$  radius indenter; and (iv) sample stage [8].

For the micro-indentation test, a table top system was used for the multiple partial unloading procedure to determine the elastic modulus of the desired areas of the TBC samples at room temperature. The table top indentation system is comprised of a spherical tungsten carbide (WC) indenter having a radius of 793.5  $\mu\text{m}$ , combined with a piezoelectric actuator (3.6 nm Resolution, Physik Instrumente, P-239.9S, 180  $\mu\text{m}$ ) and a high accuracy ( $\pm 0.15\%$  Accuracy, Honeywell, Model 31, 100 lb.) load cell [9]. The shallow indentation depth (50  $\mu\text{m}$  into the YSZ coating in the current study) allowed the test to be considered a non-destructive evaluation (NDE). The system is illustrated below in **Figure 6** [9].

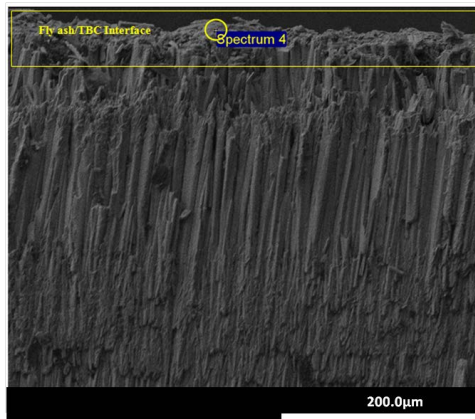
**Figure 7.** Point & ID location on Sample 3-1 for acquisition of spectrum results in Table 4.

Prior to any micro-indentation, confirmation that the molten deposit on top of the TBC ceramic top coat agreed with the elemental composition of fly ash injected into the combustion facility (**Table 2**) was examined. **Figure 7** shows a SEM micrograph of a cross-section of Sample 3-1 near the columnar tips of the YSZ coating. An X-ray spectrum was acquired at a single point within the deposition layer (circled in **Figure 7**).

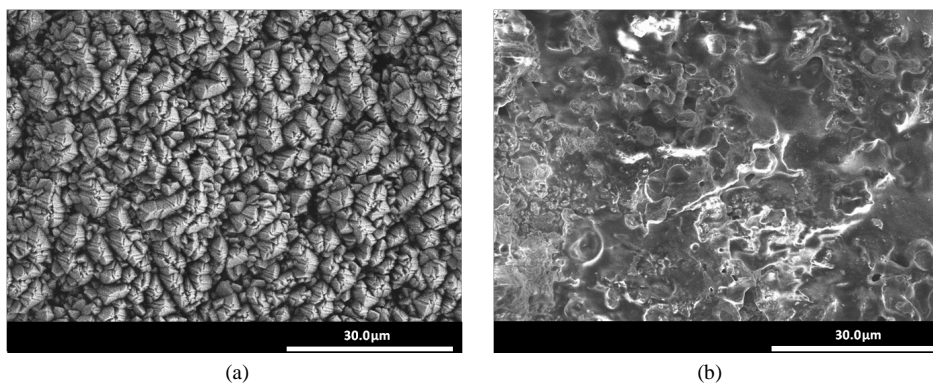
**Figure 8.** Top view of (a) unexposed Samples 2-1 and (b) molten deposition on Sample 1-5.

**Figure 8(a)** shows the top view of as-deposited YSZ coating that has been unexposed to any combustion facility testing. The columnar structure with inter-columnar gaps improved the lateral strain compliance of the coatings. The top view of the YSZ top coat with molten fly ash are shown in **Figure 8(b)**. Once molten and cooled, the deposits formed a thin, hardened, and almost glass-like ash layer on top of the columns of the YSZ coating. This subsequently reduced to the stain tolerance of the YSZ coating.

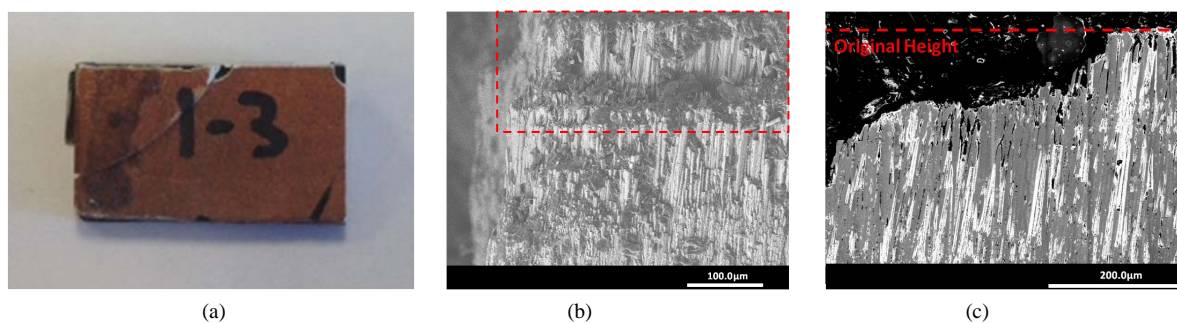
**Figure 9.** (a) Top view of Sample 1-7 and cross-section micrographs of delamination in Sample 1-3 top coating (b) after sectioning and (c) after mounting and polishing. (a) Sample 1-7: Top coat cracking; (b) Post-sectioning/Pre-polishing; (c) Mounted in a conductive mounting media.

As the molten deposits infiltrated top coat, the YSZ coating became more susceptible to delamination. Upon sectioning, a portion of Sample 1-7 developed a diagonal crack along the top surface of top coat which later led to delamination (see **Figure 9(a)**). **Figures 9(b)-(c)** show that Sample 1-3 lost roughly 100  $\mu\text{m}$  of YSZ coating near the edge where deposition was abundant. Spallation of the TBC layers is considered the final failure of the insulating system.

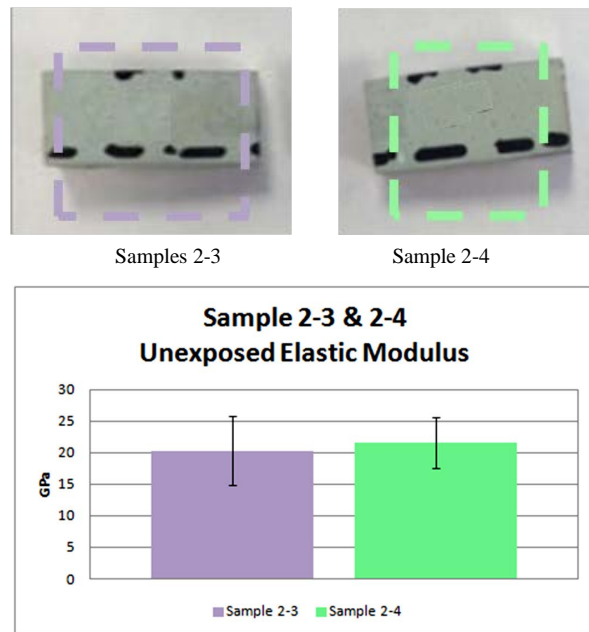
Figure 10. Images of unexposed Samples 2-3 and 2-4 and their average values for TBC modulus of elasticity.

**Figure 10** below contains an image of the two unexposed samples, 2-3 and 2-4, and their averaged elastic modulus are recorded below in test sample images. The error bars in on the results denoted the uncertainty for each sample. An average of all the individual tests on both samples was used to obtain a value for the baseline elastic modulus ( $E_{\text{unexposed}}$ ) of 20.93 GPa. The uncertainty was measured as a combination of the number of indentations on each sample and the tolerance of the table top system.

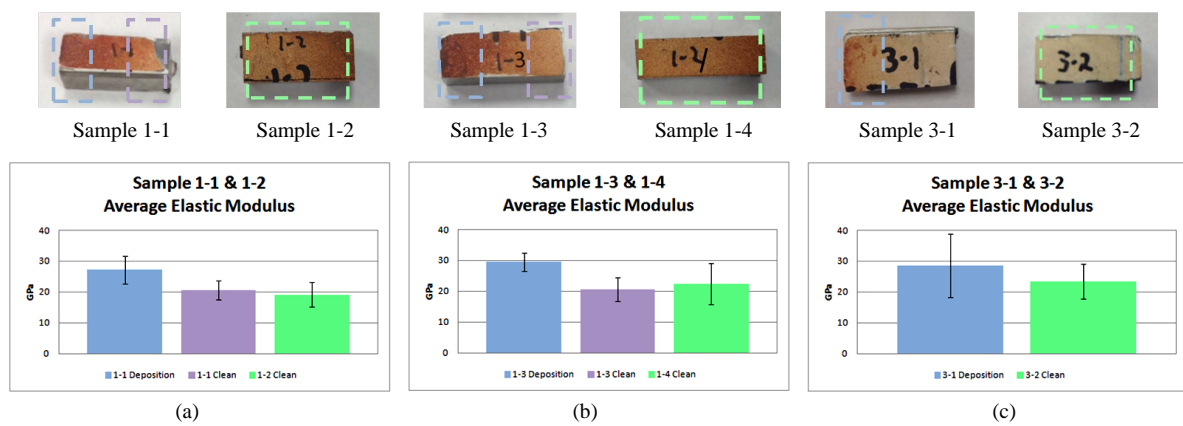
Figure 11. Image of samples and their values for averaged TBC modulus of elasticity for (a) Samples 1-1 and 1-2; (b) Samples 1-3 and 1-4; and (c) Samples 3-1 and 3-2.

Once the value of  $E_{\text{unexposed}}$  was obtained, multiple partial unloading was performed on Samples 1-1, 1-2, 1-3, 1-4, 3-1, and 3-2. **Figure 11(a)** contains the images and results for Samples 1-1 and 1-2. The colored dashed boxes in the images of the samples correspond with the averaged elastic modulus value in the lower chart of **Figure 11(a)**. The portion of Sample 1-1 bordered with the blue dashed box contained an area where molten deposits had adhered onto the TBC prior to the sectioning. The infiltrated area exhibited a higher modulus of elasticity than those of the unexposed articles or areas along the same sample or same plane without any significant deposition adherence. The same increase in Young's modulus can be observed for Samples 1-3 and 1-4 (**Figure 11(b)**) and Samples 3-1 and 3-2 (**Figure 11(c)**). The elastic modulus for Sample 3-1 was recorded for the area with deposition only due to sample compliance issues.

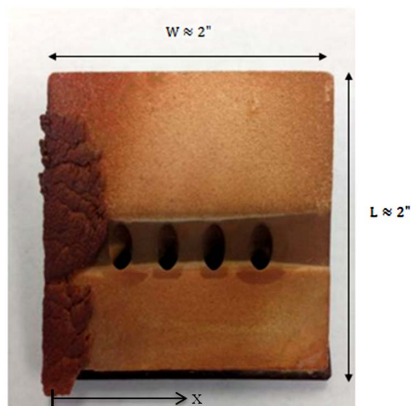
Figure 12. Dimensions of the test article faces.

In order to develop a trend for the molten deposits effects on the TBC, the modulus of elasticity with respect to the length across the TBC top face was plotted. The width of the top face, which is used for a length scale, of all the TBC coated articles is roughly 2 inches (see **Figure 12**).

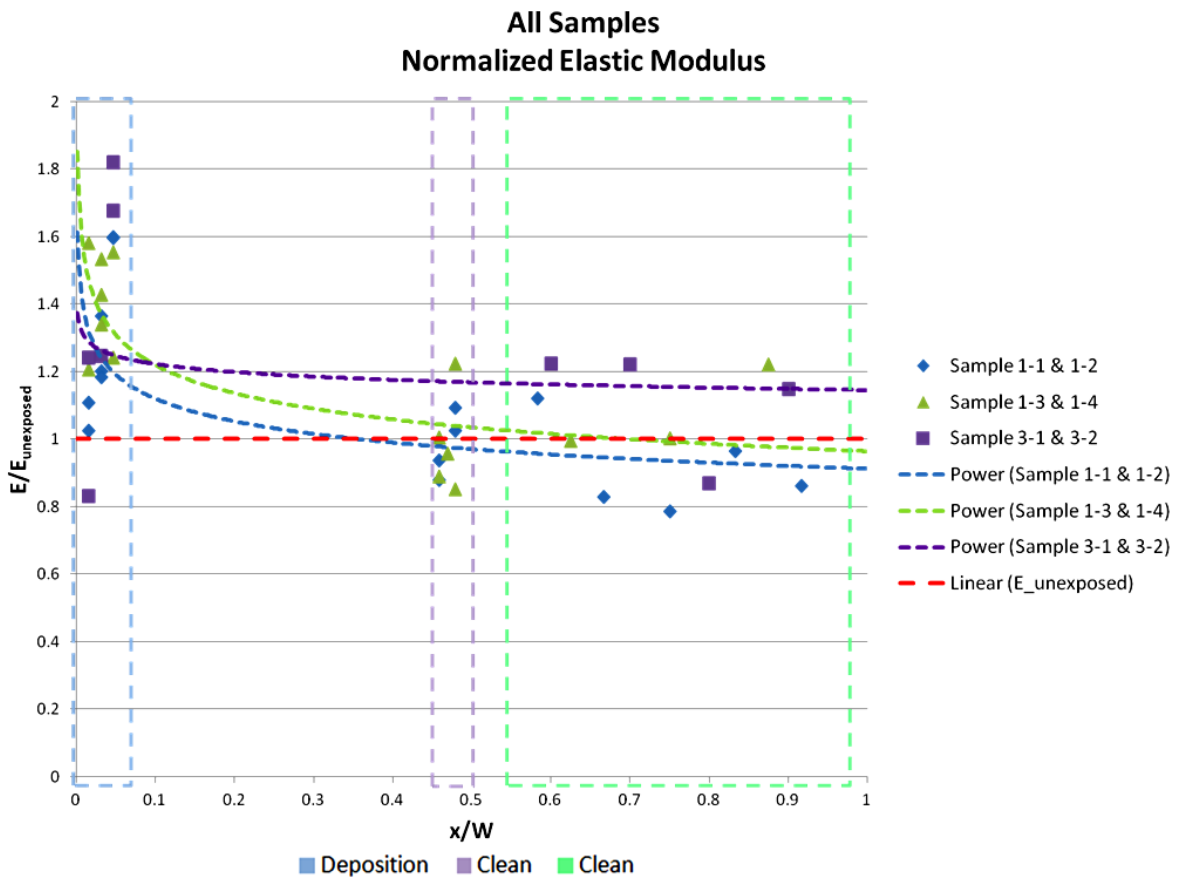
**Figure 13.** Normalized elastic modulus trends for all samples.

Individual indenter results for all samples were plotted in **Figure 13**. The graph contains the normalized distance ( $x/W$ ) versus normalized Young's modulus values ( $E_i/E_{\text{unexposed}}$ ). A power series trendline was included for

each sample set to show the relationship between the surface stiffness from near the  $x/W \approx 0$  edge to the right side of the test article face. The error was not plotted in **Figure 13** in an attempt to not clutter the plot and was already shown in **Figure 11**. The trend for Samples 1-1 & 1-2 and Samples 1-3 & 1-4 show that there was a reduction in the strain tolerance of the YSZ coating in an area of deposition infiltration, and that the modulus of elasticity approaches the baseline Young’s modulus of the unexposed test articles as  $x$  approaches 2 inches where there was significantly less deposition. The two aforementioned power series lines share a similar trend since the samples were from the same test articles. The difference in modulus of elasticity was less between for Samples 3-1 and 3-2, which was most likely due to less molten fly ash contaminants.
