Testing Geographical Methodology and Tools for the Study of Territories Damaged by Earthquakes. The Case of L'Aquila and Other Localities Three Years after the April 6th 2009 Event

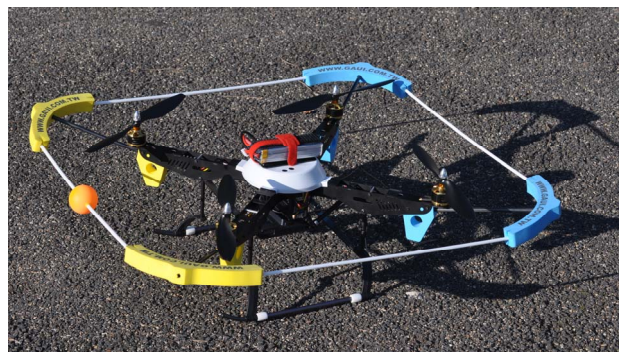
Figure 1. The remote-control helicopter equipped with a digital camera which will be used during the next field study. Photo by GREAL.

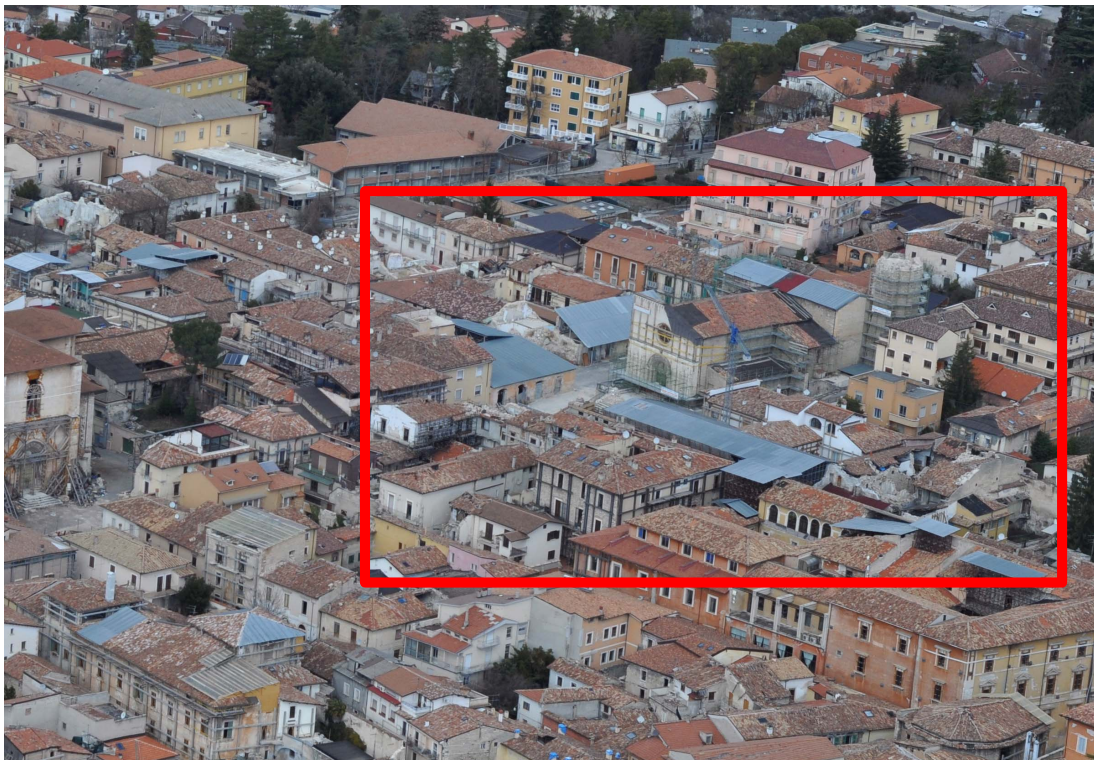
Figure 2. The church of S. Pietro a Coppito and the nearby buildings in March 2012.

and partial collapse to the front of the church, to the nave and belfry [16]. Now, the church shows the signs of safety measures having been taken, but not the signs of structural and functional restructuring; and the nearby buildings show yielding and cave-in signs or temporary patching and covering of the roofs which denote an evident dereliction status (Figures 2 and 3). A comparison with some photos of February 2010 (Figures 4 and 5) certainly indicates the present lack of confusion and the scant presence of rubble which two years before filled the square. But from a structural point of view, the general framework is not very different, since work for reducing the risk of further and dangerous settling has been carried out (*i.e.* breaking down the unsafe walls of the building located on the left side of the church) but organic and decisive action for restoration were not taken. Consequently, many buildings are subject to wear and tear and some of them continue to have openings in their perimeter walls (*i.e.* the pink building on the left in Figure 3).

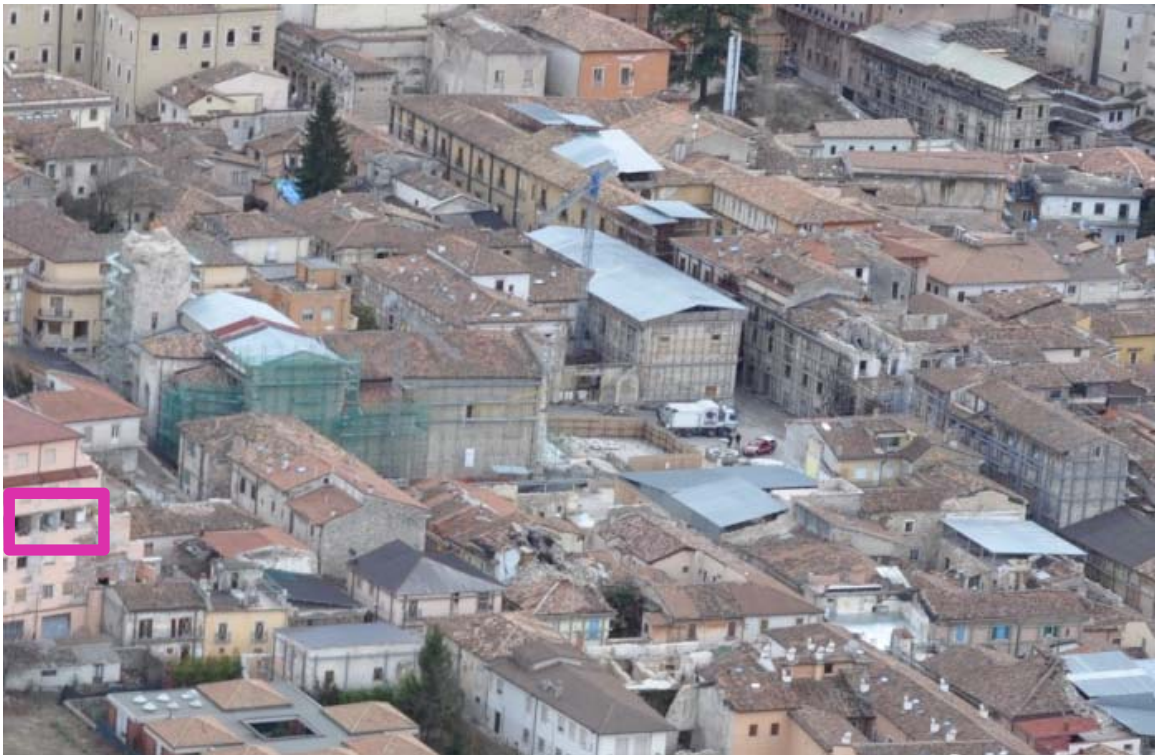
Figure 3. The situation in proximity of the church of S. Pietro a Coppito in March 2012.

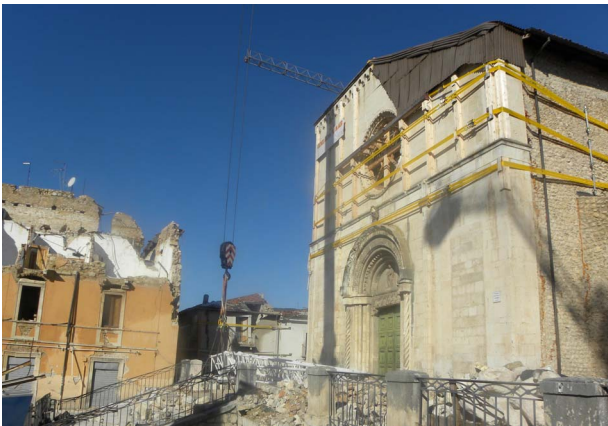
Figure 4. The church of S. Pietro a Coppito in February 2010. Photo by C. Pesaresi.

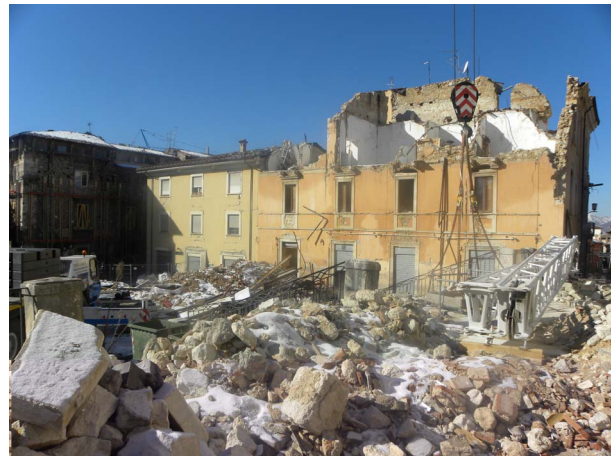
Figure 5. Some buildings near the church of S. Pietro a Coppito in February 2010. Photo by C. Pesaresi.

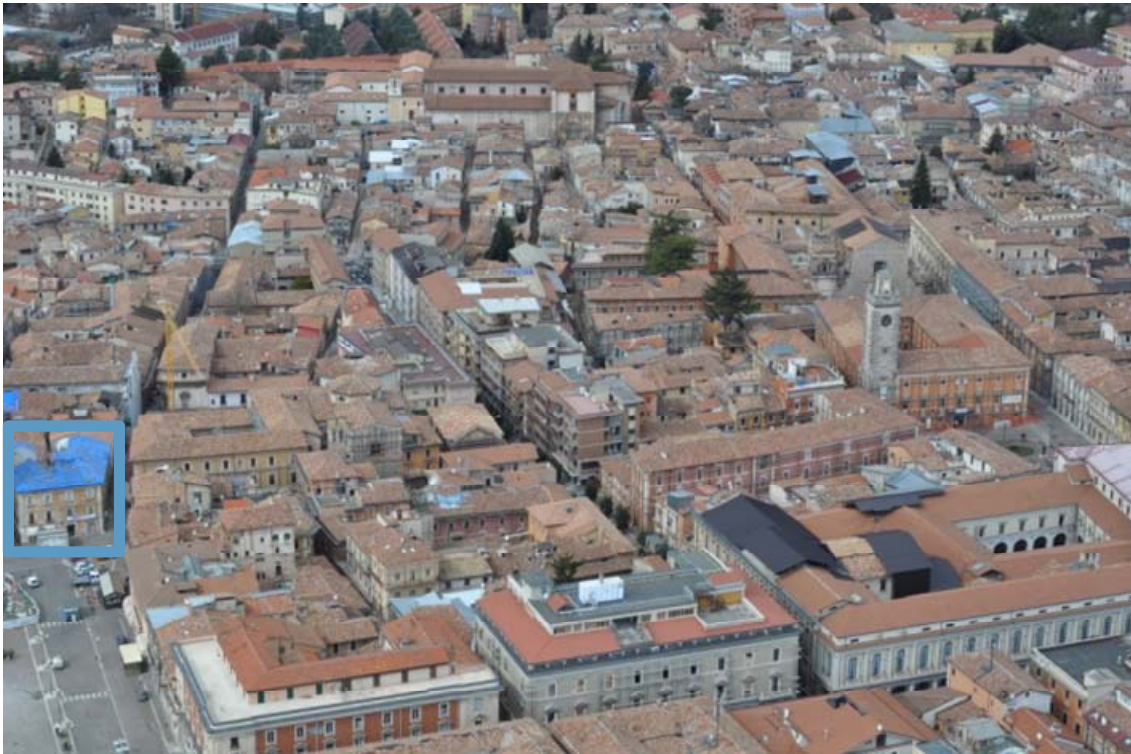
Figure 6. A general view of the area between the Piazza del Duomo and Piazza del Palazzo in March 2012.

The same atmosphere, characterized by an unusual and eerie sense of inactivity, can be felt everywhere along the town centre streets and squares of L'Aquila. For example (Figure 6), a general view of the zone between the Piazza del Duomo (partially on the left) and Piazza del Palazzo (on the right) shows numerous works of propping, provisional patching and waterproof covering of the roofs, sometimes reinforced with beams (*i.e.* the building

with light blue cover on the left). This situation, which shows relevant works of safety measures, still awaits planning which can provide for a definitive restart, since at the moment the work does not seem "in progress" and the situation is similar to two years before. In fact, the comparison between the photos of March 2012 (Figure 7) and February 2010 (Figures 8 and 9), focused on Palazzo Madama (in Piazza del Palazzo) and nearby streets (Via Bafile and successively Via Roma, on the right of Palazzo Madama), continue to show thick struts and also partial collapses (behind, on the right in Figure 7). These safety measures might represent the first step in the immediate post-emergency phase, but they did not seem sufficient in February 2010 [10] and they are absolutely inadequate three years after the earthquake because new practical steps have to be taken to give confidence to the people, to re-establish necessary balances, to promote a social and economic resumption and to recoup an important living and historical heritage.

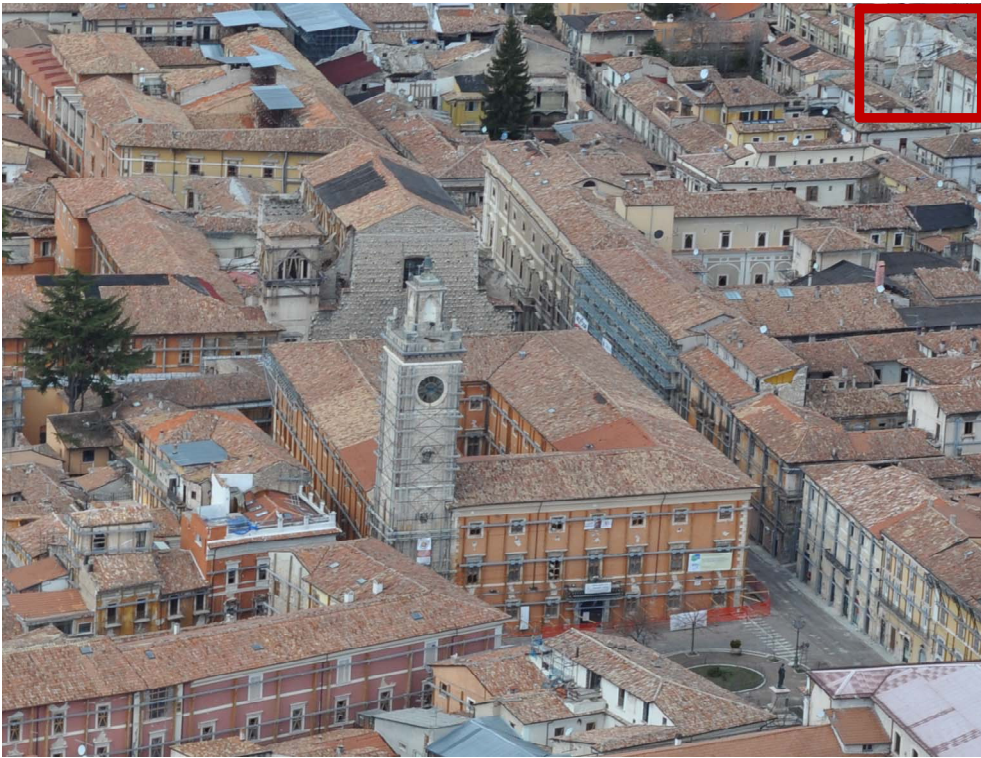
Figure 7. A zoom near Piazza del Palazzo in March 2012.

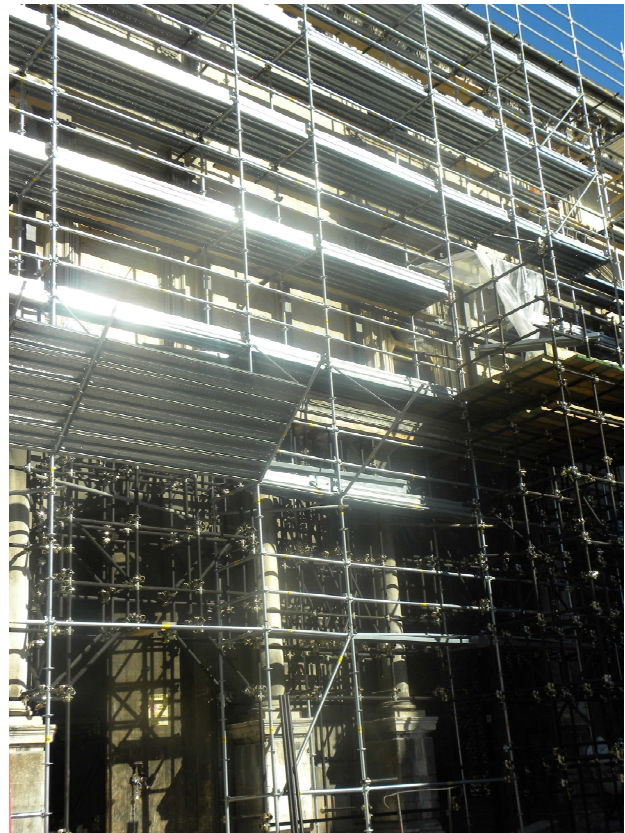
Figure 9. Work of safety measures near Palazzo Madama in February 2010. Photo by C. Pesaresi.

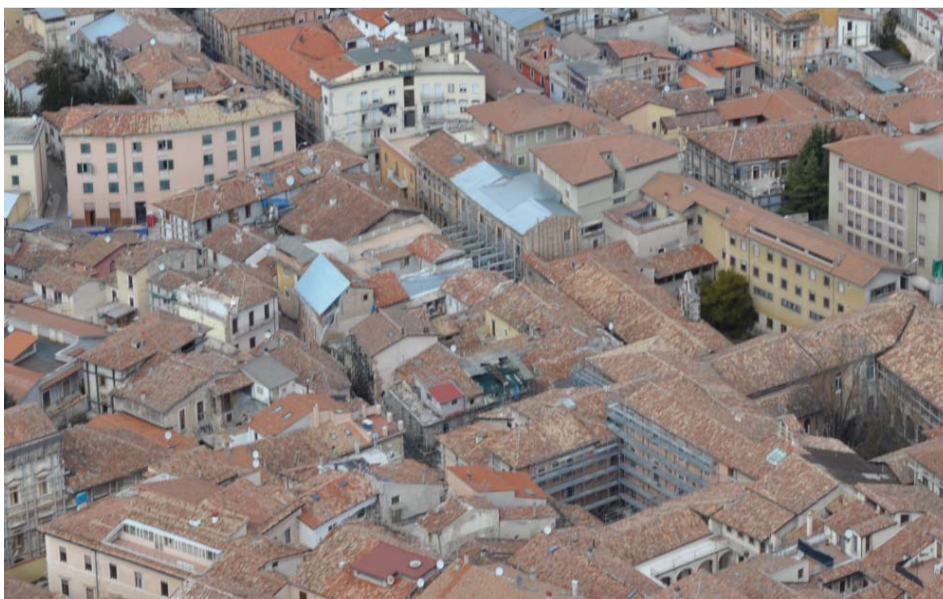
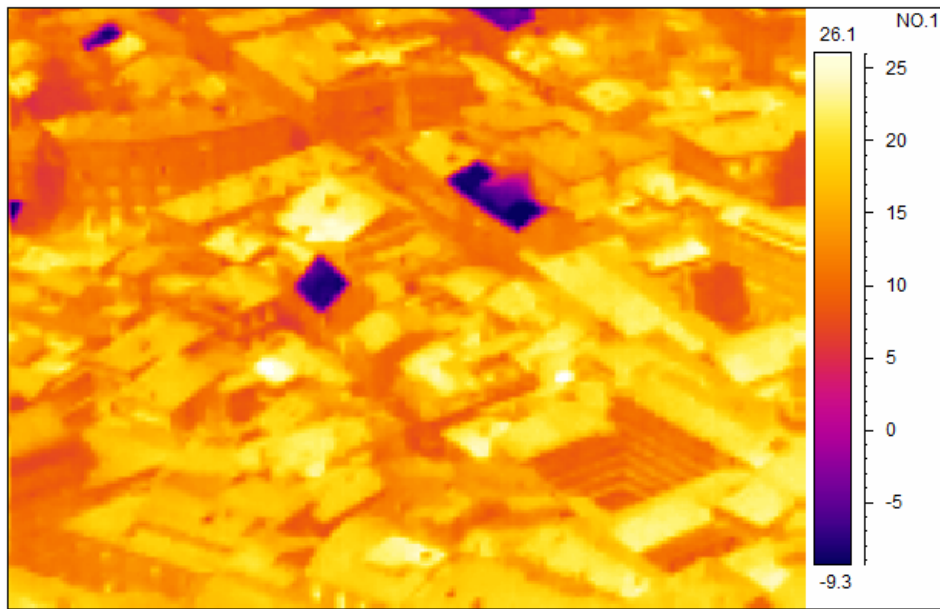
Figure 10. A central urban area of L'Aquila, seen in visible-light (a) and in thermal infrared (b).

equal to 8.5, in order to quickly obtain an indication on where attention has to be focused. For example, if we consider L’Aquila seen in visible-light (**Figure 10(a)**) and in thermal infrared (**Figure 10(b)**) we have the kind of information which immediately shows the presence of damages and provisional covering. Particularly, the scale on the right of the thermographic frame indicates the apparently “freezing-cold” surface temperature of non-painted metal roofs on top of seriously damaged buildings. This is a “wrong” indication due to the very low emissivity of the material but at the same time it is very important in indicating where these kinds of provisional roofs are. The comparison with the corresponding visible-light image confirms this data and allows us to obtain geographical information that is also useful in interdisciplinary studies.
