# Relationship between Selected Physiographic Features and Landslide Occurrence around Four Hydropower Projects in Bhagirathi Valley of Uttarakhand, Western Himalaya, India

**Landslide, Himalayas, Bhagirathi Valley, Development, Hydropower Plants**

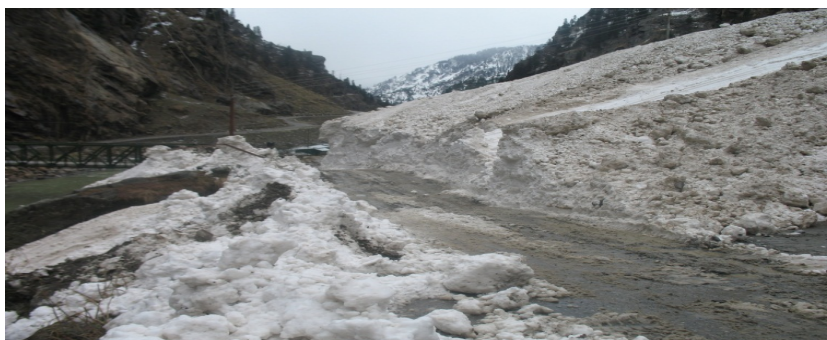
**Figure 2.** Avalanche at Dabrani Adit across the National Highway 108 (NH-108).

The gneissic terrain of the Dabraniadit at Loharinag Pala yielded five episodes of sliding despite the relatively gentle slopes ( $23.75^\circ$ ) and the fact that the road is only 0.65 km long. In this area, avalanches are common (**Figure 2**) hence any disruption of the natural landscape is likely to enhance the susceptibility of mass wasting. Here, even well-established grassland in relict avalanche terrain with the upper highlands are covered with scattered Devdar forest are also noted to be vulnerable to landslides.

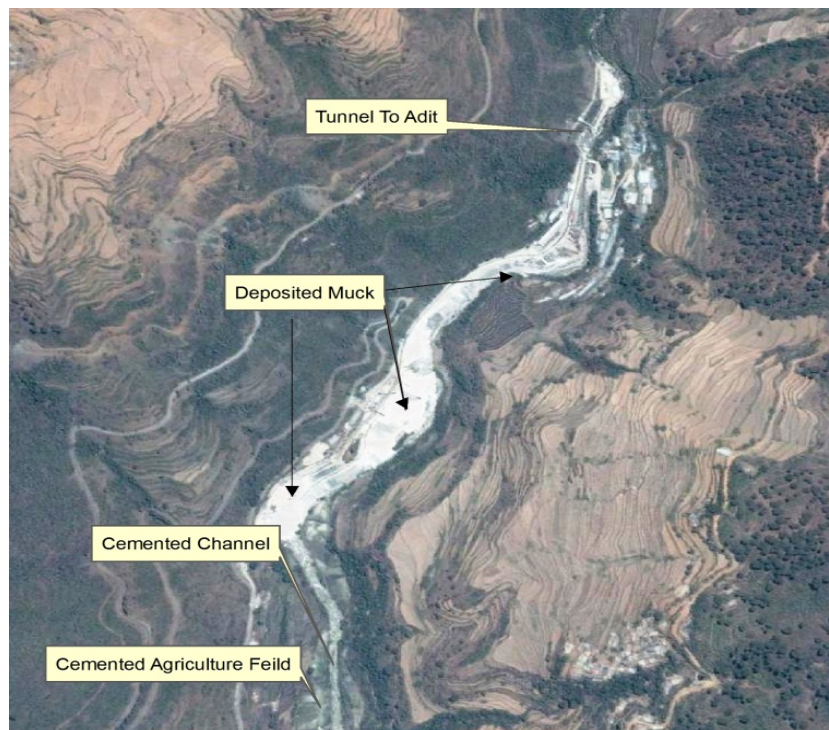
**Figure 3.** Google Earth® image showing the deposited debris and waste cement along the Dhanari Gad at DhanariAdit.

In the case of Maneri Bhali I, a relict landslide developed on a steep slope and relatively loose base material is located adjoining the village Jamak. At Maneri Bhali II, six landslides were recorded within the project area. The Dhanariadit area, on the other hand, is severely affected by excavation activity and disposal of cemented debris over a total area of  $7.08 \times 10^5 \text{ m}^2$  (**Figure 3**).

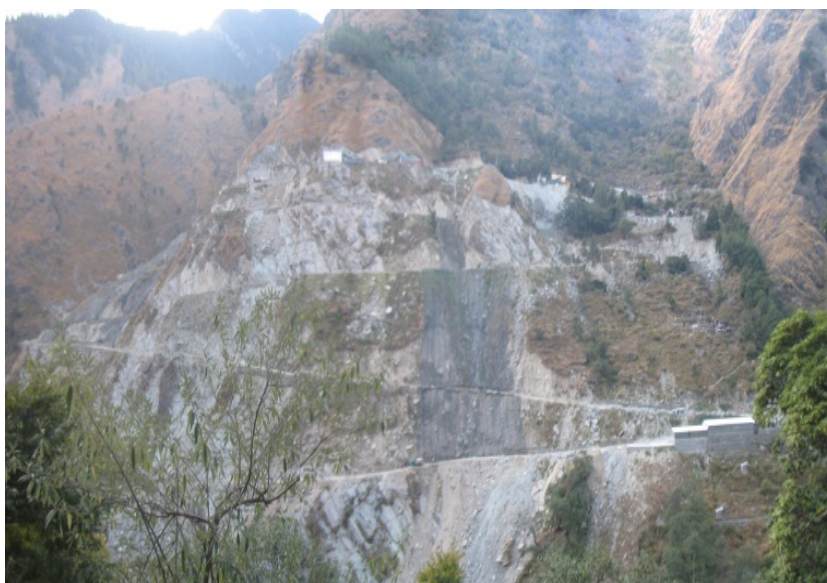
**Figure 5.** Debris deposits and mass wasting along the road access to the Gungaadit.

water. Further, freeze-thaw processes lead to greater dislocation of fragments and decrease the slope stability further. Debris from the process is discarded on the downslope side. This material is unconsolidated, highly unstable and has contributed to a large number of the landslides recorded in the course of this study. Similar conclusions about landslide causes being attributed to road construction in this region were made by Bernard [22] who estimated that approximately, two-thirds of the landslides in the Garhwal Himalaya region were initiated or accelerated by human activity, mostly by the removal of slope toes at road cuts. Also, Owen [23] attributed road construction as one of the six causative factors of the numerous landslides experienced during the 2005 Kashmir earthquake. Heavy monsoonal rains or cloudbursts may easily trigger rapid mass movement of the unstable upslope material that crashes down onto and across the road. This rapidly travelling material then sets off movement of the downslope debris, thus escalating the phenomenon. Such slides and rock falls have occurred at the sites of the power house, surge shaft, pressure shaft, Gungaadit (**Figure 5**) and Dabraniadit area of LNP.
