# Flaw Detection Capability and Sensitivity in the Inspection of Nuclear Containment Liner and Shell Mock-Ups Utilizing a Magnetostrictive Sensor (MsS) Guided Wave UT Technique

Brian P. Hohmann<sup>1</sup>, Joseph P. Crosson<sup>1</sup>, Thomas C. Esselman<sup>1</sup>, James J. Wall<sup>2</sup>,  
Mike Quarry<sup>2</sup>, Luke Breon<sup>2</sup>

This paper describes the results of a project on the inspection of visually inaccessible areas of nuclear containment liners and shells via the advanced Magnetostrictive sensor (MsS) Guided Wave (GW) nondestructive inspection technique. Full scale mockups that simulated shell and liner regions of interest in the containment of both a Pressurized Water Reactor (PWR) and Boiling Water Reactor (BWR) were constructed. Inspections were performed on the mock-ups in three stages to discern the signal attenuation caused by flaws and caused by concrete in the structures. The effect of concrete being in close proximity to the liner and shell was determined, and the capability to detect and size flaws via this GW technique was evaluated.

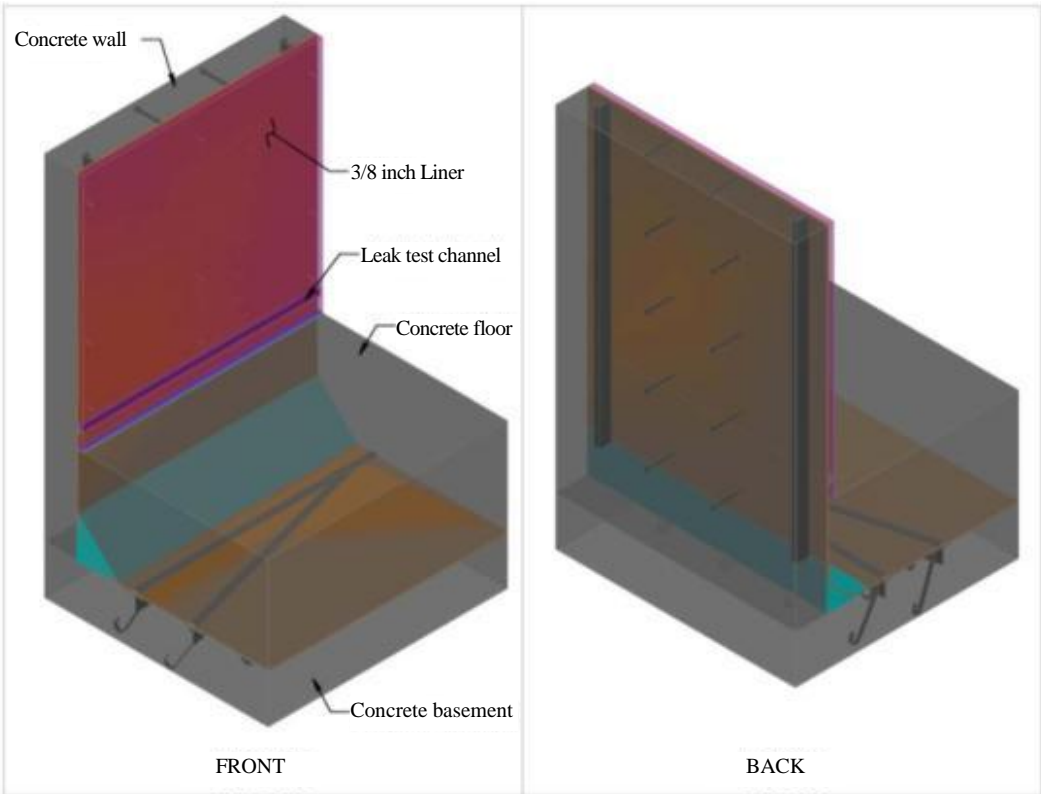
Figure 1. Rendering of mock-up of PWR containment wall liner.

The mock-up shown in **Figure 1** is a replica of a typical liner design and includes liner plate butt welds, attachments, and surrounding concrete. The liner plate is 3/8 (0.375) inch (0.95 cm) thick along the wall and the curvature into the floor where it transitions at a weld to 1/4 (0.25) inch (0.64 cm) thickness. An additional weld in the floor region created a triangular steel section and an irregularly shaped steel section. Testing of this mock-up was performed to demonstrate the extent of the coverage of the MsS guided wave inspection system into the embedded liner and beyond the 90 degrees curvature where significant signal attenuation was anticipated due to contact with the steel embedment, welds, and concrete. The mock-up was oriented in the field-observed position with the containment wall concrete oriented vertically and the floor oriented horizontally. The potential effects of concrete bonding, concrete shrinkage, and deadweight on horizontal surfaces were then examined.

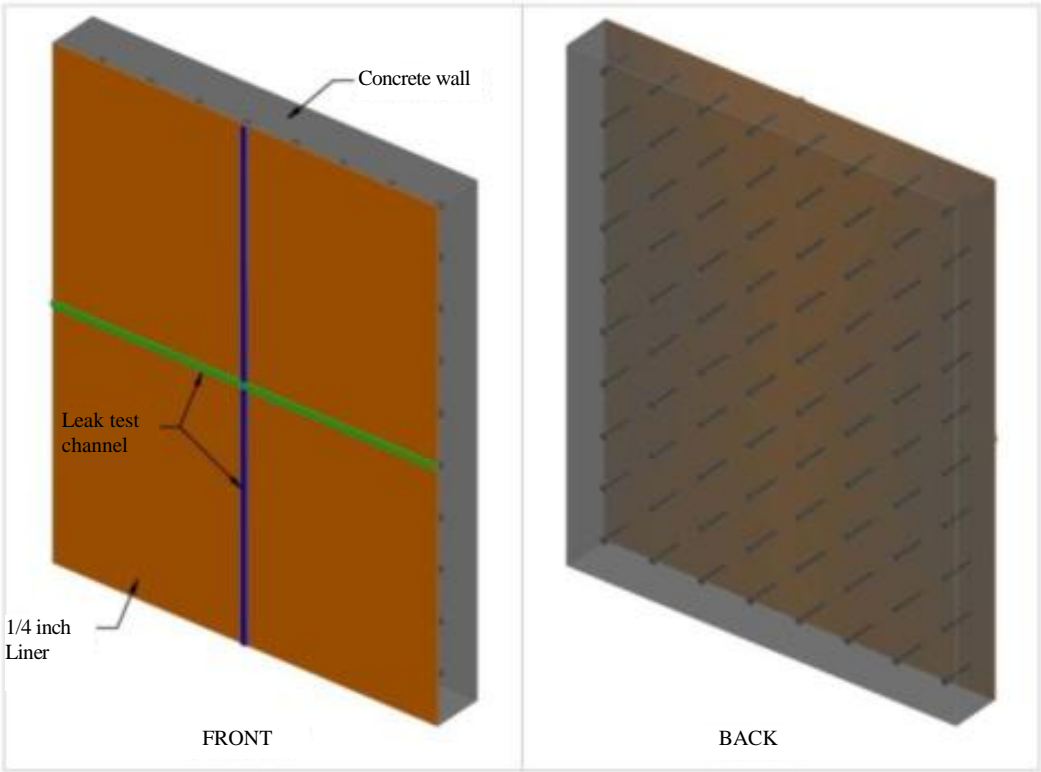
Figure 2. Rendering of mock-up of PWR flat wall liner.

The mock-up of the straight wall shown in **Figure 2** represents a typical wall where the liner is exposed on one side and is backed by reinforced concrete on the other. The liner plate is 1/4 (0.25) inch (0.64 cm) thick. It contains butt welds and stud attachments on the concrete side. The mock-up of the BWR drywell shell demonstrated the feasibility to inspect the area of a nuclear plant which is embedded in the concrete and adjacent to the sand cushion. The shell was 1 1/8 (1.125) inch (2.86 cm) thick, which closely represented the field observed shell wall thickness. This increased thickness necessitated a change in the GW inspection system parameters, most notably the use of a lower frequency range.

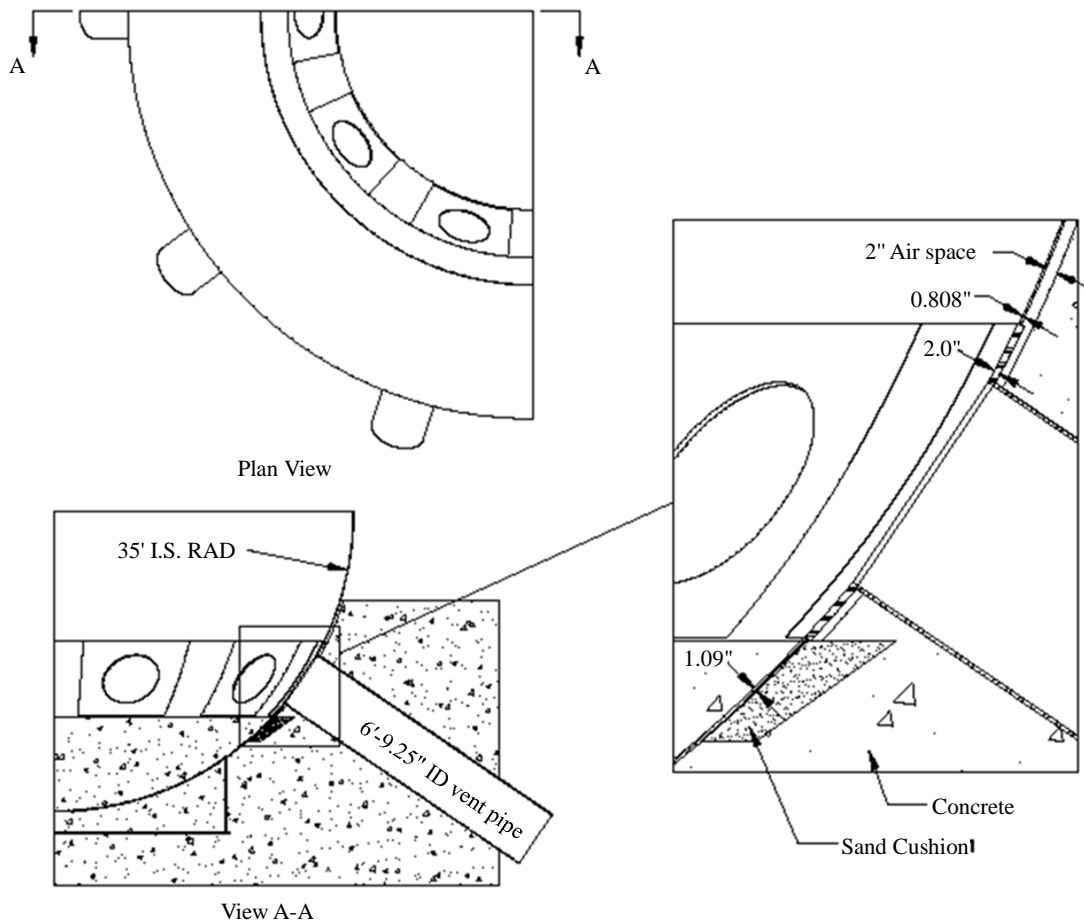
**Figure 3.** Rendering of mock-up of BWR drywell shell.

inspection when utilized in the field at an operating plant. This NDE methodology provides redundancy to the overall inspection process that decreases the probability of false positives, increases the overall detection capability, and does both of the former in a cost-conscious manner. The BWR drywell mock-up included the drywell shell adjacent to the sand cushion region. This is shown in **Figure 3**.

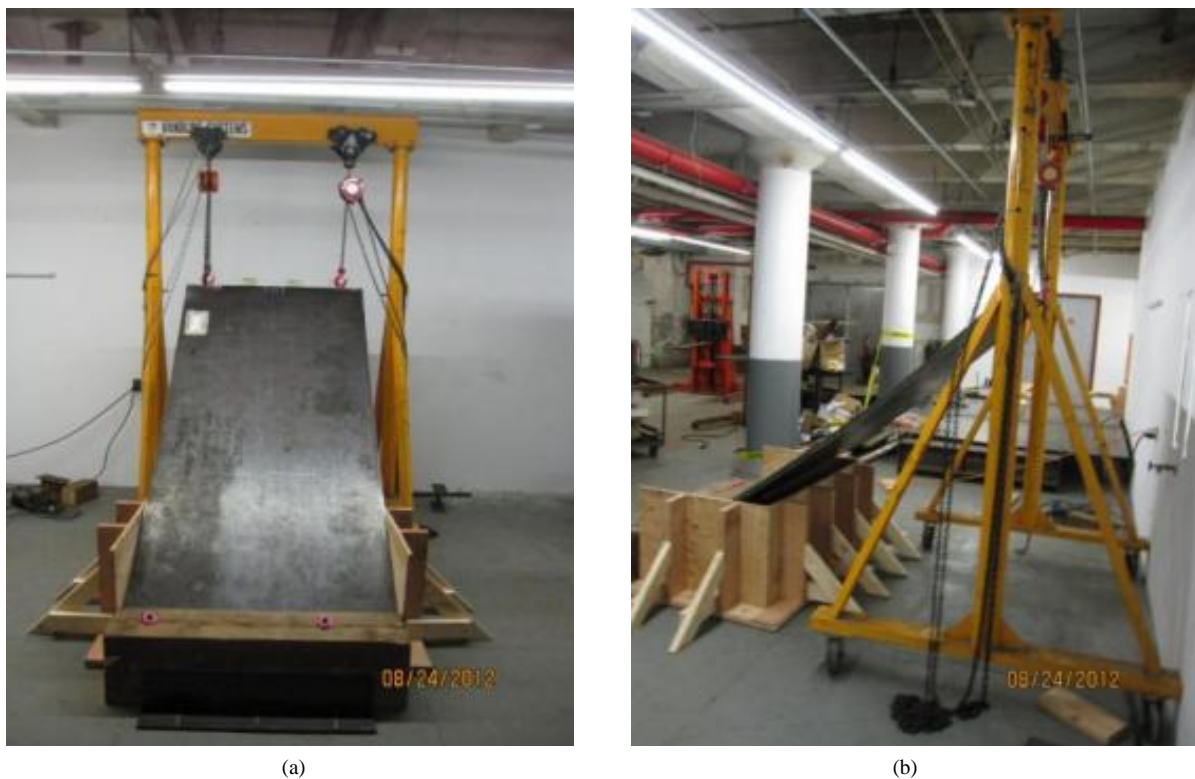
**Figure 4.** (a) Front and (b) side view of the BWR mock-up prior to concrete placement.

Following assembly of the steel liner and shell components, the three mockups were inspected with the GW technique prior to any flaws being machined into them and prior to any concrete being poured, in order to gain a baseline reading. **Figure 4** and **Figure 5** show the mockups prior to flaw insertion and concrete placement, while **Figures 6-9** show the fully constructed mock-ups after flaw insertion and concrete placement. Flaws were placed on both the ID and OD sides. A coordinate system for each mockup was developed and the coordinates for all flaws was identified. Replication of all flaws was performed before concrete was poured so flaw topography could be maintained for future inspections.

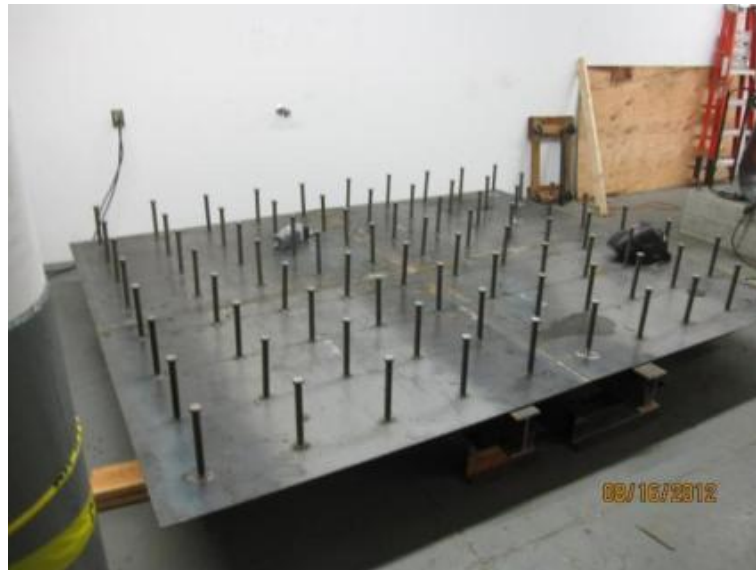
**Figure 5.** The straight wall PWR mock-up, “A”, lying with its OD side sticking up following welding of the four quadrants.

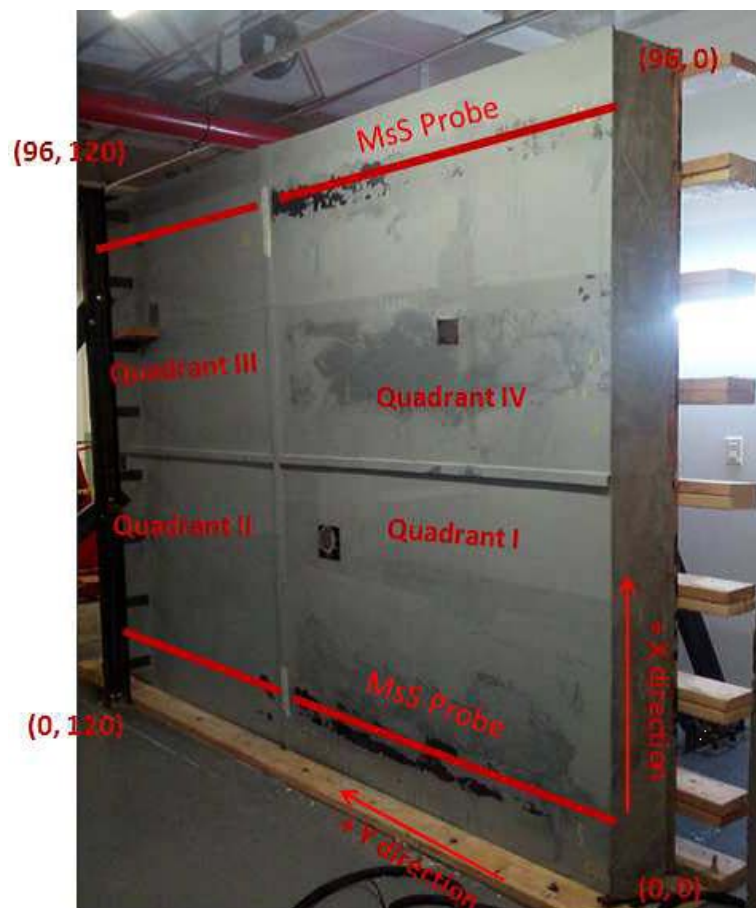
**Figure 6.** The PWR wall mock-up, “A”, in the upright position following placement of concrete. Orientation of the four mock-up quadrants, the mock-up coordinate system for flaw location, and location of the Magnetostrictive sensor (MsS) probe placement noted in red.

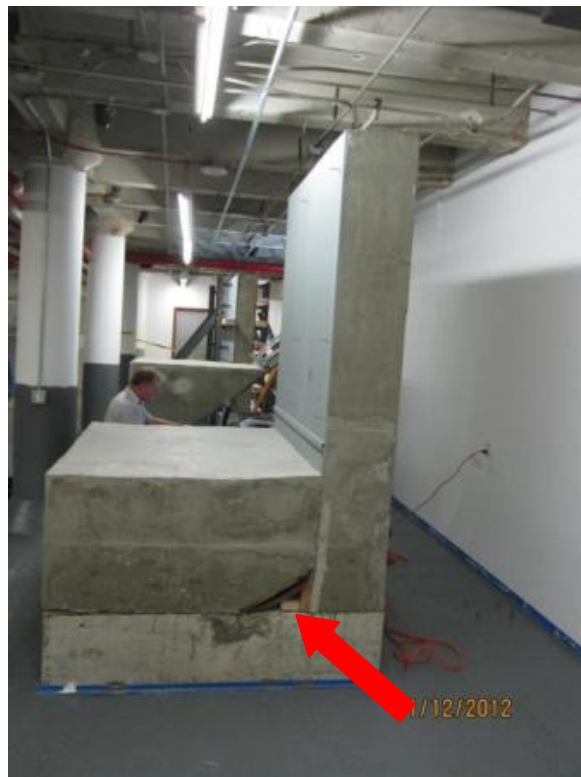
**Figure 7.** The PWR basemat mockup, “G”, following placement of concrete. Red arrow points to curved region of the liner.

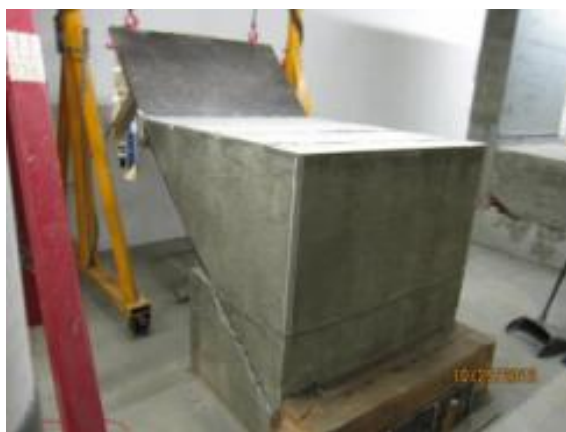
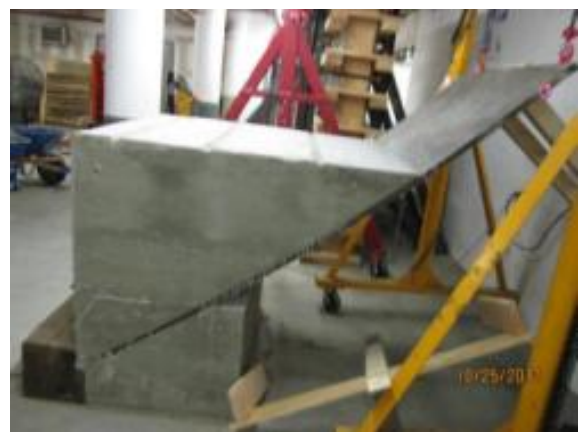
**Figure 8.** (a) Front and (b) side views of the fully constructed “BWR” shell mockup.

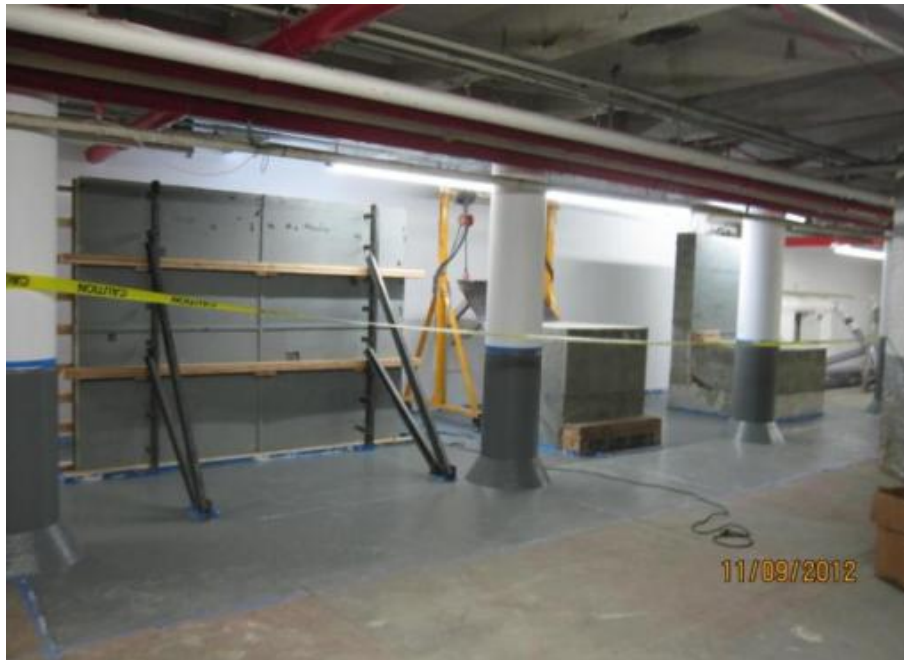
**Figure 9.** Appearance of the three fully constructed mock-ups.

A scan was initially performed on the three mockups (labeled “A”, “G”, and “BWR”) using the model MsSR3030R instrumentation prior to introduction of flaws and placement of concrete to generate a baseline signal response. The procedure utilized to acquire data included cleaning the steel liner and shell surfaces prior to testing. Any dirt or superficial corrosion was wiped off. If these tests were to be performed in the future

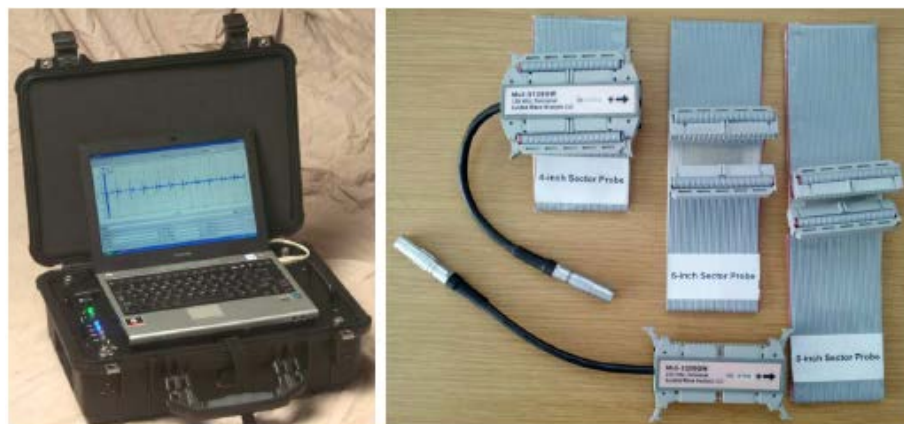
**Figure 10.** MsSR3030R equipment and MsS plate probe used for inspecting mockups.

The model MsSR3030R instrumentation and probe (Guided Wave Analysis LLC, San Antonio, TX) shown in **Figure 10** were utilized to perform the guided wave testing. The operating software in the laptop computer controlled the operating parameters of the MsSR3030R instrumentation. Data was acquired through a USB port between the probe and laptop. The MsS probe consisted of a thin iron cobalt (FeCo) ferromagnetic strip and plate probe, which was used to apply a time-varying magnetic field to the nuclear mockups being tested. The instrumentation captured magnetic induction changes in the steel liner and shell components caused by the guided waves. The directional control of the wave propagation was achieved with this system by employing a phased array approach with two sensors. The GW was controlled such that propagation along one direction on either side of the MsS probe could be distinguished and separately evaluated.

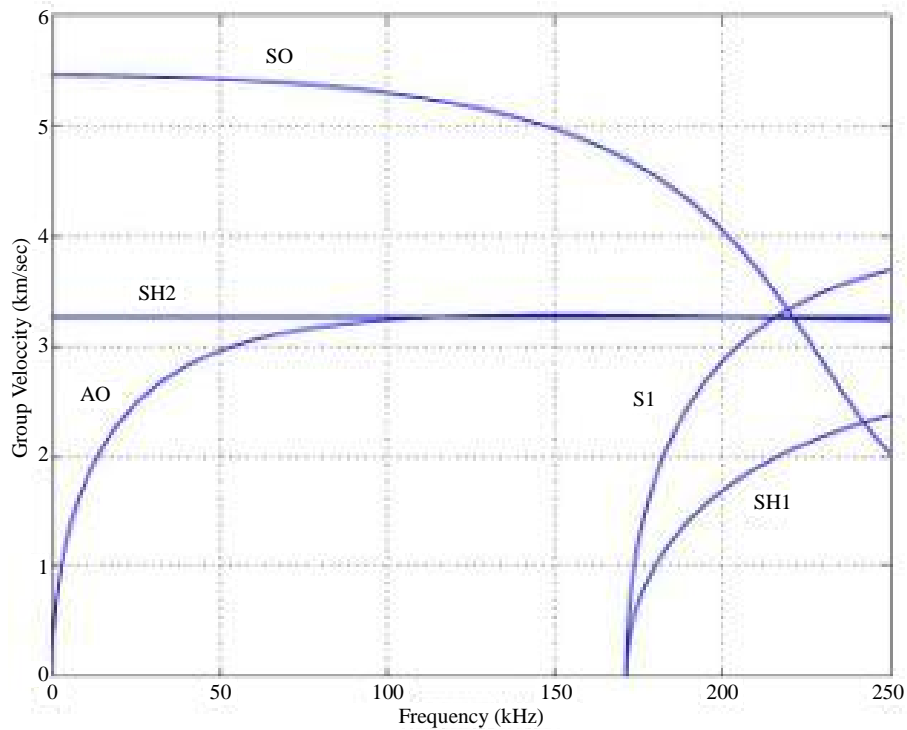
**Figure 11.** Dispersion curves of 0.375-inch-wall (0.95 cm) steel plate.

**Figure 11** shows dispersion curves that plot wave velocities at different frequencies propagating in 0.375-inch-thick (0.95 cm) plate. The plate has three wave modes: Symmetric Lamb wave (S), Asymmetric Lamb wave (A), and Shear-horizontal wave (SH). Except for the SH0 wave mode, the velocities of other wave modes are dispersive and vary with the wave frequency. The velocity of the SHO-wave, however, is constant (that is,

equal to the shear wave velocity of the plate material) and thus is independent of the frequency. This property means the SHO wave is non-dispersive so that its wave form does not change as the wave propagates a long distance. Therefore, the SHO wave mode is mostly used for the inspection of steel plate samples and was used for the evaluation of the nuclear mockups.

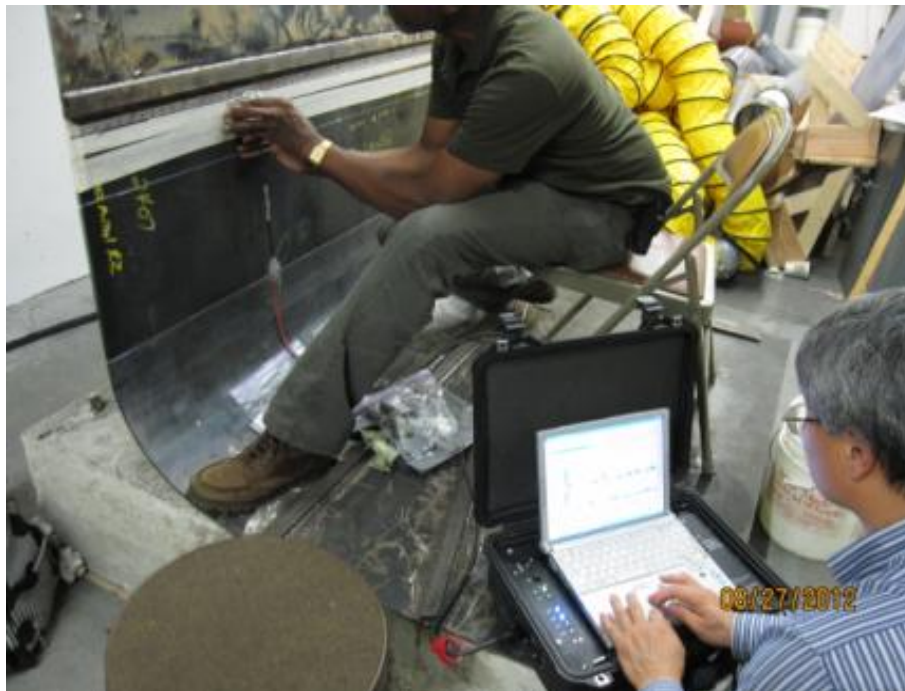
**Figure 12.** Baseline data acquisition of “G” mockup with MsS instrumentation.

on-site at an operating plant and the test surface was rough, a wire brush or sand paper would additionally be used for surface preparation. Following surface preparation, FeCo strips of suitable length were prepared and attached at exposed steel locations via a wax bonding technique. The wax bonding technique was removable and did not damage the steel surface. Mechanical coupling, shear coupling or epoxy bonding are also considered suitable for attachment of the FeCo strip. Tape was placed over the length of the FeCo strip and position coordinates were marked on the tape. The FeCo strip was then conditioned (magnetized) for shear-horizontal mode operation. The MsS probe was then connected to the MsSR3030R instrumentation and placed on the object under test. Data was then acquired and analyzed, as shown in **Figure 12**. This procedure was followed on all mockups for all three stages of testing.

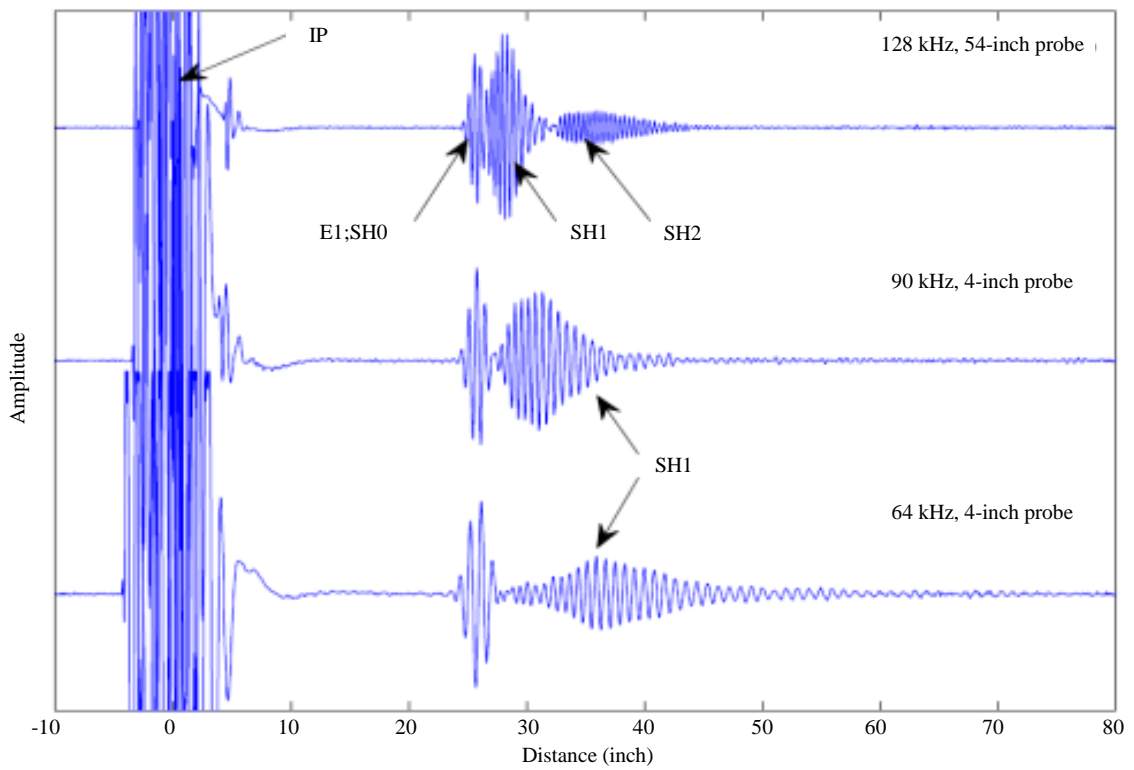
Figure 13. RF data plot acquired with 4 in. long MsS plate probe located at (-26, 12).

x-axis position being held constant following placement of the FeCo strip. Two different lengths of MsS probe, 4 in. and 8 in. were used to acquire baseline data. Data from the 4 in MsS probe were acquired at center frequencies of 64, 90, and 128 kHz and two cycles. The resulting data plots for this mockup with the probe located at the (-26, 12) coordinate position are shown in **Figure 13** and **Figure 14**. The data shows one end-reflected

signal, E1, for three different shear-horizontal wave modes (SH0, SH1, and SH2). The spectrogram data of [Figure 14](#) shows the dispersive characteristics of the SH1 and SH2 wave modes. The dispersion curve for the BWR mockup is shown in [Figure 15](#) for shear-horizontal wave modes only. The cutoff frequencies for SH0 through SH4 are shown with respect to group velocity in [Figure 15](#). The cutoff frequency is defined as the frequency at which the mode does not remain purely guided, or in other words, when a guided wave mode is converted into a radiation mode. The effectiveness of the subject NDE technique requires that the wave remain guided. The cutoff frequencies for the SH1 and SH2 wave modes were determined to be 57 kHz and 115 kHz. In an attempt to remove the dispersive SH1 and SH2 wave modes, follow-up data was acquired at lower frequencies of 32 kHz and 45 kHz, however the resulting data did not have a high signal-to-noise ratio (SNR) for end-reflected signals. It was determined that at frequencies of approximately 90 kHz and higher, the amplitude of the SH1 mode is approximately equal to the SH2 mode. For this reason, during subsequent inspections this higher operating frequency was used and the number of cycles was increased. The two operating conditions found to generate the best SNR for detection of flaws were determined to be 1) 82 kHz, 5 cycles and 2) 138 kHz, 5 cycles. The liner mockups “A” and “G”, which were only 0.375 in. and 0.25 in. thick, did not have the same limitations with dispersive waves as was found with the “BWR” mockup.

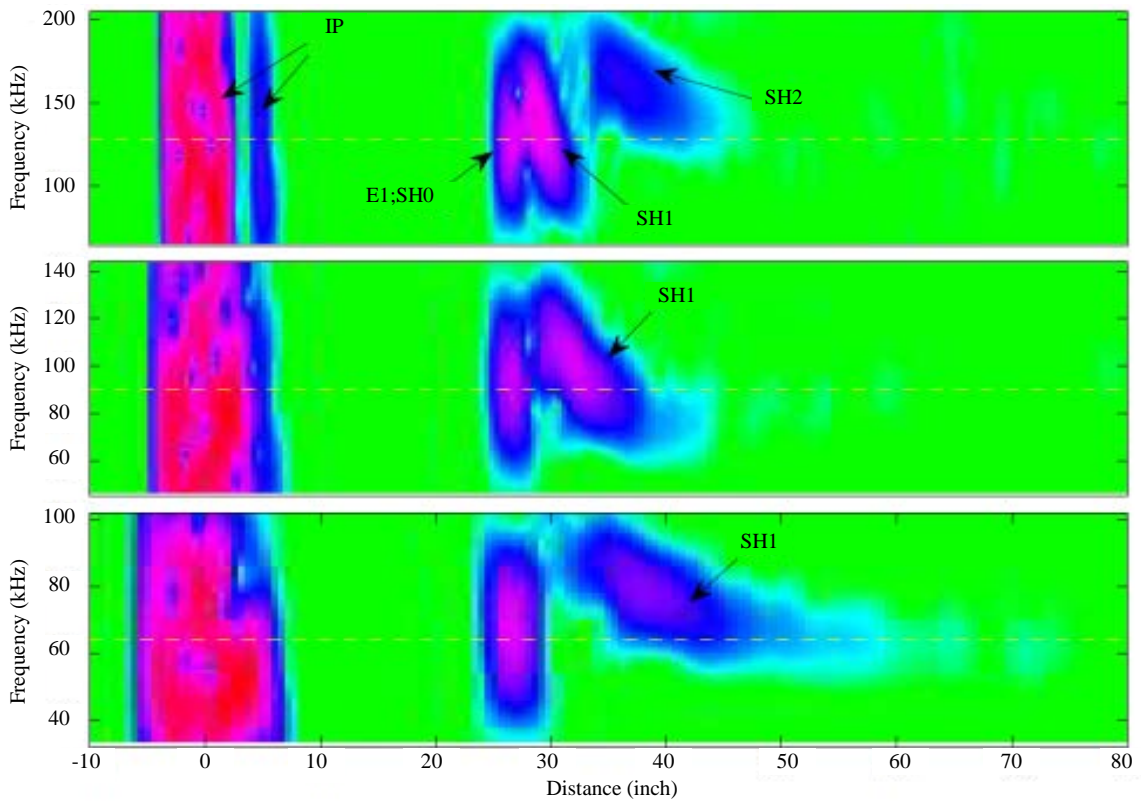
Figure 14. Spectrogram data plot of the RF data in Figure 14.

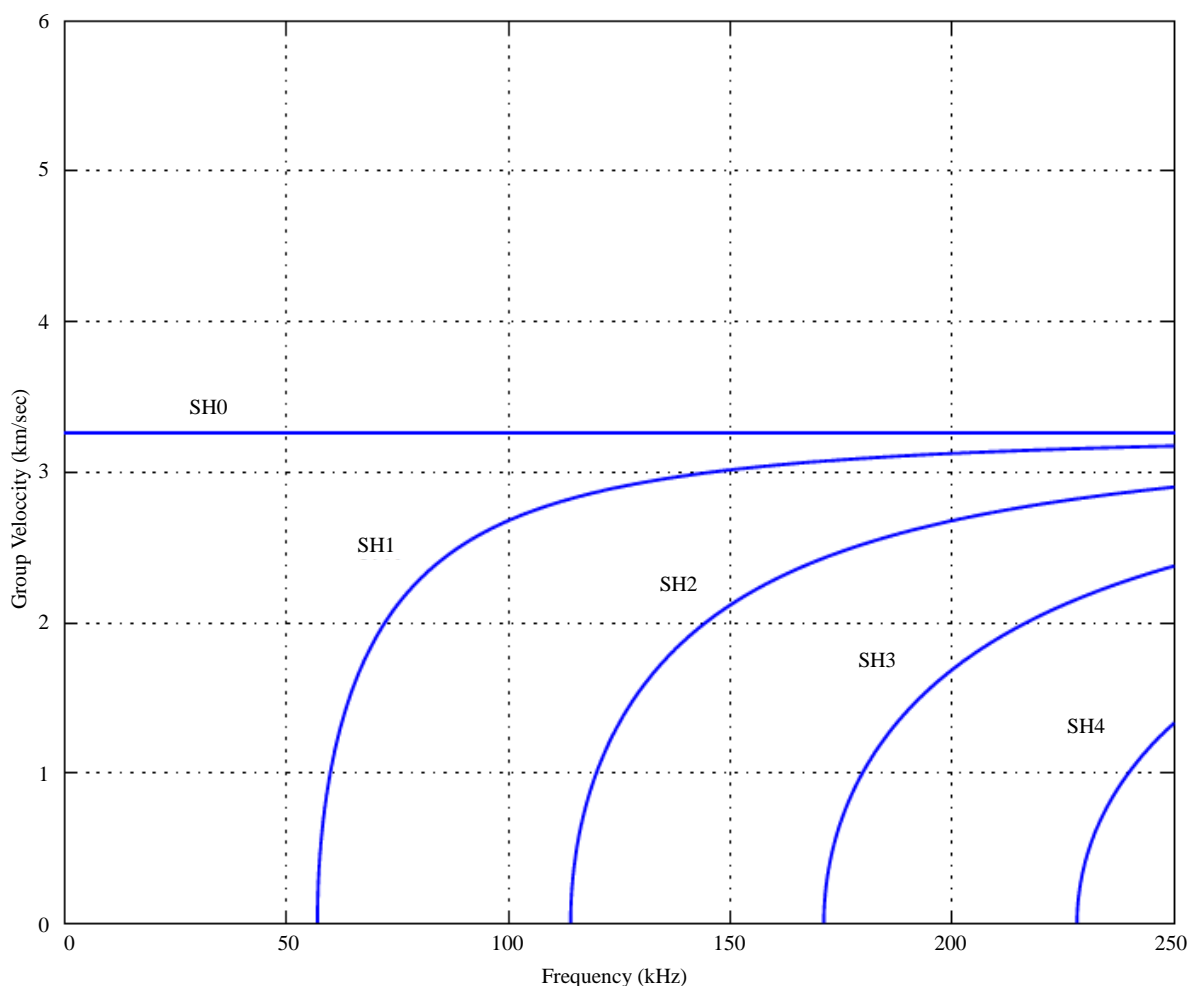
**Figure 15.** Shear-Horizontal mode dispersion curve for BWR mockup.

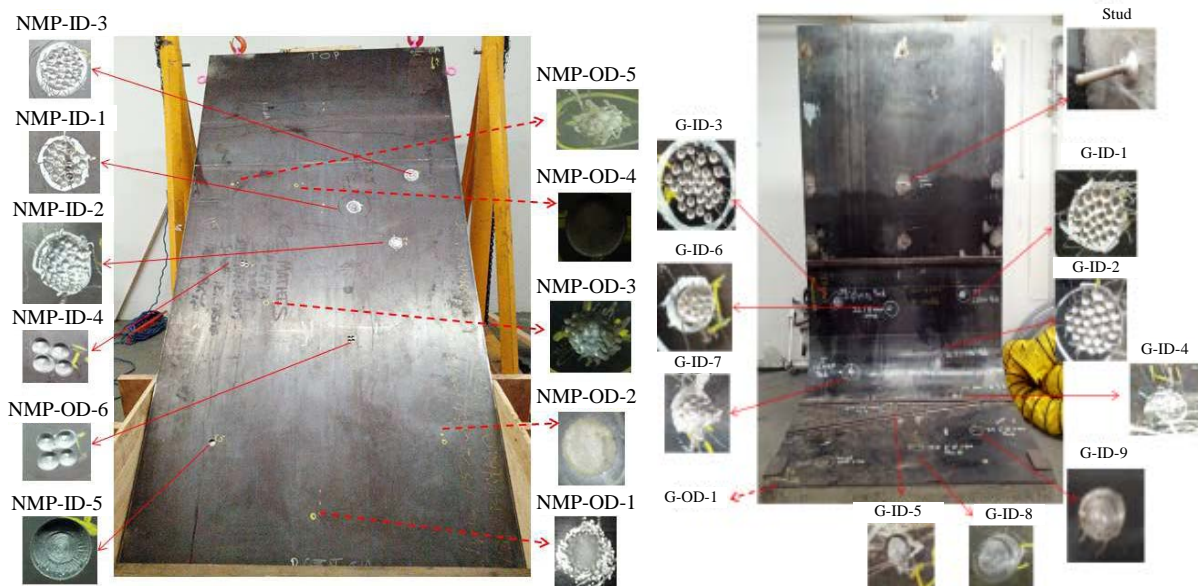
**Figure 16.** Various flaws inserted into both ID and OD side of the BWR and G mock-ups.

Various types of flaws were introduced into all three of the mock-ups in order to simulate flaws typical of in-service degradation, such as pitting and corrosion, as well as flaws typically used in the evaluation of nondestructive systems, including flat bottom hole (FBH) flaws and cluster-type flaws of multiple FBHs in close proximity. The flaws and the number of flaws were selected to determine the feasibility and sensitivity of various inspection techniques. The flaws would have been different if they were to be used for qualification of

inspectors. In all cases, a point of origin and coordinate system were selected for each mock-up, and the exact location of flaw placement was noted in order to compare with future inspections after concrete placement obscured visual observation of flaws. Flaws of varying depths and diameters were placed on both the ID and OD sides of the mock-ups, as shown in **Figure 16**, and a flaw map legend was developed to facilitate the quantification of each NDE technique with respect to flaw detection. A full description of the flaw map and inspection results is provided in reference [8]. Prior to pouring of the concrete, all flaws were replicated and then filled with a non-conductive epoxy mount material to inhibit intimate contact of the concrete with the flaw.
