Evaluation of Inverse Modeling Techniques for Pinpointing Water Leakages at Building Constructions

A. W. M. van Schijndel

Unit Building Physics and Services, Department of the Built Environment, Eindhoven University of Technology, Eindhoven, Netherlands

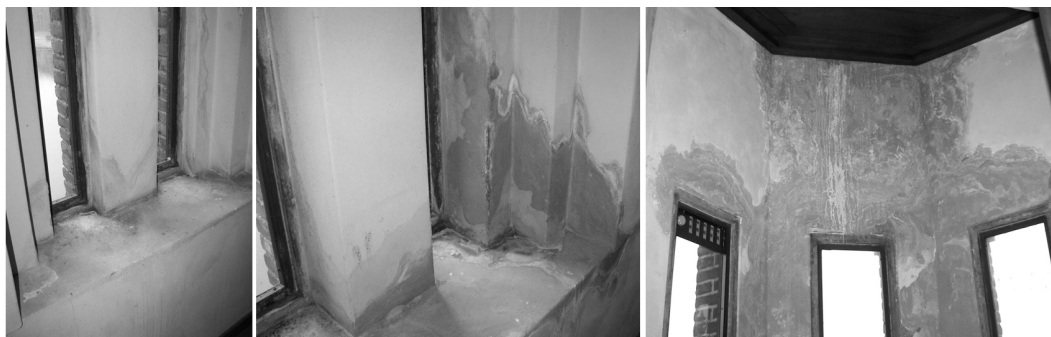
Figure 2. Observed moisture damage in the tower of the building: moist spots and efflorescence.

A few pictures of the moisture damage that occurs in the tower are shown in **Figure 2** (Briggen *et al.* [1]).

Regarding the location of the damage it can be concluded from the inspection that most damage occurs on the interior surface of the south-west facade of the tower. Since the prevailing wind direction in the Netherlands is south-west, which means that the south-west facade of the tower is subjected to wind-driven rain the most, there appears to be a connection between the rain load of the facade and the damage on the inside. There are no clear differences between the damage on lower or higher floors or between the damage on the middle and on the sides of the facade. Most damage occurs near openings in the facade and on the interior surface of the facade below balconies.

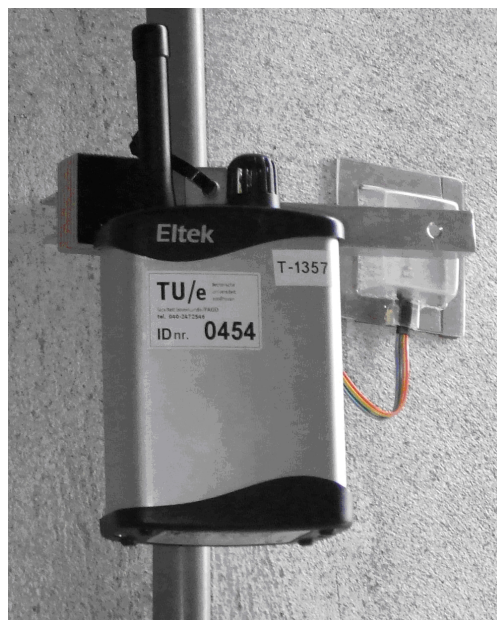
Figure 4. Measurement of the surface temperature and relative humidity using a box.

The outside climate conditions were measured by a weather station within 50m from the building. The inside air temperature and relative humidity were measured using standard equipment (see **Figure 4**). A representation of inside surface conditions was obtained by placing a small box (5 cm × 5 cm × 1 cm) against the wall and measures the air temperature and relative humidity inside. The estimation of the measurement error of this method is left over for future research.

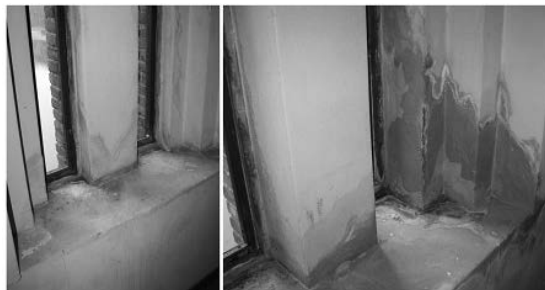
Figure 10. Observed moisture spots at the inner surface near the windows.

In this section we try to reproduce the following observed moisture spots (see **Figure 10**).

There is no match between the simulated profile at the inner surface of **Figure 13** with the observed profile of **Figure 10**. Therefore it is concluded that the location of **Figure 12** is not a possible candidate that causes the observed moisture spots.
