Failure Analysis of an Aluminum Extension Portable Ladder

Abdel-Hakim Bouzid

Department of Mechanical Engineering, École de Technologie Supérieure, Montreal, Canada
Email: hakim.bouzid@etsmtl.ca

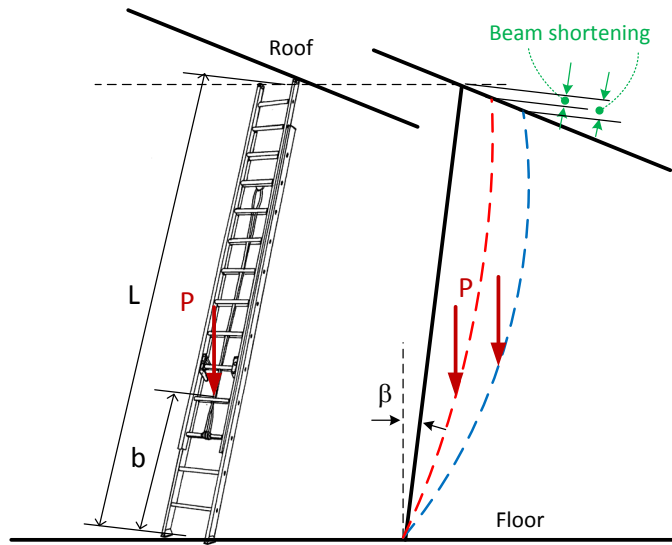
Figure 1. Beam shortening effect in portable ladder.

First, Beam shortening is a reduction of the length of a structural beam when subjected to loading. It can be produced by an axial compressive force or thermal contraction but also by bending. With reference to **Figure 1**, the shortening δ_c due to compression in the two parts of the ladder P_b for the length b and P_h for the length $(L-b)$ is given by:

The analytical beam shortening study is supported and validated by a numerical finite element buckling study that was run in parallel. The FE model shown in **Figure 3** represents the portable ladder of **Figure 1** with its three sections; the top section composed by 7 rungs the bottom section composed of 7 rungs and the overlap section composed of two rows of 5 rungs each. Three-node beam elements are used to model the beam side rails and the rungs. The bottom ends of the beam side rails are fixed in displacement in the three directions. A former experimental study on the friction condition of the rubber pad shoes with the floor showed that the coefficient of friction is greater than 0.3 while only 0.123 is sufficient to avoid the slippery conditions for the present situation. The top end nodes of the beam side rail can only move in the direction of the beam length when the load is applied in order to evaluate the amount of beam shortening as the worker climbs the ladder. Its weight is amplified

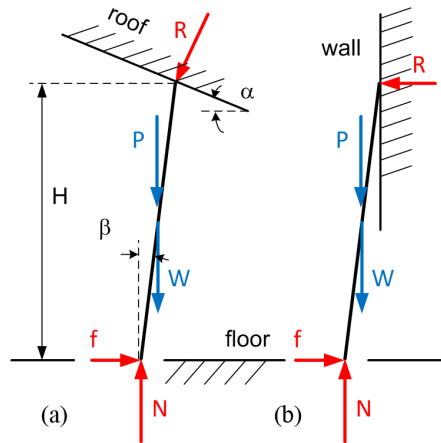
Figure 2. FBD of the portable ladder with (a) roof support (b) wall support.

Ladders are design against buckling due to compression. The normal buckling load limit is determined on the basis of the weight of the worker, the carried load and his tools. The ladder load capacity limit is obviously greater to allow for a margin of safety. However portable ladders are not designed to carry certain loads such as pure lateral loads or load generated during operation by supports and attachments other than those mentioned previously. If the free expansion of a ladder is limited as shown in **Figure 1**, then considerable compression load may be generated which coupled to a dynamic lateral load due to a moving worker can cause a serious buckling problem. This case of combined compressive axial load and bending is known as beam-column. **Figure 2** shows a free body diagram of the portable ladder with two different top supports 1) a roof and 2) a wall for comparison. The detail study of the case of a ladder with a roof support will follow.

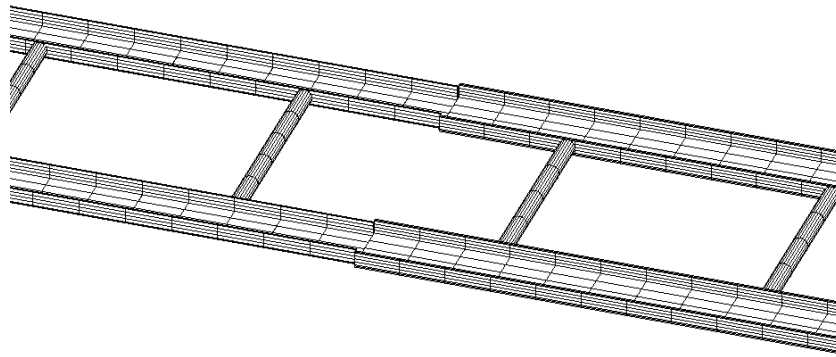
Figure 3. Partial view of the portable ladder FE model.

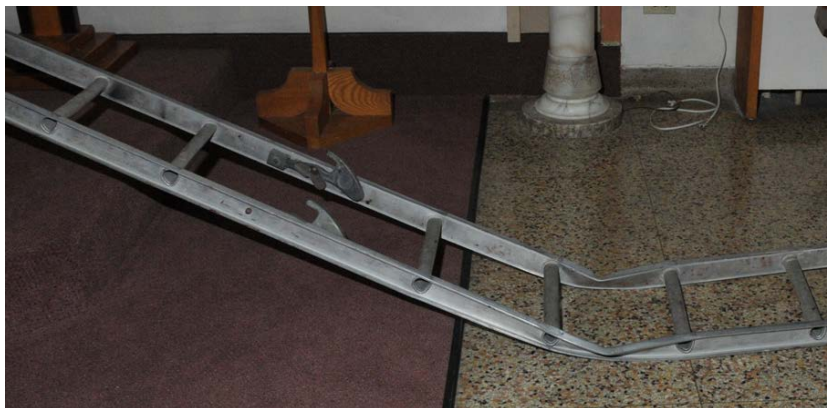
Figure 4. Portable ladder buckling.

According to the information gathered by the CSST “Commission de la Santé et Sécurité du Travail” which is the Quebec occupational health and safety organization, a worker of about 100 kg died from a fall from a ladder deployed at a height of rung 19 or 5.8 m with a 10° relative to the vertical. The lower supports with durable shoes rested on a terrazzo floor while the upper end caps were in contact with a rigid ceiling inclined at 29° with respect to the horizontal, as shown in **Figure 1**. It is important at this point to pay attention to the particular use of the ladder because normally its upper ends are supported on a vertical wall, or both side rails are supported on the edge of the wall if the latter is shorter. The 24 feet long or 7.3 m and 6.8 kg weight ladder of category 3 was deployed at a height of 19 feet or 5.8 m and there was an overlap of five rungs (1.5 m). The worker climbed to the 13th rung to change fluorescent tubes. A second worker held the ladder secure to the ground and prevented it from sliding. The accident occurred just after the second worker released the ladder to get spare fluorescent tubes while the worker on the ladder prepared his descent to be able to grab the tubes. The complete detailed study on the root cause included the bottom slip and the loss of contact at the ceiling due to curvature produced by normal bending and the buckling under the combined flexion and compression. The investigation showed that the collapse of the ladder shown in **Figure 4** is due to buckling failure. The unexpected high loads were generated as a result of the side rail beam free expansion restraint due to the end supports.

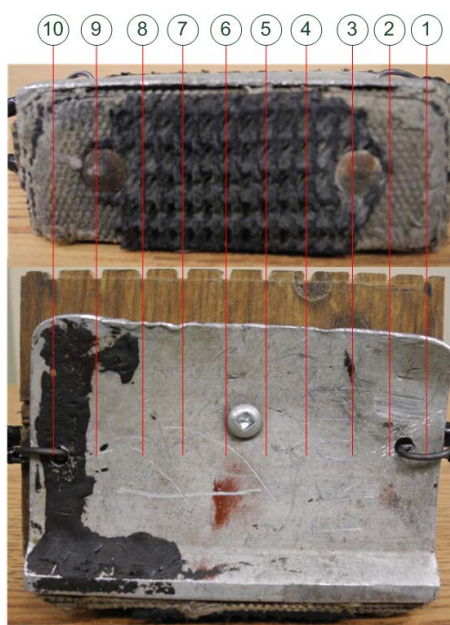
Figure 5. Load application location on the ladder shoe for friction tests.

The first intervention was to eliminate the possibility of ladder bottom end sliding failure. This was achieved by conducting a friction test experiment at the accident seen. **Figure 5** shows a picture of the ladder shoe with the position of the load reaction location. Because the shoe was worn-out, it was decided to apply the load on the shoe at the different position shown in **Figure 3** to cover the range of possible contact with the floor. **Figure 6** shows the coefficient of friction obtained for both ladder shoes. Several tests were conducted, however the graph

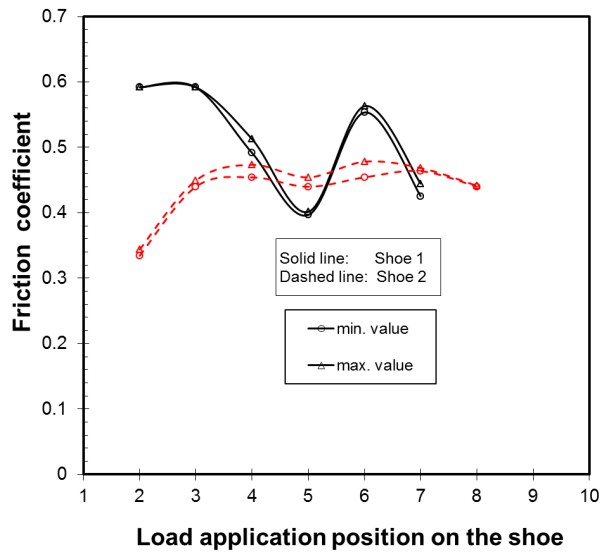
Figure 6. Friction coefficient test results.

shows only the maximum and minimum friction coefficient values indicating that the tests are repeatable. Depending on the shoe and the load position, the friction coefficient varies between 0.3 and 0.6. The higher values are indicative of the rubber being the predominant material contact surface

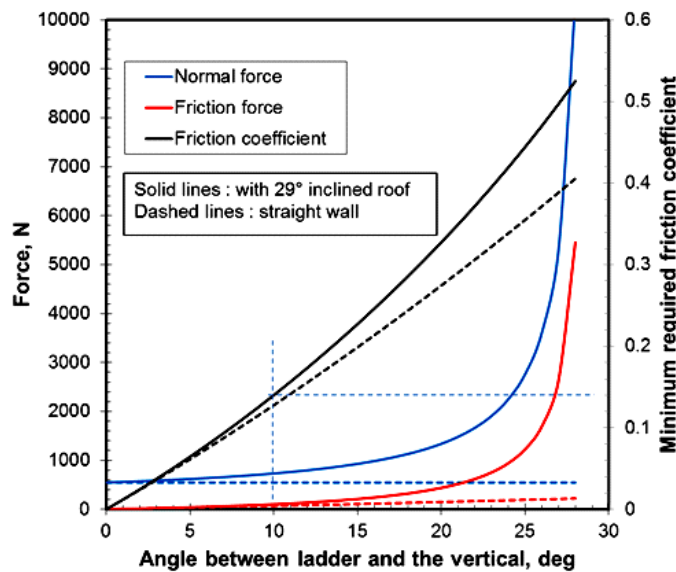
Figure 7. Friction coefficient requirement to avoid sliding.

Figure 7 gives the minimum required coefficient of friction as a function of the ladder angle with the vertical to avoid sliding. A comparison with the ladder top end resting against a vertical wall and the current case of contact with an inclined rigid roof is given. For the small angles, the required friction force necessary to avoid sliding is the same in both cases. It is clear that for an 8 degrees angle sufficient friction exists between the ladder bottom shoes and the floor exist to avoid sliding since the minimum required coefficient of friction is 0.123. However since black rubber marks were found on the floor, it can only be concluded that the friction coefficient is high and that sliding had occurred at some point. This was only possible if the contact at the top end was lost due to a considerable amount of axial deformation to clear the roof which pointed to the fact that buckling failure was the probable cause.

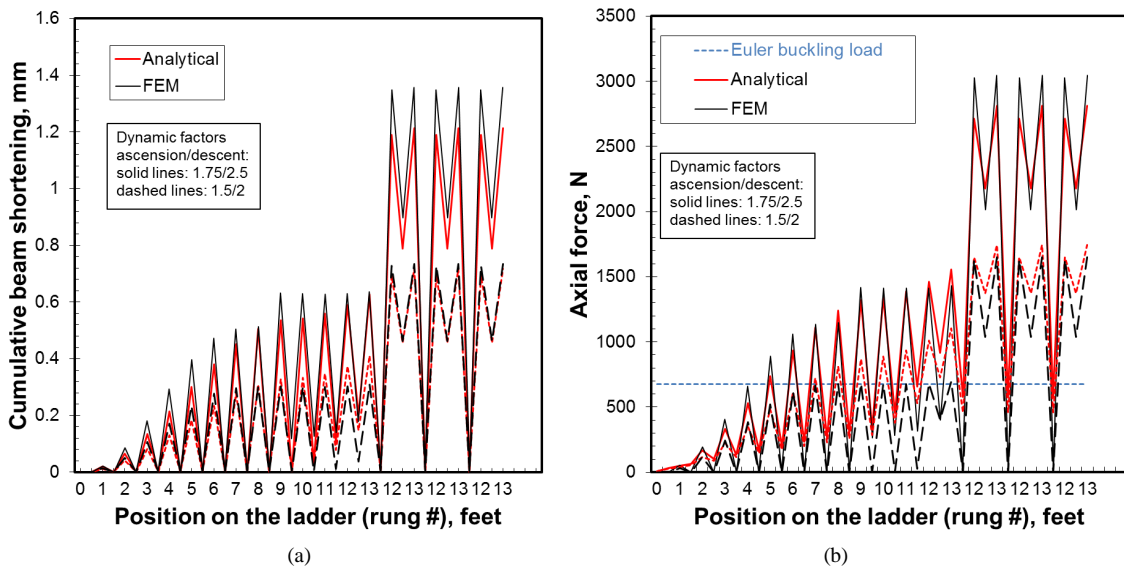
Figure 8. Dynamic factors effect on (a) axial displacement and (b) axial force.

Figure 8 and **Figure 9** show the variation of the axial displacement and force, bending moment and the buckling parameter for one ladder beam as a function of worker position on the ladder. These four parameters depend on

dynamic factors due to the ascension/descent and the load absorption coefficient due to the end pads and the roof flexibility. In general it could be said that the results of the analytical model are in a good agreement with those of FEM and in particular the axial compressive displacement or beam shortening and the axial compressive force shown.

The effect of the dynamic factors is illustrated for ratios of 2.5 to 1.75 and 2 to 1.5 are used in the simulation [19]. As the worker climbs the ladder towards the rung 13, these four parameters increase. It is to be noted that for each rung climbed, there are two states; the first one presents the dynamic state in which the worker is in movement causing a pulse load and the second one is the static case in which the worker stops instantaneously any movement of ascension or descent. The values are greater for dynamic states. When the worker reaches rung 9, *i.e.*, the middle of the ladder, the maximum values are reached. Passed this step some parameters start to level off or slightly decrease before increasing drastically on the descent. In fact, once the descent is initiated from rung 13 down to rung 12, the bending moment of the ladder is higher because the dynamic factor is higher at descent. Adding to the fact that the axial compressive force is higher during this movement, this causes the

bending moment and lateral displacements to amplify causing instability. It is to be noted the Euler buckling load for a column is given only for a reference in the axial force vs. position on the ladder graph of Figure 8(b). It should not be considered as a load limit criteria for buckling because the ladder behaves as a beam-column and therefore the buckling parameter defined by Equation (9) and shown in Figure 9(b) obtained for the different method should be considered. The CSA standard method gives the higher buckling parameter with all method showing buckling to occur with the most probable case with dynamic factors of 1.75/2.5. If the CSA method is considered rather conservative the analytical and FE models do not account for material defect, initial deflection or curvature, eccentricity and other factors that are taken care of somewhat by the CSA method. For the effect of dynamic factors, these calculations are conducted with a stiffness coefficient of 0.5.

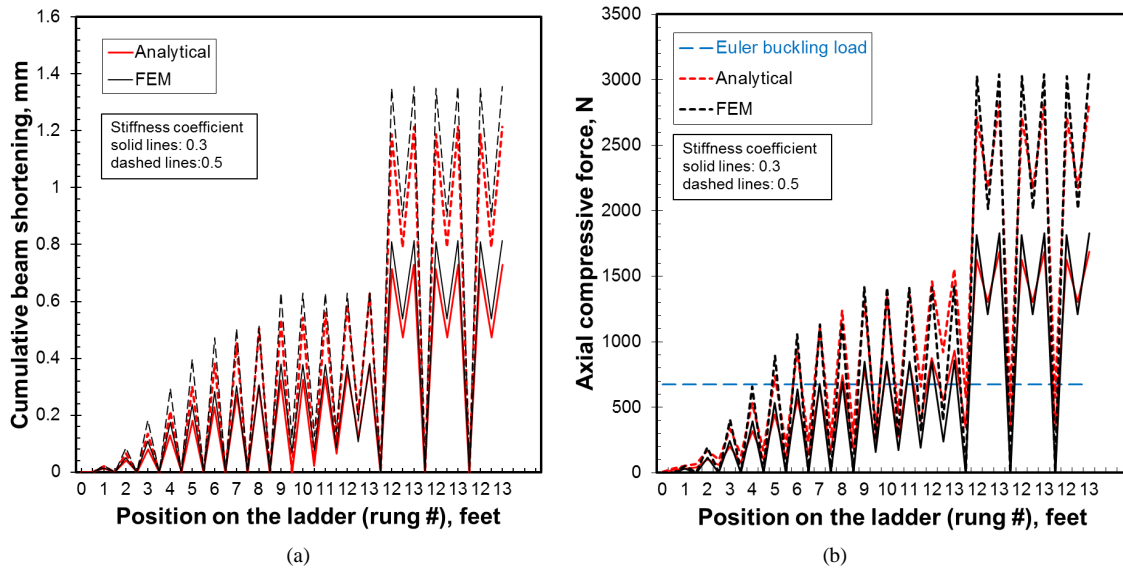
Figure 10. Stiffness coefficient effect (a) axial displacement and (b) axial force.

Figure 10 and Figure 11 show the effect of the stiffness coefficient on the four previously stated parameters. Values of 0.5 and 0.3 representing compression load absorption of 50% and 70% respectively are considered.

The calculations are done with the dynamic factors of 1.75/2.5. The higher the stiffness coefficient is the less compression load is absorbed and therefore the higher the four parameters are. Once again, as the worker climbs the ladder towards rung 13 the loads increase and the risk of instability is higher and in particular with the 0.5 value. The bending moment and its amplified values due to the effect of compression are shown in **Figure 11(a)**. It is clear that when the worker engages in the descent from rung 13, lateral deflections and bending are amplified causing instability and in particular when little or no absorption of the load occurs. This study is consistent with the second worker declaration that the accident occurred just after he released the ladder to get spare fluorescent tubes while the worker on the ladder prepared his descent to be able to grab the tubes.

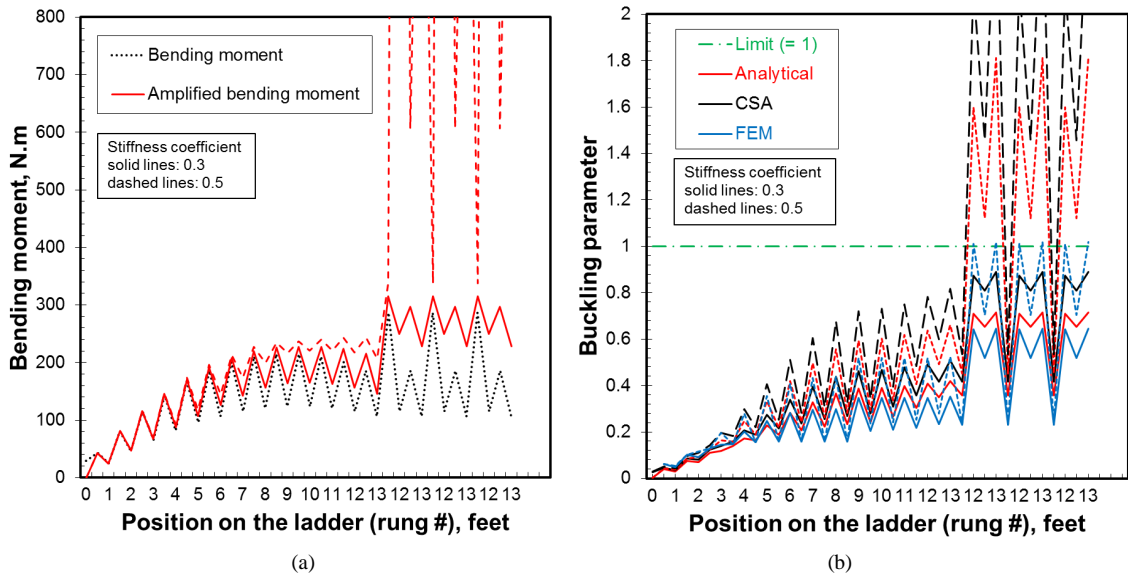
Figure 11. Stiffness coefficient effect on (a) bending and (b) buckling.
