Concrete Compressive Strength Estimation by Means of Nondestructive Testing: A Case Study

Correlations between the results of nondestructive tests (surface hardness and ultrasound tests) and the compressive strength of the concrete in the bleachers of the Albino Turbay soccer stadium in the city of Cianorte, which is located in the northwestern part of the state of Paraná, Brazil, are developed in this study.

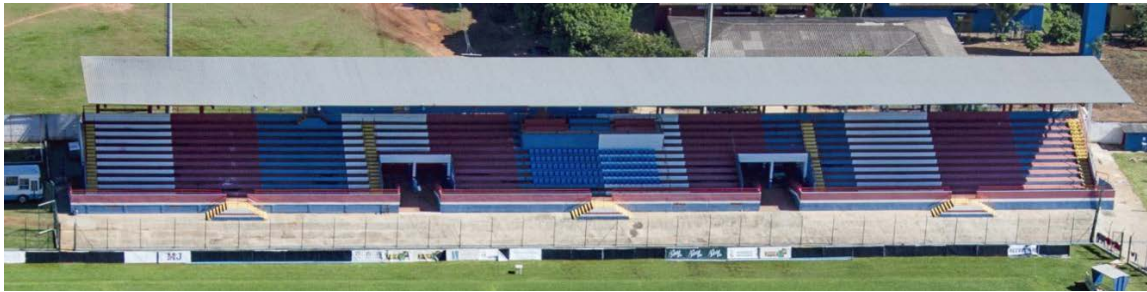
Figure 1. Total view and schematic of the bleachers. (a) Total view of the stadium's bleachers; (b) Schematic of the bleacher modules.

The reinforced concrete structure of the bleachers consists of modules (**Figure 1**) that are separated by cold and expansion joints. Module 1 was constructed in July 1991; each of the other modules was constructed in a subsequent stage. Module 5 was the last module to be constructed.

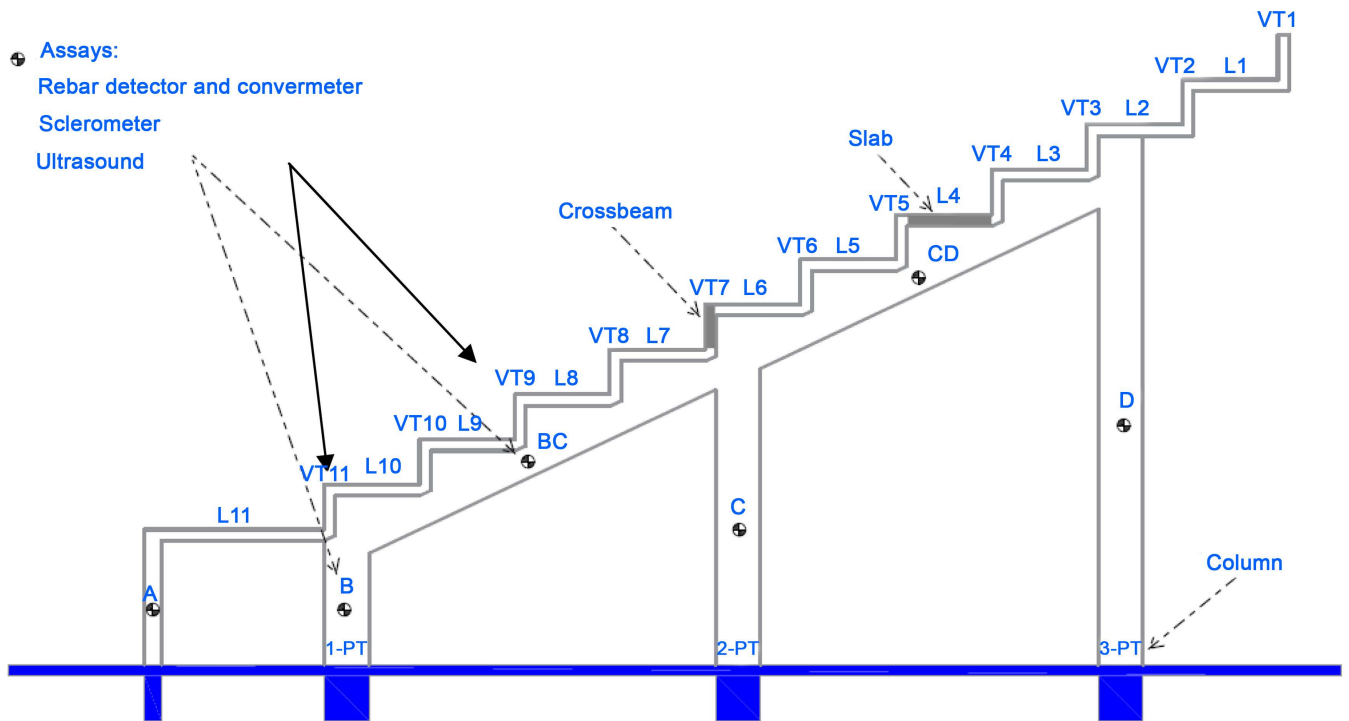
Figure 2. Cross-section of the porticos' structure.

The structure of each module consists of porticos; each portico has three pillars (PT) and an upper sloped beam that receives the cross beams (VT). These beams provide support for the unidirectional slabs that are used as seats (**Figure 2**). Because the porticos are sloped, the space below them is used for restrooms, a gym, a medical department and the main entrance to the stadium.

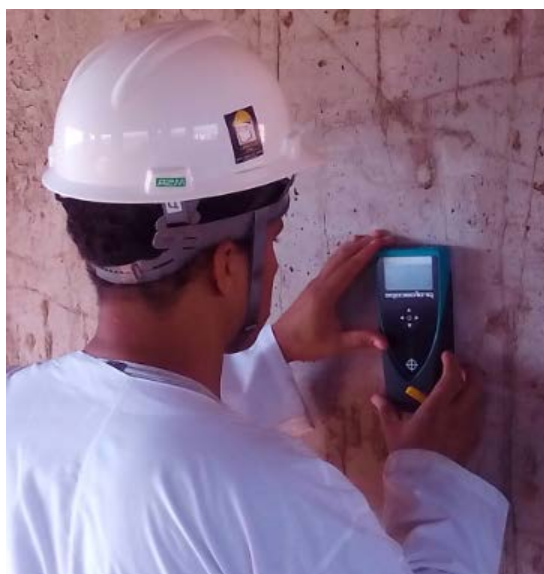
Figure 3. Electromagnetic detection test of the structural elements' rebar.

An electromagnetic detection test (**Figure 3**) was performed to locate the rebar in the structural element to reduce its interference on the results of the ultrasound and surface hardness tests.

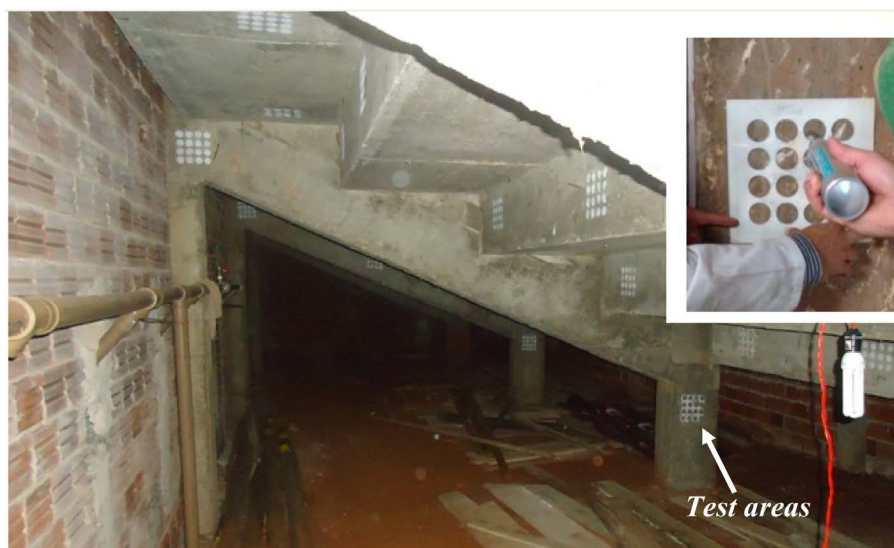
Figure 4. Indication of the hardness test areas on the exposed concrete surfaces of the structural elements under the bleachers (insert scelerometer).

The position of the test area was defined in a manner that it was geometrically and uniformly distributed along the structure. As shown in **Figure 4**, the test area was defined by a grid that was drawn on the surface of the structure (exposed concrete). The instrument that was employed in the test was a Schmidt “N” Type scelerometer.

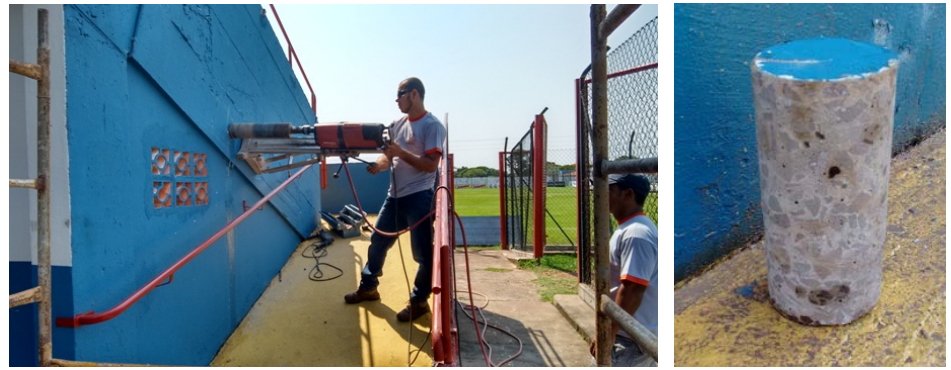
Figure 5. Extraction of specimens from the bleacher's structure.

The extraction of the concrete specimens followed the recommendations of standard [1] and was performed with a 100 mm diameter Hilti drill with a diamond crown (**Figure 5**). A total of 26 concrete specimens were extracted from the entire structure. The specimens were duly identified and sent to the Laboratory of Civil Construction Materials of the State University of Maringá in Umuarama for testing.

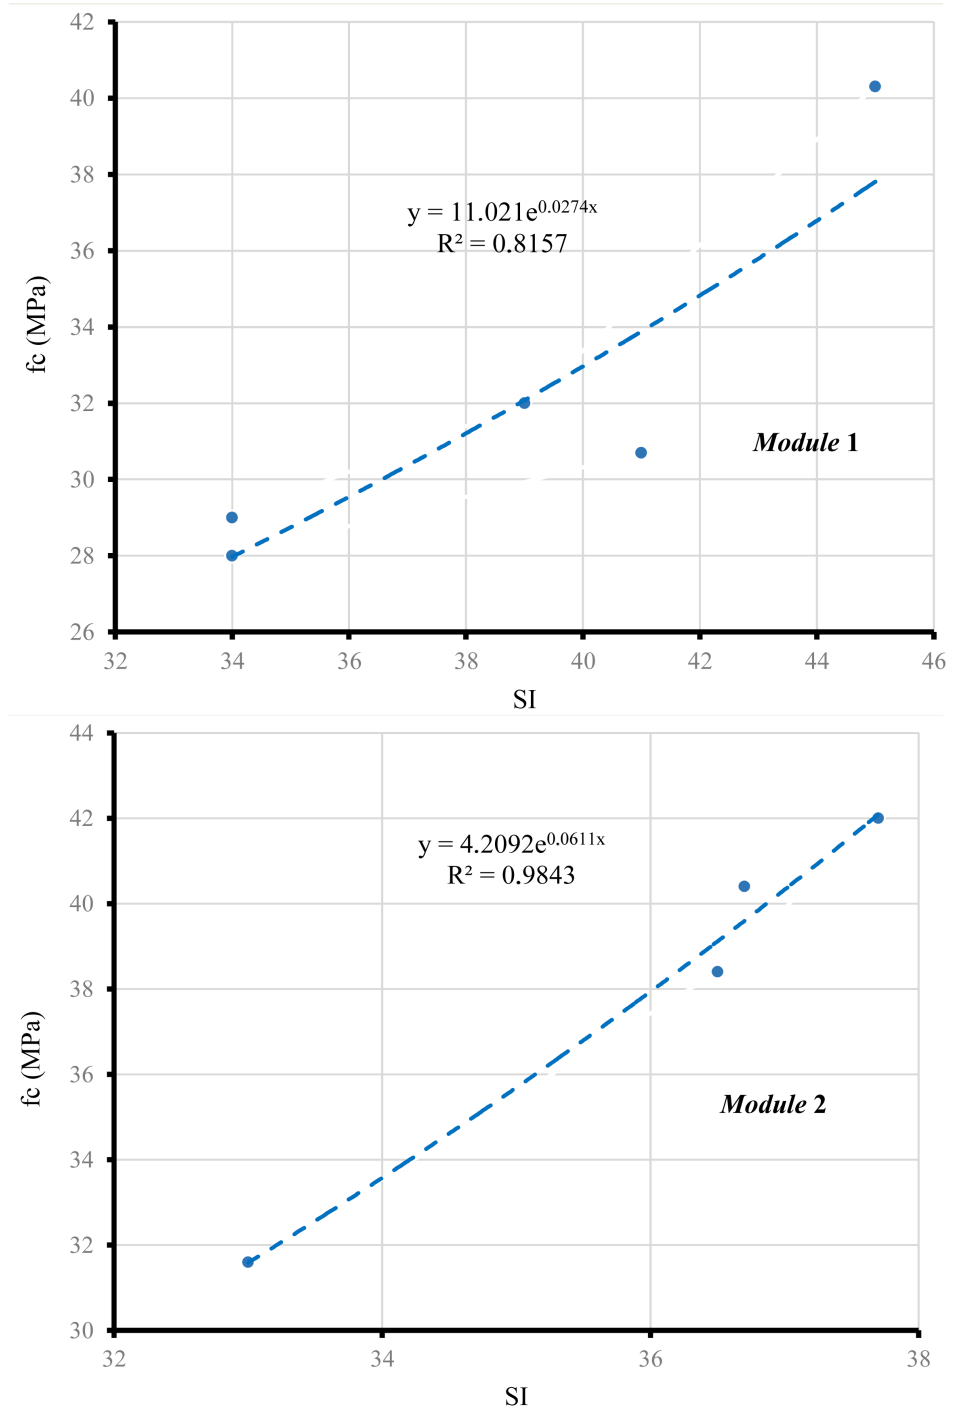
Figure 7. Correlation curves between the SI of the structure and the f_c of the concrete specimens (modules 1 and 2).

The correlations between SI and f_c are shown in **Figure 7** and **Figure 8**. The curves were defined by the correlation of the values of SI obtained in the tests that were directly performed at the points of the structure of each module and the f_c values obtained in the tests of the specimens collected from the same points.

The regression equations that represent the correlation between SI and f_c and the respective correlation coefficients (R^2) are indicated in each curve.

The correlation coefficients of the curves varied between 0.69 (module 3) and 0.98 (module 2). This range is not substantially different from the range obtained in a study by [5] in which the lowest correlation coefficient was 0.78 and the highest correlation coefficient was 0.90 for a series of five different concrete compositions.

The observation of the curves reveals that the higher the f_c value is, the higher the SI of the structure's concrete. The best correlation was obtained for module 2, with R^2 almost equal to 1, which indicates that the equation has a high reliability.

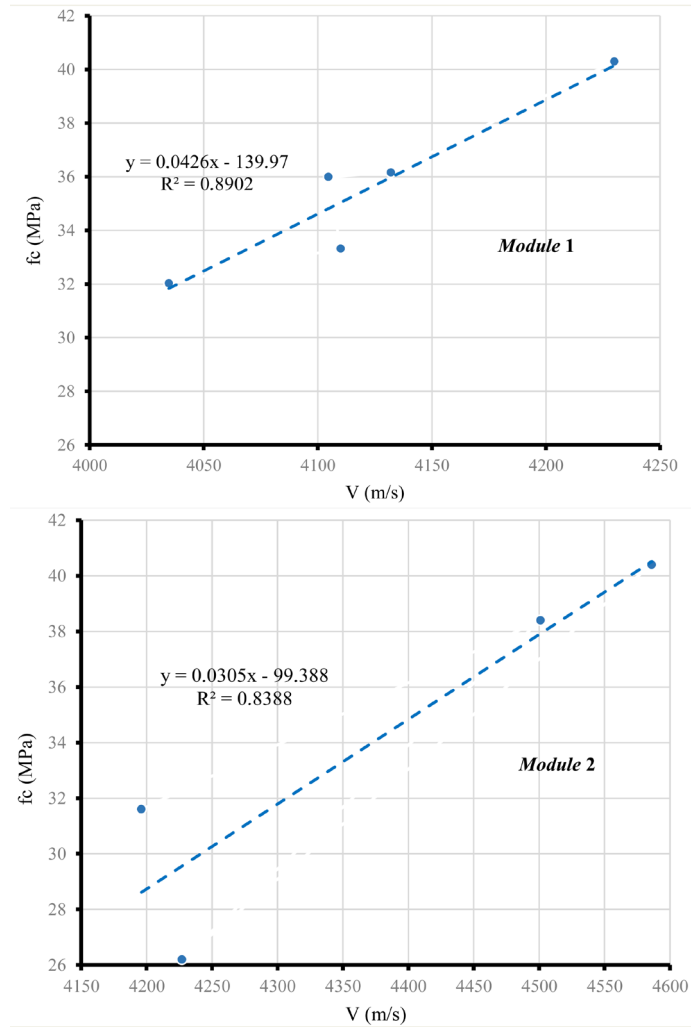
Figure 10. Correlation curves between V and f_c of the concrete specimens (modules 1 and 2).

Figure 10 and **Figure 11** show the correlations between V and f_c . The curves were constructed by correlating the values of V obtained in the test that was performed in the concrete specimens with the values of f_c obtained in the compression tests of the same specimens. A correlation between the velocity tests could not be directly established for the structure and the strength of the specimens due to the influence of the rebar and the difficulty of performing the tests in the direct transmission mode, which directly affected the readings of the wave propagation velocity in the structure.

The regression equations that represent the correlation between V and f_c and the respective coefficients of the correlations (R^2) are indicated in each of the curves.

The coefficients of the correlations of the obtained curves ranged from 0.46 (module 5) to 0.89 (module 1). Better correlations between 0.69 and 0.96 were obtained in

The curves indicate that the higher the wave propagation velocity is, the stronger the concrete, which is demonstrated by the high correlation between the strength and the ultrasound velocity.
