Causes of Cracks on Recently Constructed Flexible Pavements: A Case Study on Kabati to Mareira Road in Kenya

Benjamin K. Chamia¹, Zachary Abiero Gariy², Stephen M. Mulei²

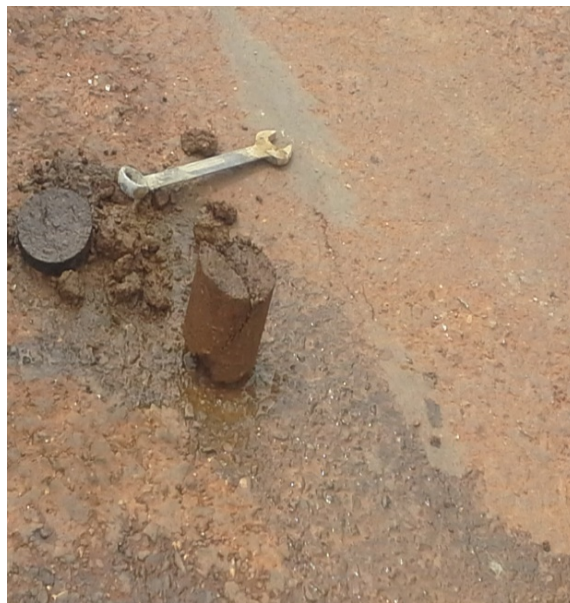
Figure 1. Core extracted from cracked section on the road.

A sample of the cores extracted for laboratory testing is illustrated in **Figure 1**; **Figure 2** shows a core undergoing compressive strength test; **Figure 3** displays extraction process of cores on the road; and **Figure 4** demonstrate part of the road surface with longitudinal cracks.

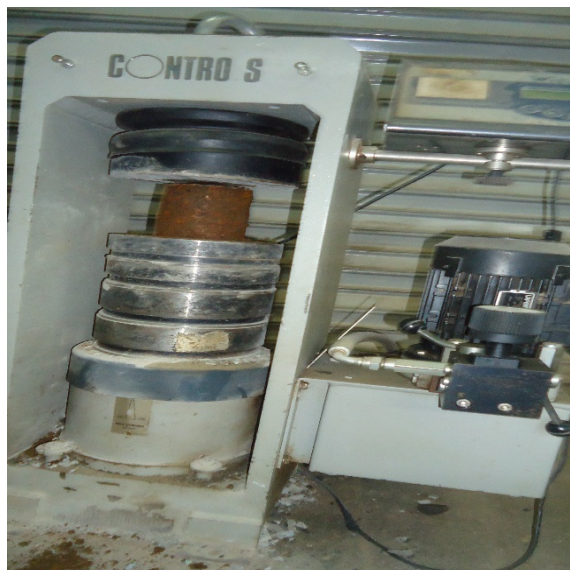
Figure 2. Compressive strength testing at MTRD on a core.

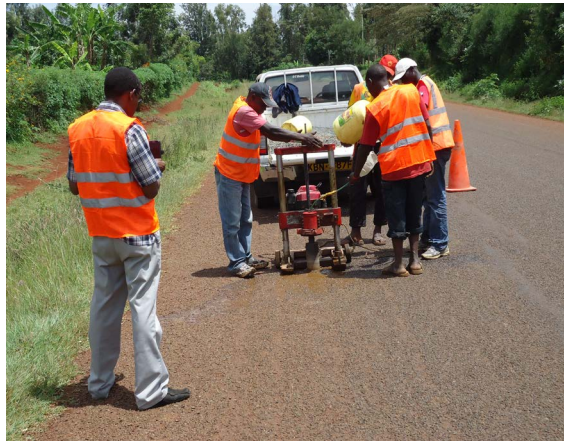
Figure 3. Core cutting on road surface.

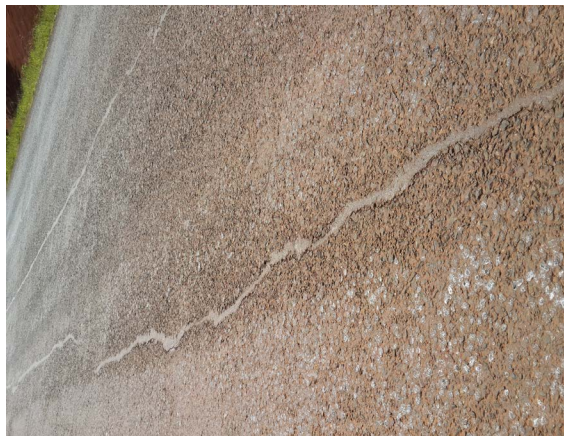
Figure 4. Sealed longitudinal cracks.

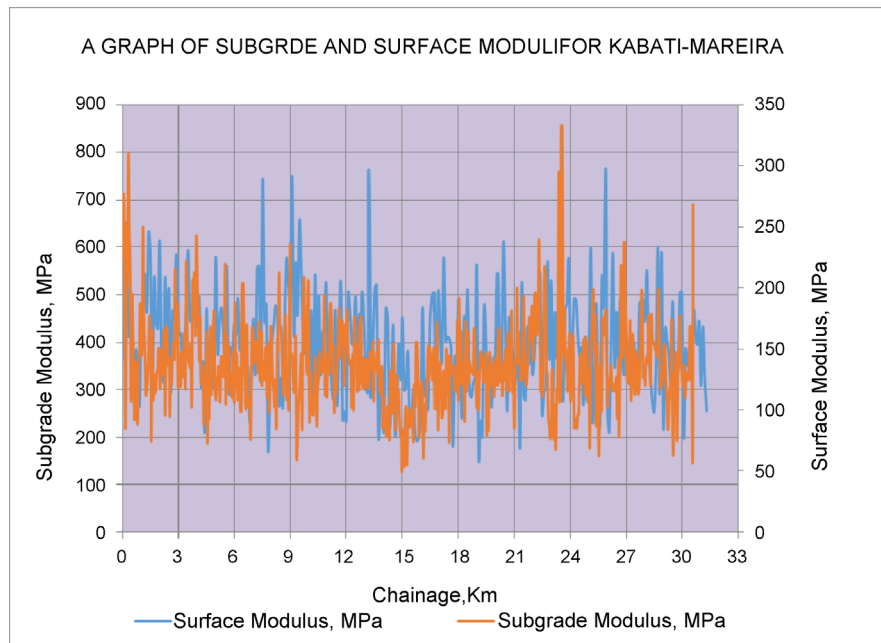
The deflection data was analyzed using Rosy Design Software to obtain layer moduli as shown in the **Figure 5** graph.

The subgrade elastic moduli values range from 55 to 308 MPa with an average value of 91 MPa indicating Subgrade Class S4 at *in-situ* moisture condition. The lower limit of 55 MPa indicates Subgrade Class S2. The surface and subgrade moduli profile as indicated in **Figure 5** have similar pattern, as locations with high sub-grade moduli have also high surface moduli and vice versa. Moisture contents in sub-grades are prone to variation due to natural effects, including rainfall, evaporation and proximity of water table as well as material type. Every layer material has a different behavior which is largely influenced by the characteristics of the other pavement layers (Chief Engineer, 1987) [17]. This

Figure 5. A graph of sub grade and surface moduli along the alignment.
