An Assessment of the Seismic Performance of the Historic Tigris Bridge

Atila Kumbasaroglu, Alper Celik*, Osman Demir, Ahmet Ihsan Turan, Hakan Yalciner

Civil Engineering Department, Erzincan University, Erzincan, Turkey

How to cite this paper: Kumbasaroglu, A., Celik, A., Demir, O., Turan, A.I. and Yalciner, H. (2019) An Assessment of the Seismic Performance of the Historic Tigris Bridge. *Open Journal of Civil Engineering*, 9, 230-239.

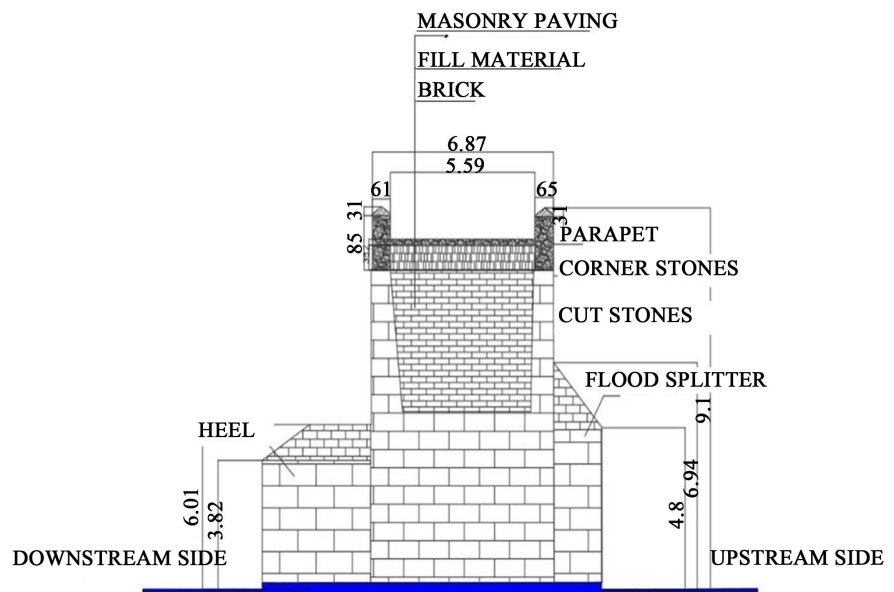
The Tigris Bridge is considered to fall in the category of multi-span flat-top bridges. The bridge is 172 m long. Its width varies between 5.45 and 6.24 m over the first five spans and increases to the range 9.69 - 10.20 m from the fifth span on. The road over the bridge is currently covered with the original paving stones following restoration. The parapet height is 85 cm at the end and rises to as much as 155 cm near the middle (Figure 1).

Figure 1. Cross Section Drawing (Halifeoğlu *et al.*, 2009c).

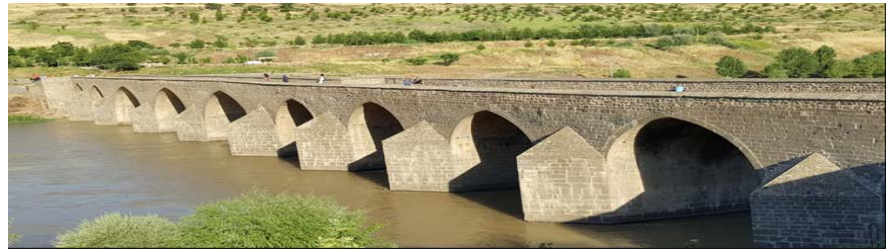
The capstones are nine capped pyramidal flood splitters [fender piles] stand on the north (upstream) side of the bridge. Flood splitters 1, 2, 3, and 4 (S1, S2, S3, S4) are lower in height than the others. Also, the spandrel walls of the spans 6, 7, 8, 9, and 10 retain their original construction features up to half their heights. However, different masonry work has been applied to the spandrel walls of the spans 1, 2, 3, 4, and 5 as shown in Figure 2 and Figure 3.

Figure 2. Capped pyramidal flood splitters on the upstream face.

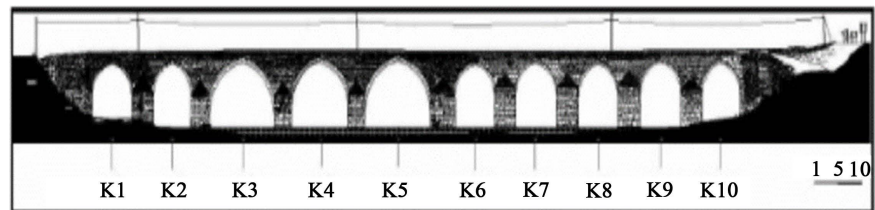
Figure 3. Upstream facade—elevation drawing [3].

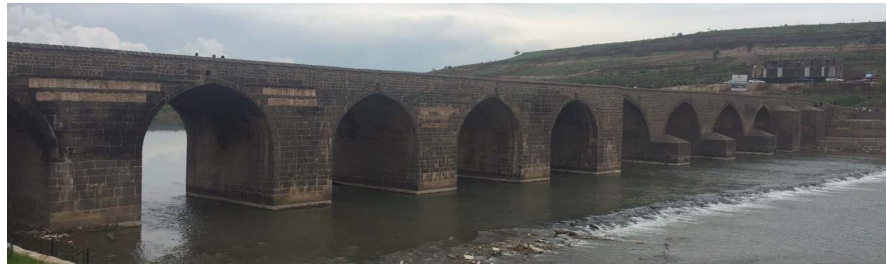
Unlike the north side, the southern (downstream) side of the bridge does not feature a flat facade wall. The arches of the spans 1, 2, 3, 4, and 5 are recessed by around 4 m. Following a study of traces left on the current bridge, it was determined that this section collapsed after [it was initially built] and that it was built with recesses during repairs (**Figure 4**).

Figure 4. View of the downstream facade of the historic Tigris Bridge.

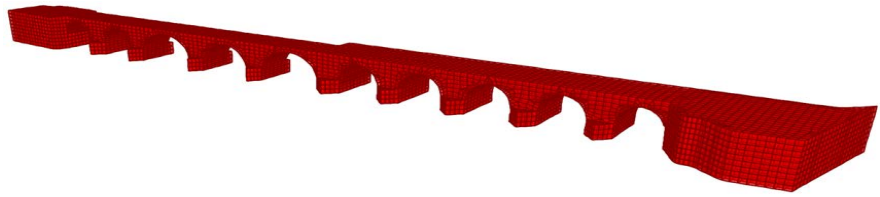
In finite element modeling, the geometry of the structure or structural elements is determined by a finite number of nodes. To determine the behavior of the structure accurately, a large number of nodes were used in creating a finite element model of the Tigris Bridge. Specifically, 12,937 solid elements and 17,541 nodes were used in the finite element model created. For this study, the degrees of freedom at the base of the bridge were assumed to be fixed. The finite element model created for the Tigris Bridge is shown in **Figure 5**.

Figure 5. Finite element model of the Tigris bridge.

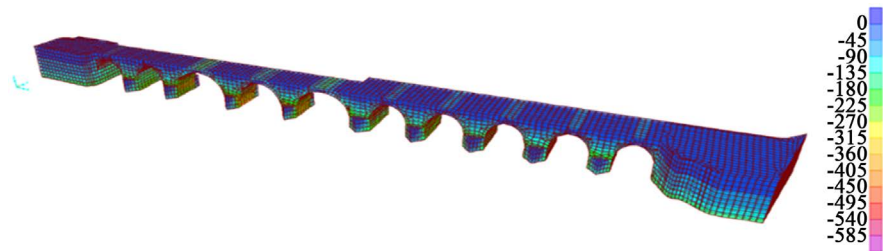
The distribution of maximum compressive stresses obtained from the static analysis shows that the largest stresses occur at the points where stone arches meet the footings of the bridge and at the bottoms of the footings. The largest stress was found to be 0.618 MPa (**Figure 6**).

Figure 6. Gravity load analysis—maximum compressive stresses (Mpa).

The maximum compressive stress that develops in the structure is 0.618 MPa, which does not exceed the compressive strength specified for masonry walls.

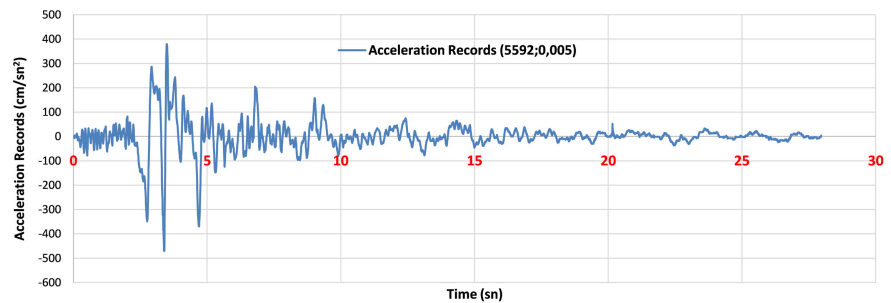
A time domain finite element dynamic analysis was performed on the model that was created using a macro-modeling technique. Acceleration data for the east-west component of the March 13, 1992 Erzincan Earthquake were applied to the model to simulate the behavior of this structure under dynamic loads. The largest acceleration [in the earthquake record] was -470.915 cm/s^2 at 3.395 seconds (**Figure 7**).

Figure 7. East-west component of the Erzincan Earthquake.

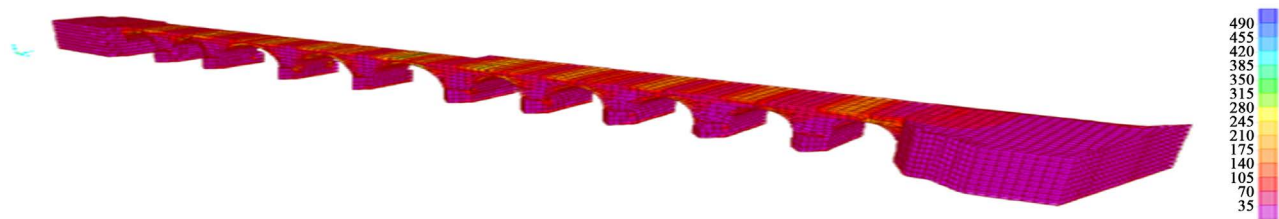
of the structure, Erzincan Earthquake record was used considering the similarity of local ground conditions. The distributions of stresses and maximum shear stresses that were obtained in the linear dynamic analysis in the time domain using acceleration records of the east-west component of the March 13, 1992 Erzincan Earthquake are shown in **Figure 8** and **Figure 9**.

The dynamic analysis for the Erzincan earthquake calculated the maximum shear stress in the x-x direction as 0.507 MPa, the maximum shear stress in the y-y direction as 0.180 MPa and the maximum shear stress in the z-z direction as 0.893 MPa.

Maximum stresses in the X direction were observed in the arches of the bridge and the paved area above the arches; maximum stresses in the Y direction were observed at the footings of the arches, the edges of the base of the bridge, and the inner portions of the arches; maximum stresses in the Z direction were observed at the edges of the bases of the footings where the arches meet.

Figure 8. X-dir shear stress values for the Erzincan Earthquake (MPa).

Direction	Compressive stress developed (MPa)	Shear stress developed (MPa)	Effective shear strength (MPa)	Safety status
X-X	0.618	0.507	0.347	Insufficient
Y-Y	0.618	0.180	0.347	Sufficient

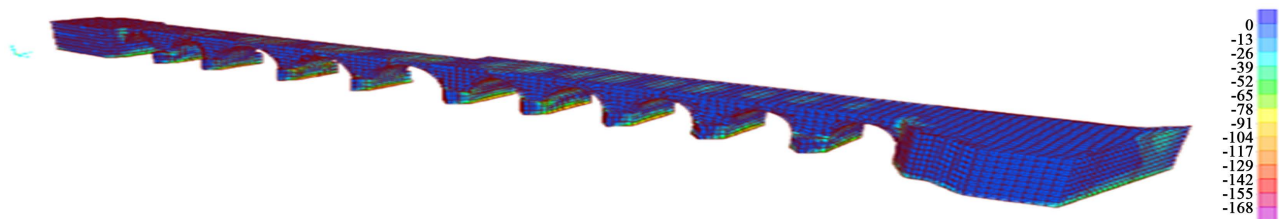
Figure 9. Y-dir shear stress values for the Erzincan Earthquake (MPa).
