# About the Causes of the Koror Bridge Collapse

**Corneliu Bob**

University "Politehnica" of Timisoara, Timisoara, Romania  
Email: [cbob@mail.dnttm.ro](mailto:cbob@mail.dnttm.ro)

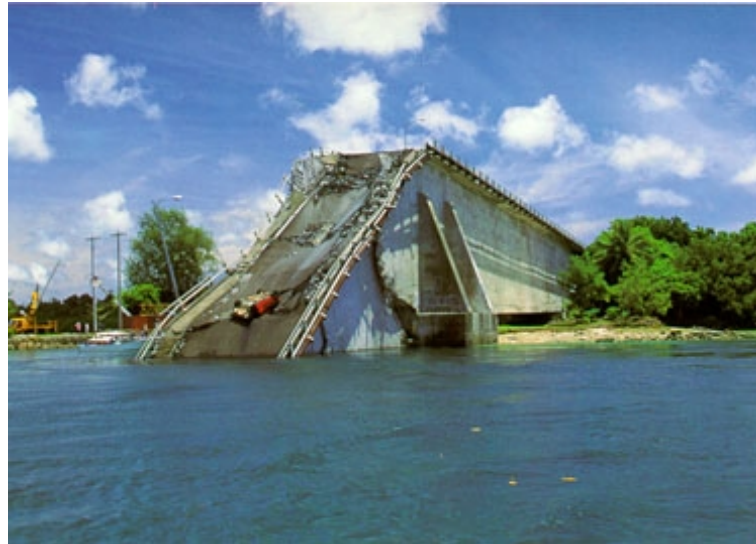
The target of the work is to establish main causes, in the author conception, of the Koror Bridge collapse (Figure 1).

**Figure 1.** The Koror Bridge collapse.

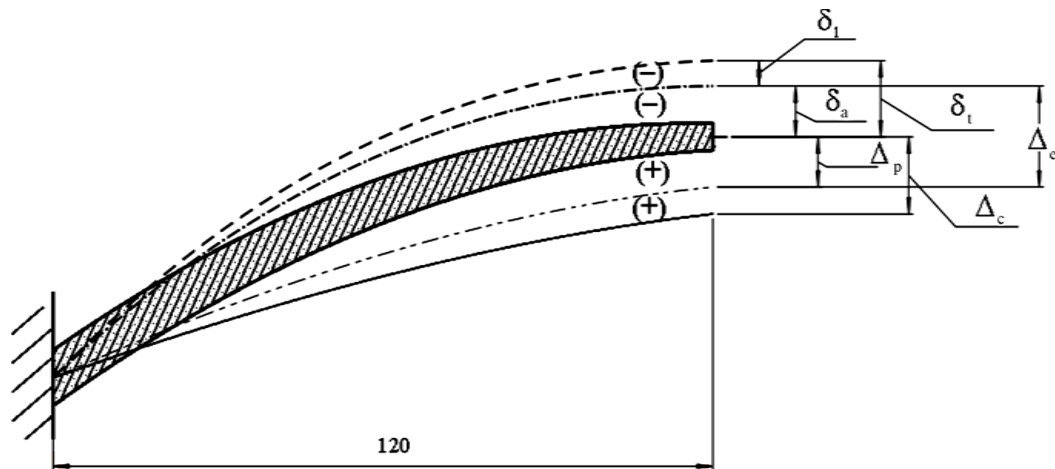
In the **Table 1** and **Figure 2**, deflection at mid-span under various assumption presented by Man-Chung Tang are given.

**Figure 2**, proposed by the author of this work, is an illustration of the deflection due to different factors (prestress, elastic behaviour, creep influence). The last column in the **Table 1** is the author proposal for the total deflection at mid-span.

Figure 2. Deflections due to different factors.

The assumption started from the test results (column 3): the prestress loss is 50%. Calculation of total elastic deflection assumes a reduce girder stiffness by 50% as compared whit initial design. The creep deflection was obtained from positive deflection by introduction of modified elasticity modulus  $E'$  with formula [6]:

The final deflection, taking into account creep deflection before closure (assumed 20% [1]), is about 2.43 m. It is the same with the extrapolation of measured deflection at 36,500 days (100 years), of  $\Delta_{exp} = 2.4$  m [1].

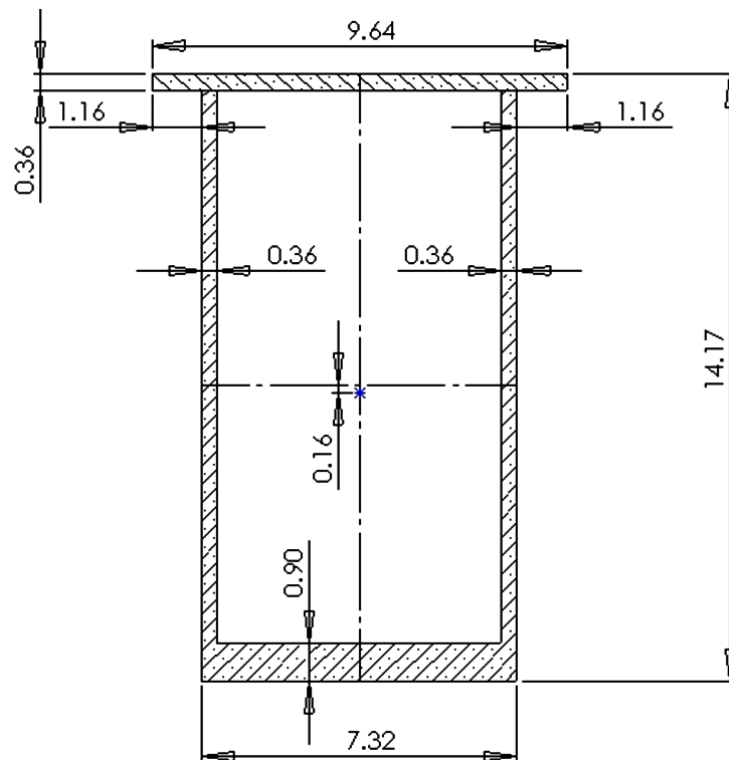
**Figure 3.** Cross-section near the main pier.

Under ultimate conditions the bending moment due to permanent loading and the total shear force were appreciated as actual bending moment  $M_g = 1800 \text{ MN}\cdot\text{m}$  and the shear force as  $V_g = 34 \text{ MN}$ ; the mean cylinder strength was found  $f_{cm} = 35 \text{ MPa}$  [1].

The prestressing system consists of 300 tendons with the diameter of a bar,  $\phi = 32 \text{ mm}$  and the ultimate strength of  $f_u = 1050 \text{ MPa}$ . Maximum allowable stress of the tendons during stressing was  $0.8f_u$  and  $0.7f_u$  after anchoring and before losses the ultimate tension capacity of all 300 bar tendons in the top slab was: 241 MN for  $f_u$ , 200 MN for  $0.8f_u$ , 180 MN for  $0.7f_u$  and 100 MN for  $0.4f_u$  [1].

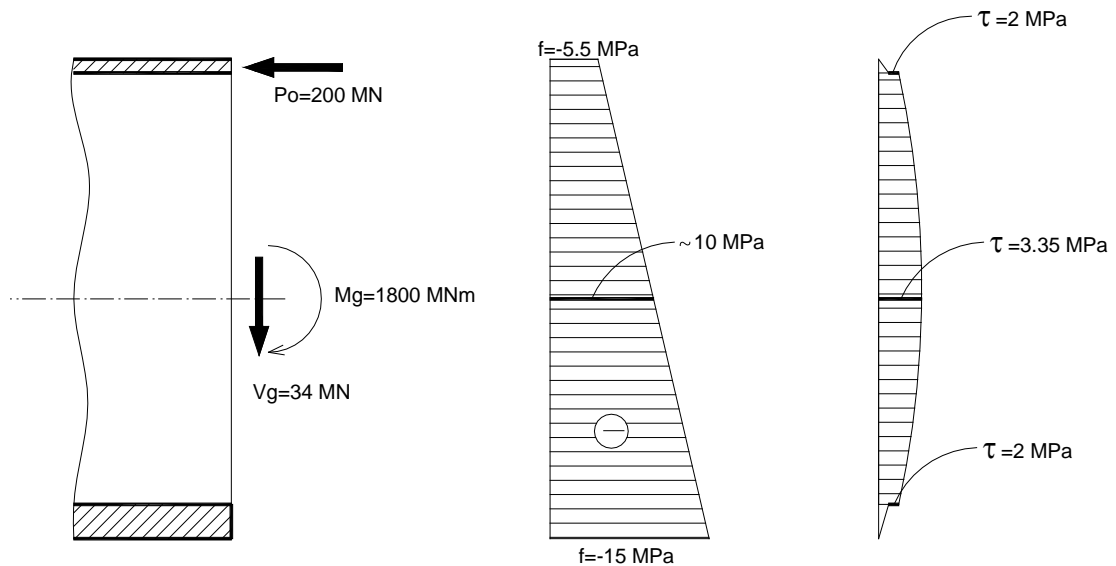
**The initial phase** with full prestress ( $0.8f_u$ ) is presented in **Figure 4**, where the external actions are: bending moments due to permanent loading; the prestress force  $P_0 = 200 \text{ MN}$  and shear forces.

The cross-section has maximum values at the bottom slab  $f_c = -15 \text{ MPa}$ . At the top of slab there compression stress of  $-5.5 \text{ MPa}$  for the actual bending moment.

The shear is also presented in **Figure 4**, with the maximum value  $\tau_c = 3.35 \text{ MPa}$ ; main tension stresses for  $\tau = 3.35 \text{ MPa}$  resulting are:  $\sigma_1 = -11.32 \text{ MPa}$ ,  $\sigma_2 = +1.00 \text{ MPa}$  and no inclined cracks will appear.

**Figure 4.** Elastic analysis of initial phase with full prestress.

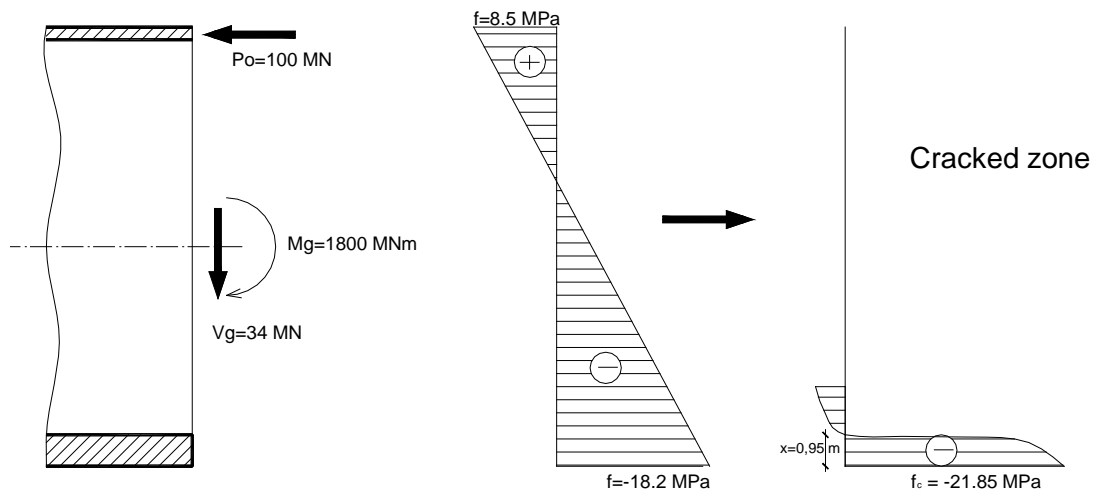
**The phase with prestress loss** of 50% ( $0.4f_u$ ), as it was measured by experimental determinations, is illustrated in **Figure 5**.

**Figure 5.** The phase with prestress loss.

The state of stress obtained with the entire cross-section gives a tension zone at the top of the slab with a values  $f_c = 8.5$  MPa. In such circumstances, the beam will crack and state of stress of the cross-section near the centerline pier is also illustrated in **Figure 5**. For this phase, the inclined cracks are not imminent to appear because of small value of main stress  $\sigma_2^{\max} = +3.35$  MPa and the strength to inclined main stress is  $R_f \cong 2f_{cr} = 7.4$  MPa  $> 3.35$  MPa. The pattern of cracks (with vertical crack near the main pier) is a confirmation of the diagrams illustrated in **Figure 5** and data concerning stresses from **Table 2**.

The compressed zone is restricted on 0.95 m (bottom portion of box girder) and the stresses are high:  $f_c = 21.85$  MPa.

The cause of such prestress loss was, maybe, as it was pointed in [2] "... the top flange and the web to have been particularly congested with longitudinal, transverse and vertical prestressing tendons crossing one another as well as anchorages for the various tendons". In addition to it the top flange was cracked from the early stage of using of the bridge.

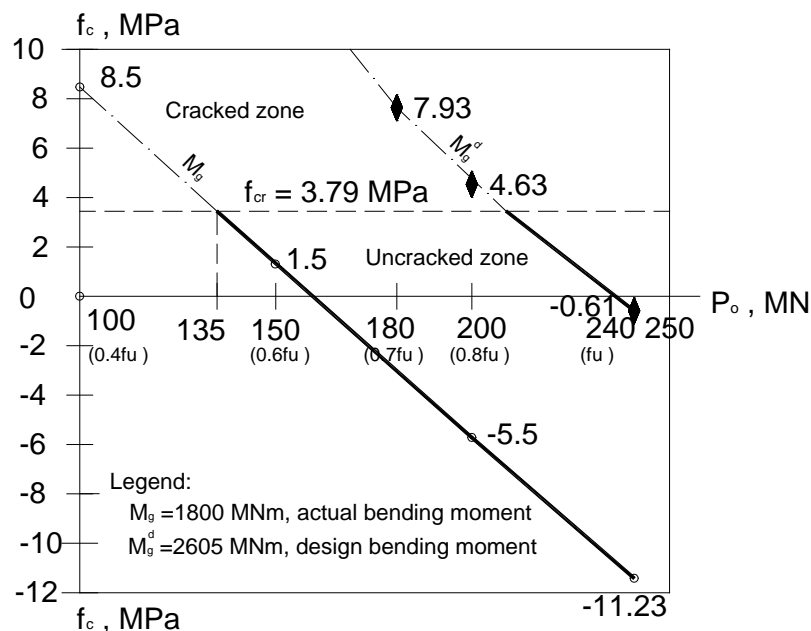
The potential value of stress at the top of cross-section for different prestress forces applied at the top slab is presented in **Figure 6** (from elastic analysis). It can be concluded: the cracking strength of  $f_{cr} = 3.79$  MPa is attended at a prestress force smaller than 200 MN ( $0.8f_u$ ) at 135 MN ( $0.56f_u$ ) for actual bending moment; a cracked zone in the early phase with smaller prestress is presented.

**Figure 6.** The correlation of potential tension stress v. prestress force at the top slab.
