A Conservative Approach to Treatment of Dental Erosion: Case Report

Khaila Davis, Risa Yuk Low, Reisha Rafeek* D

School of Dentistry, Faculty of Medical Sciences, University of the West Indies, St Augustine, Trinidad & Tobago Email: *reisha.rafeek@sta.uwi.edu

How to cite this paper: Davis, K., Low, R.Y. and Rafeek, R. (2019) A Conservative Approach to Treatment of Dental Erosion: Case Report. *Open Journal of Stomatology*, **9**, 241-248

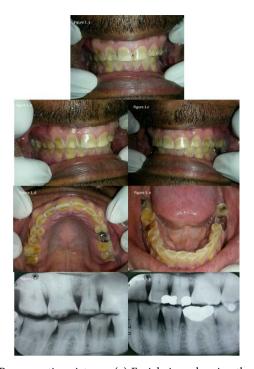
Figure 1. Pre-operative pictures. (a) Facial view: showing the worn anterior teeth, discolored with thinned out incisal edges; (b) Right lateral view: showing the eroded and discolored buccal surfaces; (c) Left lateral view: showing eroded and discolored buccal surfaces; (d) Upper Occlusal view: shows the palatal surfaces worn down and cupped out; (e) Lower occlusal view: shows the heavily eroded first and second molars; (f) Right bitewing; and (g) Left bitewing: show the moderate loss of enamel and dentine but with good bone levels.

Dental Health Survey, the patient has a score of 2 and is thus classified as having moderate TSL. **Figure 1** depicts the patient's TSL score of 2 as there is loss of enamel on more than 1/3 of the surface area on the buccal/lingual/palatal surfaces and more than 2 mm of exposed dentine on the incisal edge without pulpal exposure or exposure of secondary dentine [10].

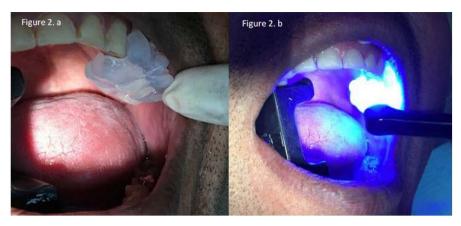
Figure 2. Use of regofix transparent. (a) Stent placement; (b) Light curing through stent.

silicone material. Teeth underwent minimal preparation, etchant, primer and adhesive placed and cured, and were restored using 3M Filtek™ Z 250 Universal Restorative Composite (St. Paul, MN, USA). The composite filled stents were seated on the posterior teeth and cured increasing the OVD. The stents allowed for replication of the diagnostic wax up, and also aided in ease of placement of composite. The use of the transparent Regofix® facilitated the ability to light cure the composite through the stent [Figures 2(a), Figures 2(b)]. The restorations were polished and morphology recontoured. Aesthetics was addressed via placement of composite veneers on the labial and buccal surfaces as well as palatal surfaces and building in canine guidance [Figures 3(a)-(c)]. The patient was advised that his bite would be uncomfortable initially, after which his neuromuscular feedback will adapt to the new OVD of his dentition. Prior to placement of the anterior composites, the patient experienced difficulty in biting anteriorly. Once the posterior and anterior composite restorations were in place, the patient adapted well to the new occlusal scheme and was able to function comfortably. Over a period of 3 months, the patient remained at the increased OVD. During this continued stabilization period, the patient returned for monthly reviews requiring minor repairs of chipped composite restorations.

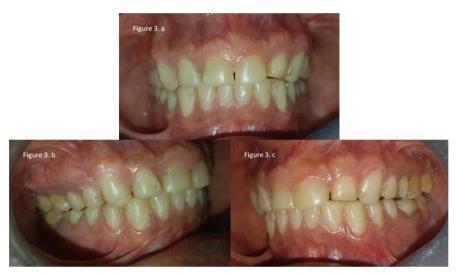
Figure 3. Composite veneer restorations of labial/buccal surfaces to restore aesthetics and canine guidance. (a) Facial view; (b) Right lateral view; (c) Left lateral view.

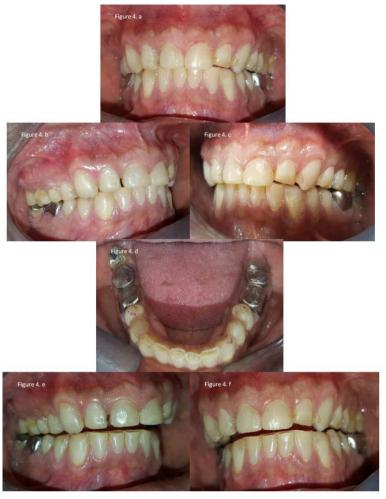
Figure 4. Post Operative Pictures. (a) Facial view; (b) Right lateral view, (c) Left lateral View: showing composite veneers with improved aesthetics in the position of maximum intercuspation; (d) Lower occlusal view: showing the cemented metal onlays on the first and second molars; (e) Right lateral excursion and (f) Left lateral excursion: show the canine guidance restored to the patient (g) & (h) Right bitewings, (i) & (j) Left bitewings: these bitewings show the metal onlays ce mented with no defective margins and the composite restorations intact.

Upon the 6-month review after final cementation, the patient returned with intact metal onlays and some minor chips in the composite restorations that required repair with reestablishment of canine guidance [Figures 4(a)-(j)].

At the one-year post-operative review of placement of posterior onlays and anterior composite veneers the patient has been functioning comfortably with no repairs required. The patient was offered the options of either anterior porcelain veneers or ceramic crowns but has opted to wait longer as he is comfortable.
