Climate Change and Anthropogenic Interferences for the Morphological Changes of the Padma River in Bangladesh

Abstract

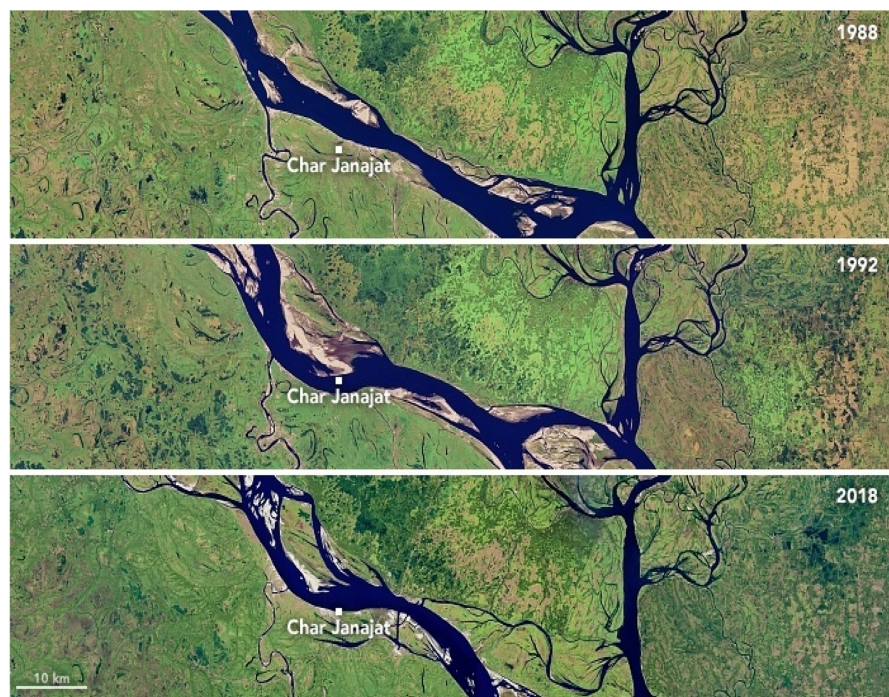
Figure 2. Comparison of Landsat satellite images of Padma River from 1988 to 2018.

The extreme erosion patterns have two leading causes. First, the Padma is a natural, free-flowing river with little bank protection, other than some occasional sandbags to protect buildings. Second, the bank sits on a large sand bed that can be eroded quickly. Like parents measuring a child's height, scientists measure erosion on the Padma River by noting differences in its width, depth, shape, and overall appearance. These natural-color satellite images show the changes to the shape and width of the Padma since 1971, and each twist and zigzag tells a different geologic story about the river. All images were acquired in January and February, during the dry season.

Based on the observed images of the river, the Padma shows the greater spatial extent of the channel widening at Hardinge Bridge. Within 240 km reach of the Jamuna, neither the alignment nor the spatial extent has differed distinctly for climate change conditions. Abrupt shifting of the channels from one bank to another bank is not seen. However, there are some sporadic locations where noticeable change is seen. More straightening at the downstream portion of the river is observed due to climate change conditions. At upstream of the proposed Padma Bridge, increased bed erosion has been found.
