The Conservation Imperative: Developing a Framework for Climate Change Adaptation in Coastal Heritage Conservation—A Study of Monuments in Kenya

Kenya's coastal monuments, crucial for its cultural heritage, face increasing threats from climate change, including sea-level rise and erosion. This research investigated the conditions of the monuments as impacted by climate change and the need for adaptation strategies to protect these sites. Employing a mixed-methods approach, including literature reviews, on-site observations, and interviews with professionals and locals, the study documented significant climate-related damages, such as wall flaking, erosion, and structural decay. The findings revealed a critical gap in current conservation practices, highlighting the necessity for a holistic adaptation framework. This framework comprises four key components: vulnerability assessment, risk management, community engagement, and policy integration. Vulnerability assessment involves mapping climate risks, while risk management integrates engineering solutions with traditional conservation methods. Community engagement ensures local participation in decision-making, and policy integratio

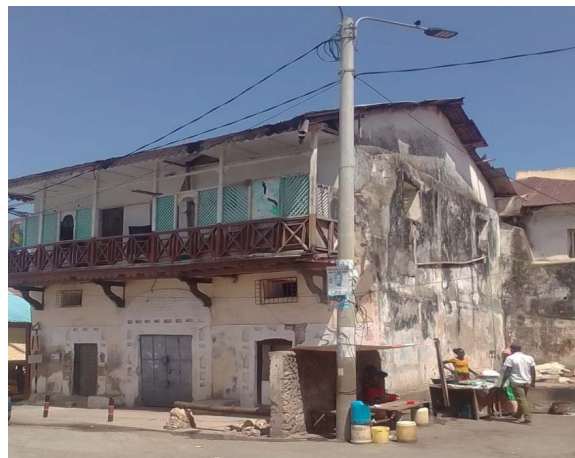
Figure 1. Building with flake walls.

Figure 1 and **Figure 2** illustrate the visible deterioration of buildings in Mombasa Old Town. Coral stone walls and limestone mortar plaster show extensive weathering, with flaking and discolored paint. Decorated surfaces are damaged, and ceilings and roofing are detaching. Timber elements, such as balconies, roof supports, window frames, and security bars, display decay and fungal growth.

In Mombasa Old Town (MOT), edifices constructed with coralline and calcareous mortar manifest pervasive weathering, characterized by plaster delamina-

tion, chromatic alteration of applied coatings, and the progressive tarnishing of previously pristine surfaces. Ornate façades exhibit notable degradation, while overhead and roofing assemblies demonstrate detachment. Ligneous structural components, including cantilevered balconies, fascia boards, roof supports, and fenestration frames, display discernible decay, fungal proliferation, and, in certain instances, volumetric expansion, exfoliation, or complete structural failure. These deteriorations are compounded by the corrosive degradation of metallic reinforcement bars, superficial fissuring of upper wall surfaces, plaster exfoliation, and visible repainting interventions indicative of prior dilapidation.

This discernible degradation of edifices is inextricably linked to the escalating ramifications of anthropogenic climate change along the Kenyan coastline. The region's inherently warm and humid climatic regime has undergone exacerbation in recent periods, attributable to the inexorable ascent of global mean temperatures. This situation creates protracted periods of moisture exposure that catalyze the accelerated weathering of coralline and calcareous mortar. The lithological constituents, intrinsically porous and susceptible to environmental perturbations, exhibit marked vulnerability to salt crystallization and moisture retention. Moreover, the transgression of sea levels, coupled with the amplified aeolian transport of saline particulates inland, precipitates salt efflorescence within structural walls, culminating in plaster delamination, chromatic alteration of applied coatings, and the progressive tarnishing of previously pristine surfaces. Concomitantly, heightened atmospheric humidity and oscillating thermal amplitudes engender propitious microclimatic conditions for biodeterioration.

Ligneous structural elements, such as cantilevered balconies, fascia boards, and fenestration frames, succumb to protracted dampness, fostering fungal infestations, volumetric expansion, and eventual structural decay. The hygroscopic nature of these timber components facilitates moisture absorption, leading to internal material breakdown, warping, and, in extreme instances, complete disintegration. The detachment of overhead and roofing assemblies is similarly correlated with the attenuation of load-bearing materials under the cyclical stress induced by alternating hydric and desiccative phases, which instigates the progressive loosening of structural cohesion over temporal scales.

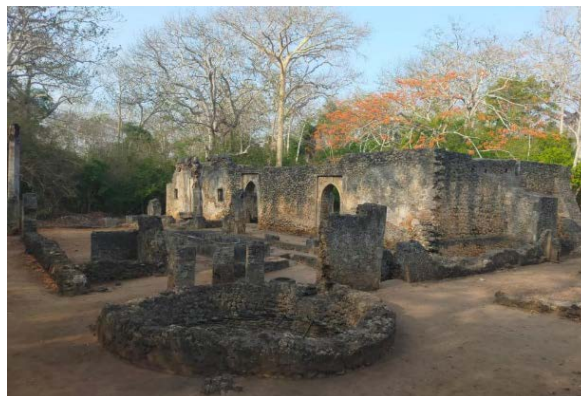
Figure 5. The Gede Ruins.

World Heritage Centre, 2023). Rebuilt in the 15th and 16th centuries, the ruins have suffered significant dilapidation, largely attributed to climate change, including a dwindling water table as evidenced by the deepened well near the Great Mosque. Walls have collapsed and disintegrated, with existing structures exhibiting major cracks. **Figure 5** shows a section of the ruins.

Similarly, the Gede Ruins, an archaeological site, has undergone substantial structural degradation, characterized by collapsed walls, disintegrated coralline stone, and significant fracturing. A deepened well proximate to the Great Mosque signifies a declining phreatic surface. This is an indicator of shifting climatological patterns, reflecting prolonged periods of drought and inconsistent rainfall patterns. These hydroclimatic shifts weaken the underlying substrate and undermine the structural foundations of the site, contributing to the collapse of extant walls and the fracturing of the coralline stone fabric. The ruins, which once benefited from the relative stability of the forest's microclimate, now face heightened exposure to the vagaries of changing regional climatic patterns.

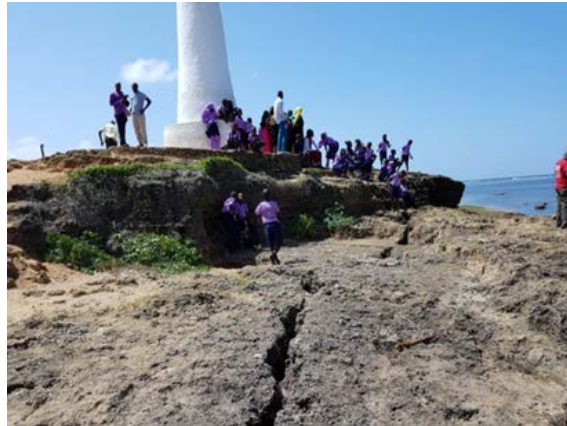
Figure 6. Vasco da Gama Pillar.

The coral-built Vasco da Gama Pillar is located in Malindi, Kilifi County. Erected in 1498 CE, the Vasco da Gama Pillar stands as an early European monument in East Africa. Commissioned by Portuguese explorers led by Vasco da Gama during his initial voyage to India, it served as a navigational marker and a symbolic representation of Portuguese presence in the region (NMK, 2023). As depicted in **Figure 6**, it exhibits several significant cracks, rock deterioration, and soil erosion. Insects are prevalent, and some have created dune-like formations. Visible renovations suggest previous structural damage to the pillar.

The Vasco da Gama Pillar exhibits structural fracturing, lithic decay, pedological erosion, and entomological infestation, with aeolian dune accretion around its base, indicative of prior damage and extant vulnerabilities. Equally, these deleterious environmental dynamics are analogously impacting this cultural heritage. The structural fracturing, lithic decay, and pedological erosion are being exacerbated by the increasing intensity of coastal winds and the variability of precipitation patterns, both demonstrably influenced by shifting climatological conditions. The accumulation of aeolian sand deposits at its base suggests an intensification of wind-driven erosion and subsequent sediment displacement. The elevated ambient temperatures and increased atmospheric humidity also foster entomological infestations that further compromise the monument's structural integrity and material stability.

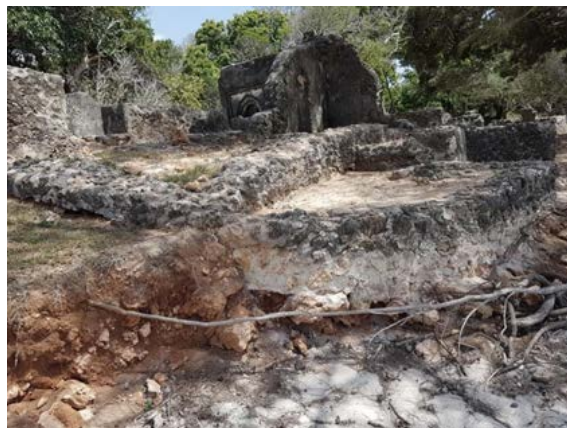
Figure 7. Jumba La Mtwana.

Jumba la Mtwana, an archaeological Kenyan National Monument since 1982 (NMK, 2023), is depicted in **Figure 7**. This historic site features a tomb, four mosques, and four distinct houses: the Great Mosque, the House of the Cylinder, the House of the Many Pools, and the House of the Kitchen. Climate change im-

pacts are evident in the deterioration of its structures, including soil and rock erosion, cracking, and wall disintegration, resulting in its ruined state. The site holds significant economic, historical, social, archaeological, and natural value.

Correspondingly, Jumba la Mtwana is deteriorating due to erosional processes, pedo-logical instability, an increased prevalence of structural fracturing, and progressive walls disintegration, leaving key architectural elements such as its mosques and domestic structures in a state of ruin. Coastal erosion, driven by the synergistic effects of rising tidal levels and intensified seasonal precipitation, has destabilized the monument's structural materials. Moreover, fluctuations in ambient temperature have accelerated the degradation of its plaster and mural surfaces. The cumulative impact of these environmental stressors is the progressive ruin of its mosques and other architectural elements that once held significant historical and cultural values.
