# Rubblization: A Practical, Cost Effective and Sustainable Option for Repairing Deteriorated Airfield Pavement in the Empty Quarter Desert of Saudi Arabia

### **3. Project Details—Airfield in Empty Quarter of Saudi Arabia**

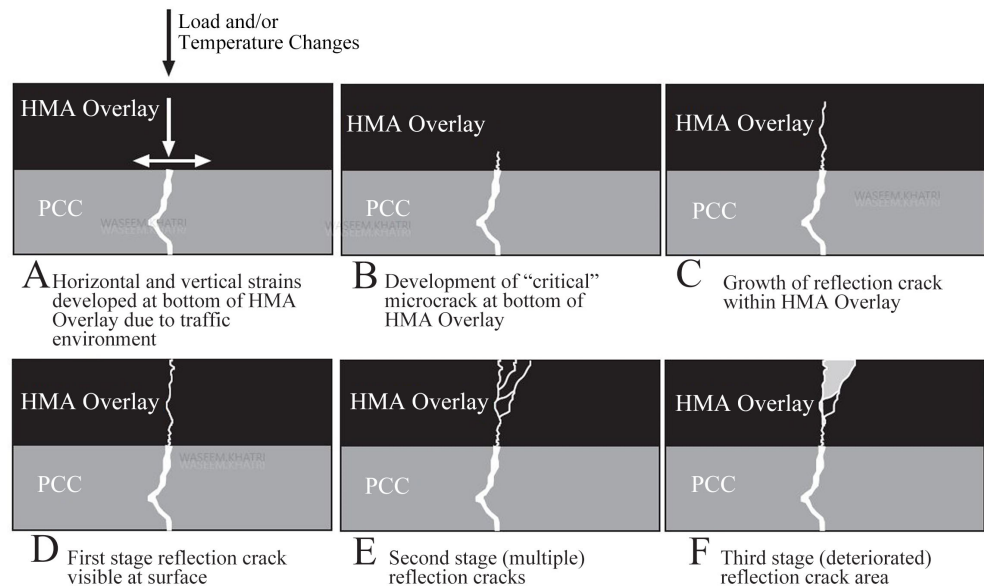
**Figure 2.** Growth mechanism associated with reflection cracking.

The cracks form at the bottom of the asphalt layer, above a joint or a crack, and propagate vertically to the surface. These reflection cracks, which begin as a pattern of narrow, difficult-to-seal cracks that mirror the joints and cracks in the underlying concrete pavement, permit water to enter the pavement, triggering early deterioration of the overlay, which increases life-cycle costs and reduces the useful life of the pavement [3].

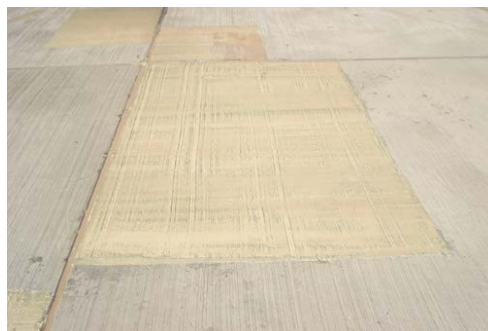
The pavement started showing distress within few years of construction and mainly at the joint area with concrete curling, corner breaking, delamination, sealant damage and spalling at other locations. These distresses were repaired at regular interval with shallow and deep patches as required. **Figures 4-9** show the patches, joint sealant damage and curling of slabs.

**Figure 4.** Conceret patche repaired (large size).

After assessment on site, the following were identified as the main causes of the observed concrete deterioration:

- Improper types and detailing of dowel bars at the joint;
- Accumulation of blowing sand dunes in the joints and preventing their movement;
- Higher temperature range between day and nights.

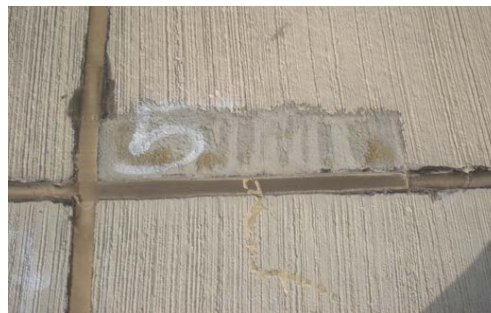
**Figure 5.** Conceret patch repaired (smaller size) with deformed joint sealant.

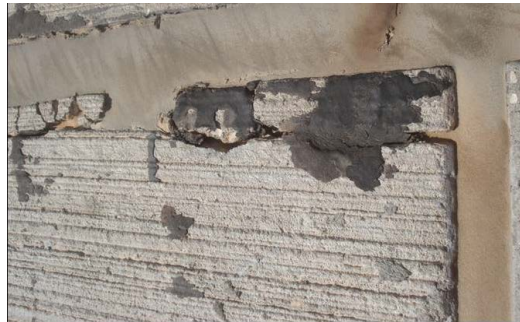
**Figure 6.** Deformed joint sealant crack patching.

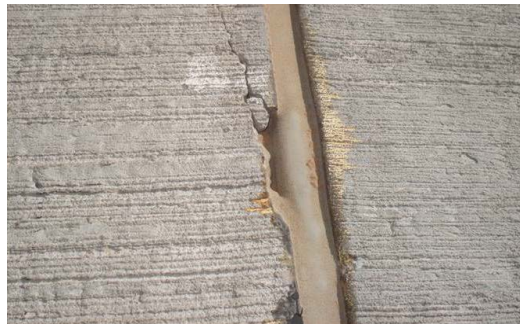
**Figure 7.** Joint and sealant damage.

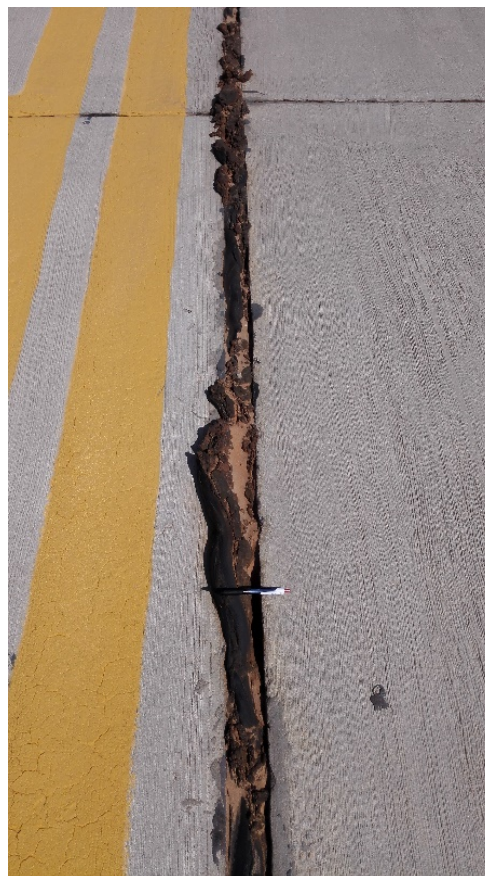
**Figure 8.** Joint sealant damage due to heat.

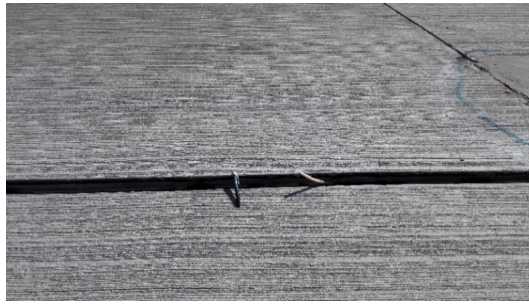
**Figure 9.** Curling of slabs and poor sealant condition.

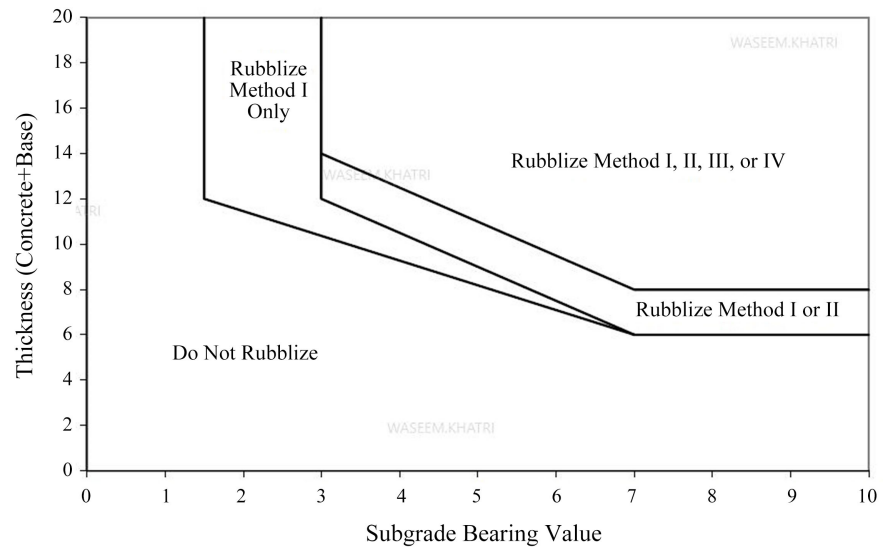
Based on **Figure 10**, the sub-grade values provide the indication to select appropriate technique. For example, a lower CBR subgrade value of three with thicker slab and aggregate base coursed of more than 300 mm (12 inches) can be rubblized.

**Figure 10.** Illinois DOT rubblization type selection guide [8].

With reference to above **Figure 10**, a quick check was carried out to assess if the pavement can be rubblized.

CBR values were determined using DCP (Dynamic Cone Penetration) tests as per ASTM 6951. The value of the subgrade CBR was more than 90% and also the thickness of the concrete slab including the aggregate base course came to 530 mm (21 inches), which allows pavement to be rubblized.

3) Rubblization of existing concrete pavement needs initial assessment to ensure that the pavement can be rubblized as per **Figure 10**.

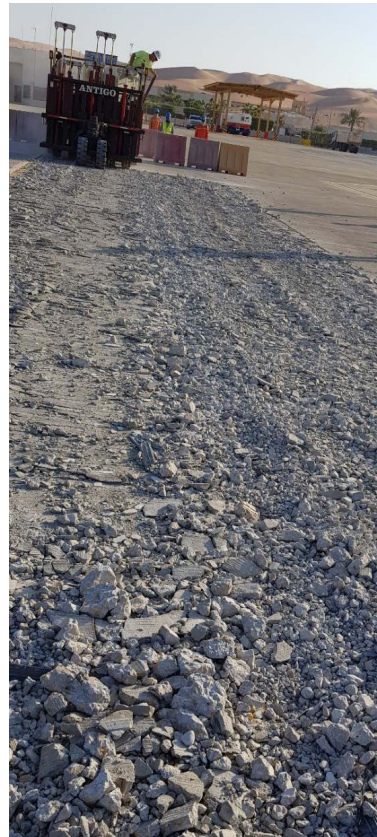
Before the rubblization process started, a designated test section of approximately 50 meters long by 3.6 meters wide was selected within the runway pavement. The contractor rubblize the test section using varying degrees of energy and/or various striking heights until a procedure was established that will rubblize the pavement to the required extent as contained in project specifications. The rubblized layer was visually assessed for the size of rubblized particles. After the rubblization, a test pit of 1.2 meters square was dug to determine that the breaker is producing pieces of the specified sizes as contained in the specifications. The rubblized particle sizes were checked throughout the entire depth of the pavement. The test pit material was removed from the test strip and the hole filled using aggregate base coarse material. The replacement material was placed in layers and was properly compacted.

**Figure 13.** Test Strip.

Following **Figures 13-15** below shows the test strip and the test pits pictures excavated.

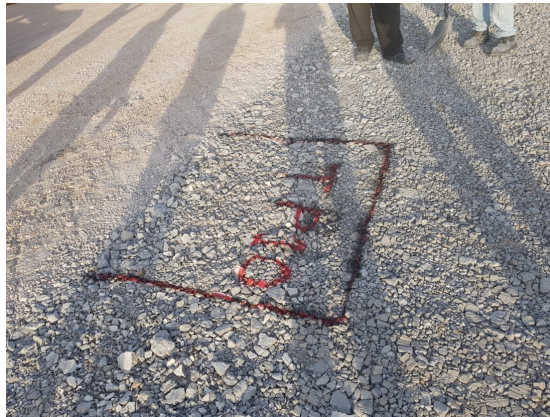
**Figure 14.** Test pit.

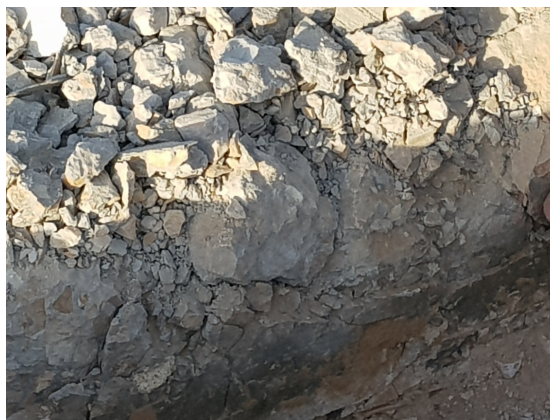
**Figure 15.** Excavated test pit showing fractured concrete.

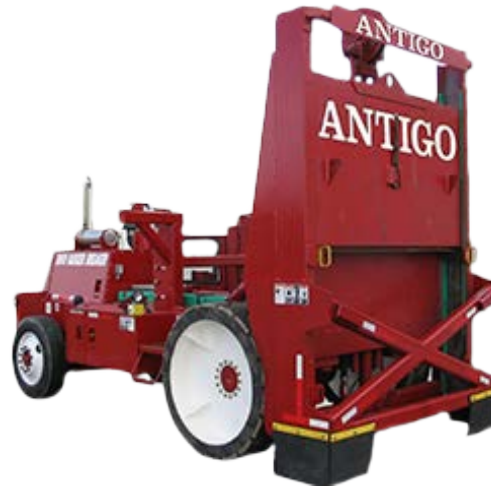
For the pavement rehabilitation, guillotine and MHB (multi-head breakers) equipment were used. Guillotine breaker and multi-head breakers are shown in **Figure 16** and **Figure 17**. The pavement was first applied with guillotine style breaker (approximately a 7-ton load) to induce full depth fractures to prepare for further fracturing using multi-head breakers (MHB). The spacing of hammer strike using guillotine breaker was approximately 500 mm and the height of drop was 1000 mm [14].

**Figure 16.** Guillotine Breaker (Antigo Construction) [14].

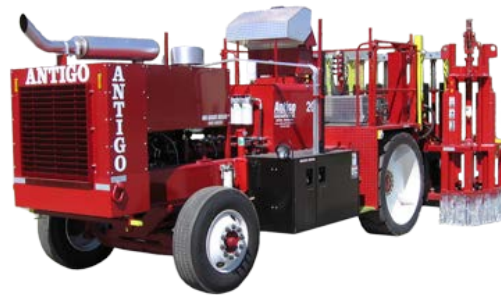
After application of the guillotine breaker, MHB was applied with a spacing of 0.5 to 1 m and 1000 mm to 1300 mm hammer drop height. These hammers are arranged in such a manner that their function is synced with each other.

**Figure 17.** Multihued breakers antigo construction [15].

The MHB is a rubber-tired, self-propelled unit that carries hammers mounted laterally in pairs with half the hammers in a forward row and the remainder diagonally offset in a rear row. There is continuous breakage from side to side. Each pair of hammers is attached to a hydraulic lift cylinder that operates as an independent unit, develops varying energy depending upon drop height selected, and cycles at a rate of 30 to 35 impacts per minute. The 2.44 m wide machine carries 12 hammers 200 mm in width. A wing, carrying two hammers are 300 to 381 mm in width, can be added to each side for a total effective breaking width of up to 3.95 m. The breaking energy is applied to the pavement via 38-mm wide steel strike bars welded to the bottom of the hammers. Breaking widths can be as narrow as 0.91 m or increased in increments to as wide as 3.95 m. The breaker was equipped with a screen to protect vehicles from flying debris during the fracturing process [15].

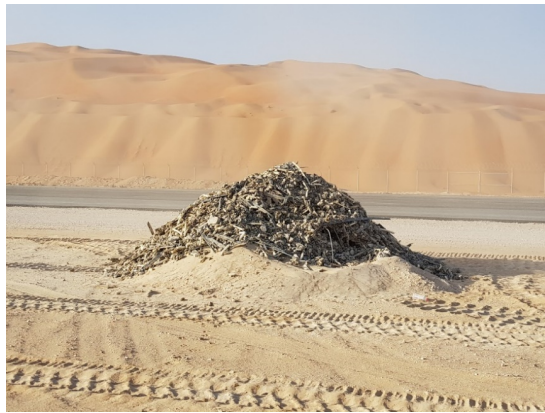
There were substantial amount of old concrete joint sealant rubber and joint dowels, reinforcement mesh, which needed to be cut and removed by hand after the rubblization as shown in **Figure 18** and **Figure 19**. This was a labor-intensive exercise and took some time to fully clear out to ensure proper compaction is achieved and all the foreign materials is removed from the rubblized pavement before the compaction started.

**Figure 18.** Heap of sealant.

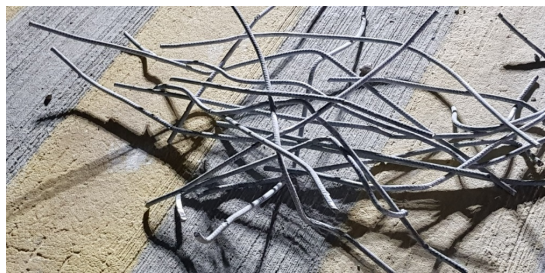
**Figure 19.** Reinforcement bars removed from pavement.

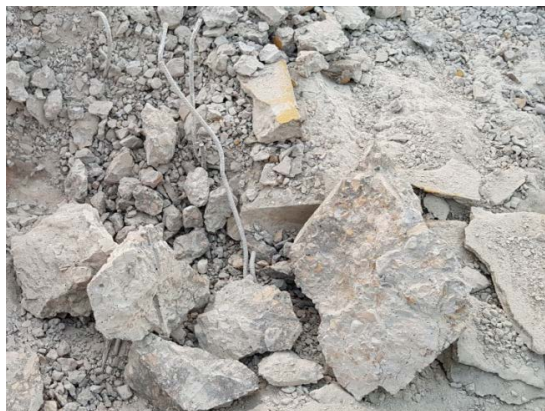
A rubblized pavement is shown in **Figure 20**. Once the rubblization is completed the surface is rolled using “Z” grid rollers with a minimum of two passes to compact the surface as shown in **Figure 21** below. After this, a further pneumatic roller is applied with a minimum of one pass to ensure the seating of all the rubblized aggregates.

**Figure 20.** Rubblized concrete.

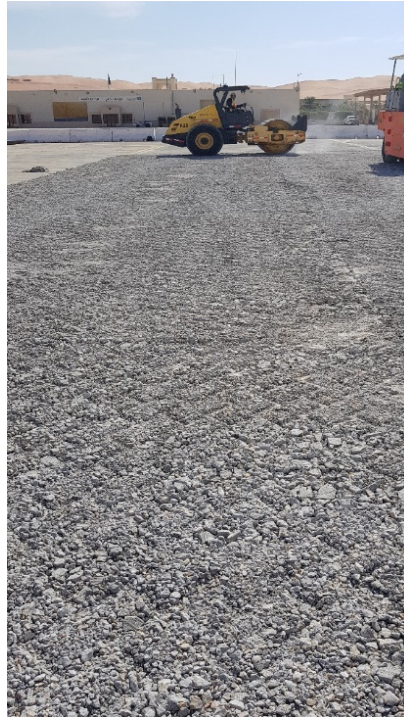
Finally, a vibratory steel drum roller applied with a minimum of one pass before construction of bituminous layer. Once the rolling was completed the asphalt concrete construction was followed as normal. A prime coat was not applied due to fact that there were not sufficient amounts of fines on the surface to hold the surface together.

**Figure 21.** Roller compacted rubblized pavement.

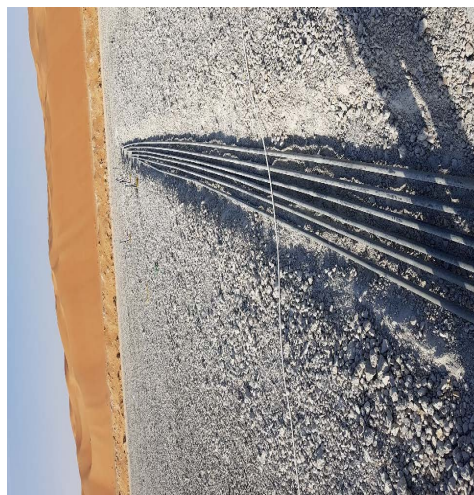
The FAA allows that the conduits can be placed in the asphalt layers. But this approach could have resulted in delays to projects in cutting asphalt concrete layer for the conduit slots which were as wide as 1500 mm at some locations and 500 mm wide at the majority of the locations. Also cutting asphalt concrete creates issues with joints running in the center of the Keel area that will impact the strength of asphalt concrete in the longer run. To address this, it was decided to lay the conduits in the rubblized layer by cutting and making a slot of 100 mm deep as shown in **Figure 22** below. The conduits were inserted in this 100 mm deep section and filled with asphalt concrete around it and compacted. This also ensured materials compatibility with receiving layer was asphalt concrete instead of using originally proposed controlled low strength material (CLSM). This method of construction can be added in the FAA to speed up the construction process and allow installation of conduits within the rubblized layer.

**Figure 22.** Conduit laid in excavated rubblized concrete.
