Classification of the Juturnaíba Dam: Potential Risk and Damage

Monica de Aquino Galeano da Hora Rocha, Manoel Isidro de Miranda Neto

Master's Program in Civil Defense and Security, Fluminense Federal University, Niteroi, Rio de Janeiro, Brazil

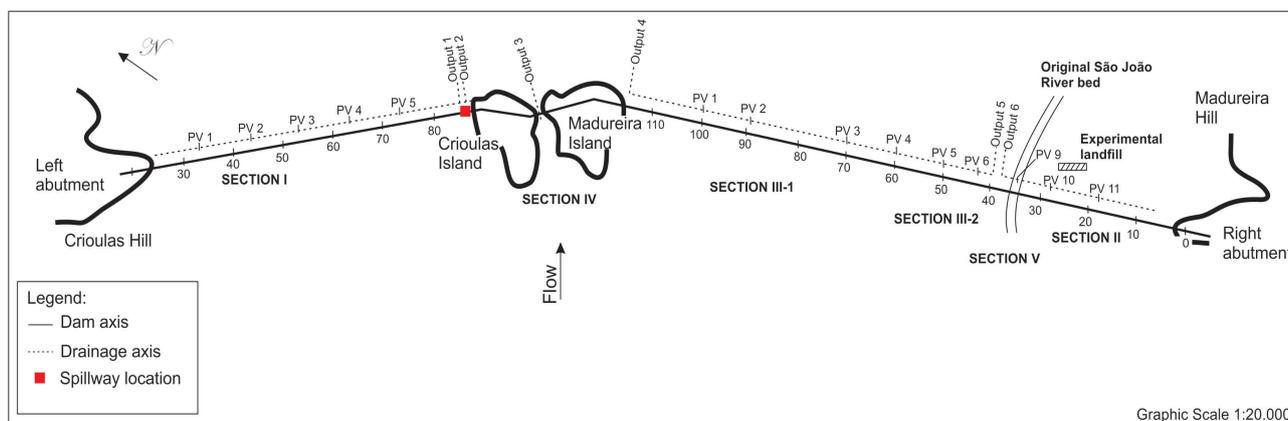
Figure 2. Axis of the Juturnaíba Dam, showing the location of the piles on the São João river bed, including inspection wells and outputs of the well drains (Adapted from [20]).

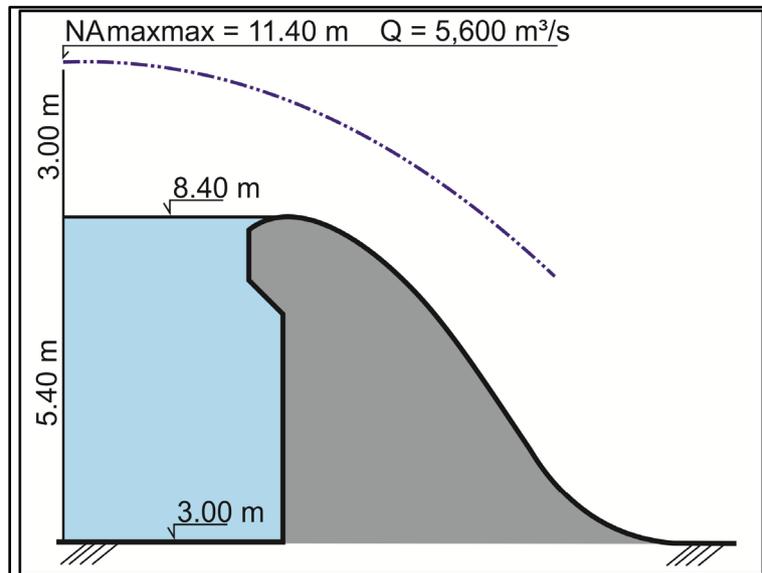
With regard to the design and construction of the Juturnaíba spillway, no documents related to the calculation worksheets of the design flow sizing were found. The only available document found was the drawing titled "Zigzag Spillway Model-Plant-Sections-Details" [21]. In the drawing, detail "1" shows the cross-section of the spillway, in which only the design flow of 5600 m³/s is identified without an associated recurrence interval. Thus, to evaluate the damping of this flood and its lamination through the spillway, [26] estimated the PMF and found the figure of 5587 m³/s, showing that the DNOS design flow is compatible with the 10,000-year flood; thus, the Juturnaíba spillway was dimensioned according to dam safety criteria. **Figure 3** shows a reproduction of detail "1" from the original DNOS plant.

Figure 3. Diagram of the cross-section of the spillway ([26] adapted from [21]).
