Engineering Investigations and Durability Problems of the Construction Materials of the Roman Babylon of Egypt

How to cite this paper: Hemeda, S., Akarish, A.I.M. and El-Nagga, A.A. (2018) Engineering Investigations and Durability Problems of the Construction Materials of the Roman Babylon of Egypt. *Open Journal of Geology*, 8, 404-436.

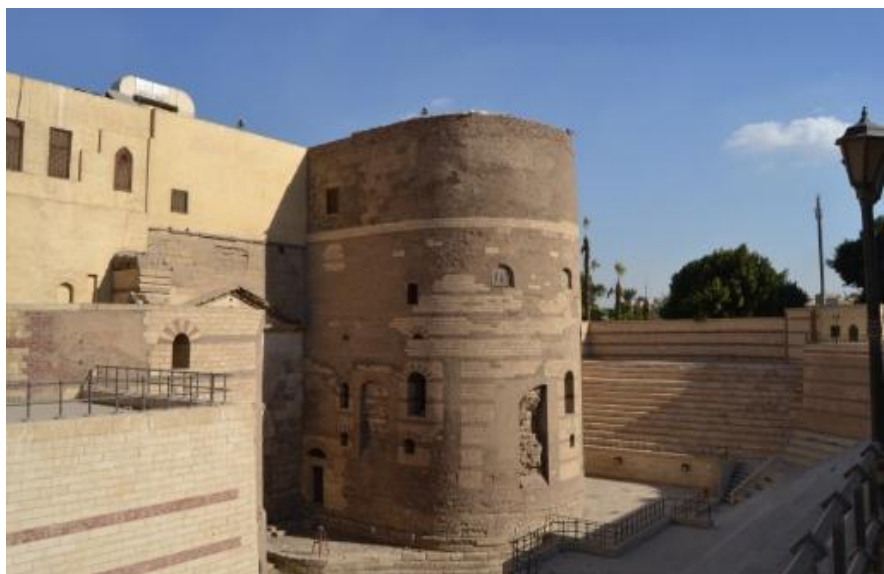
2) The second tower: It is lower than the first one (height is about 11 m, **Figure 4(a)**). The essential element is the wage bricks with some regular rows of limestone in different parts. The bottom part was built of old limestone, in which some parts are ruined and are replaced by new limestone in the frame of the contract 102. It has three big and six small holes with arches. Also, has three solid entries having different sizes of ruined limestone courses with regular wage bricks lines, **Figure 3** and **Figure 4**.

Figure 3. A roman towers underneath of the hanging church.

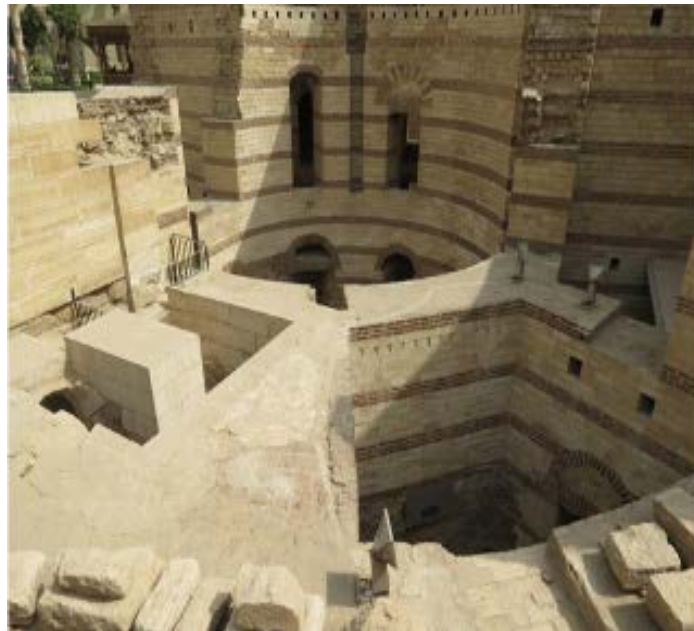
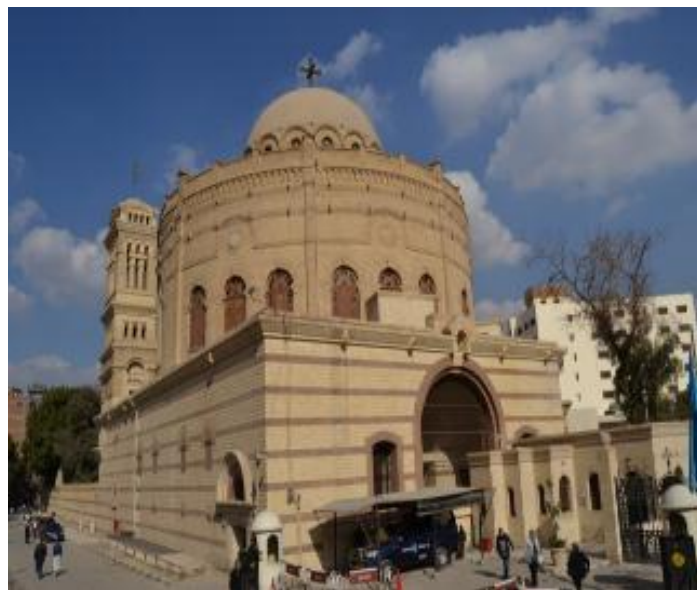
Figure 5. (a) round south tower of the Babylon of Egypt (b) Saint George Church built on the roman tower (Greek tower).

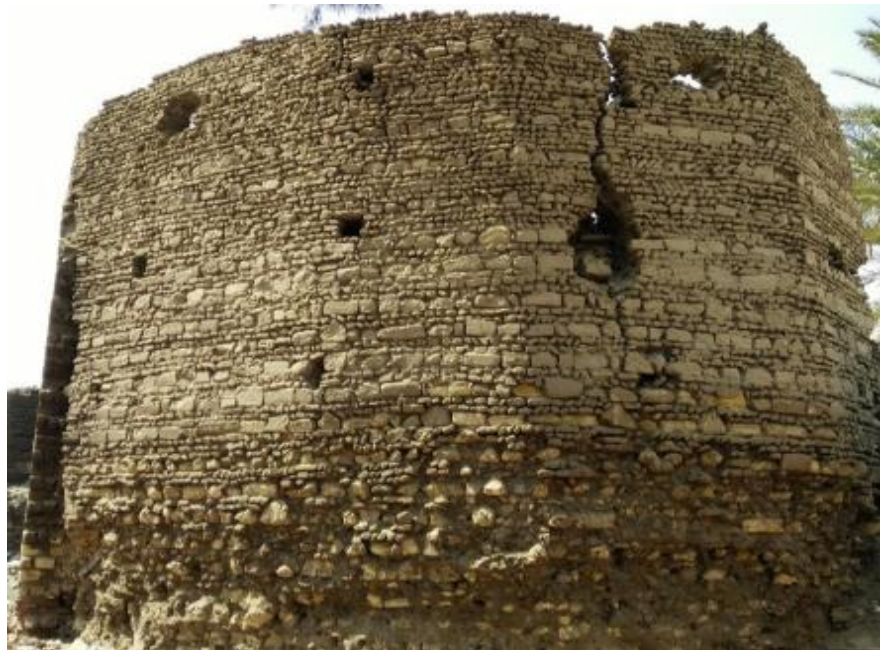
It is located next to the tombs and separated into two parts, vertical and rounded parts. 1) The vertical part contains two divisions. The first division, which though to be new, is formed of five sections of limestone, each one is (five) rows, in addition to (five) lines of wage bricks, each one consists of (3) lines, while, the second division contains two levels. The lower level has 9.95 m width and its right side rises 8.14 m, where the left is 5.74 m. It is formed of irregular ruined limestone and wage brick. The upper level formed of twelve rows of limestone and twelve rows of wage brick. All are joined by lime mortar which is a common way in that period. A group of irregular ruined limestone found at the top of this level is covered by soot that might be resulted due to burning rubbish next to it. 2) The round part is of about 1.10 m high and its bottom consists of ruined wage bricks and limestone joined by lime mortar pervaded with good limestone. The upper part is about 5.70 m height and its width is about 12.40 m, **Figure 8** and **Figure 9**. It formed of fourteen rows of limestone and fourteen rows of wage brick; some of it consists of two, three or five courses lines with mortar to attach them. There's a big break in the upper part and seven missed parts (**Figure 7** and **Figure 8**).

Figure 7. South east tower of the Babylon of Egypt.

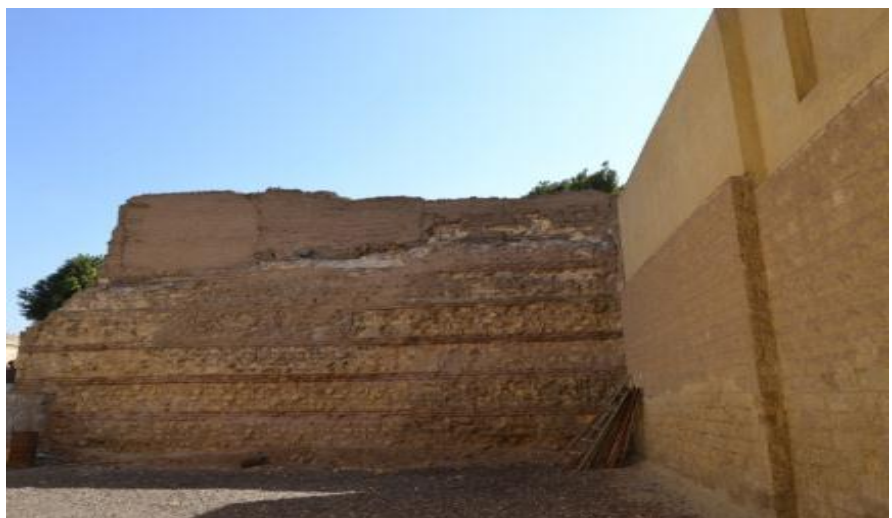
Behind the application wall: This wall has ancient and new parts. The ancient one has (six) sections of limestone, each section consists of (five) rows and (five) sections of wage bricks, every section has (3) lines attached with lime mortar to connect the lines together. Its width is about 16.85 m and height about 6.53 m. Also has irregular dimension with a crack in the (3) first sections across the wage bricks and limestone and a wooden strain in the third section. The new part is formed of some lines of wage bricks and having height about 1.86 m and width about 14.50 m. this part isn't irregular with 3 vertical separated with a wooden strain (**Figure 10**).

The Roman Babylon suffered from sustained serious damages on the surface of the stone walls at their lower levels due to the long term flooding. Fully penetrating cracks at the walls may result mainly because of the old settlements and partially due to the dewatering while corner of stones had been removed at

Figure 10. The North western wall of the fortress of Babylon.

specific locations. The cracks at the towers and walls were stable after the dewatering as was evident from the glass markers installed. One very significant source of surface disfiguring might result from the fesses of bats that inhabited the tower in thousands.

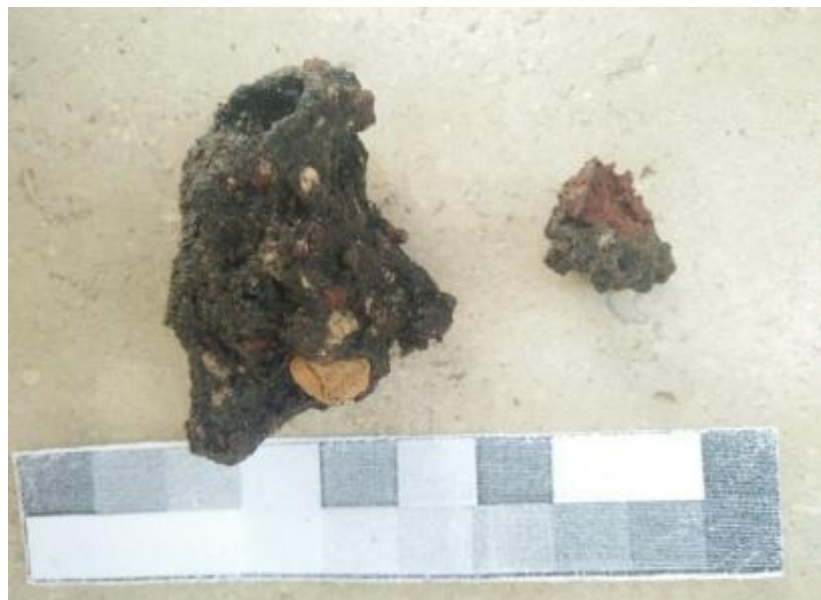
Etching a hand specimen mortar sample with dilute HCl (10%), it was clear to recognize the main materials used in the mortar, **Figure 33**. Such include small flakes and aggregates of limestone red brick as well as sand grains and lime, which corroborate the petrographic investigations.

Figure 33. Mortar sample after etching by dilute HCL, Note that: limestone, brick and furnace slag fractions are detected.

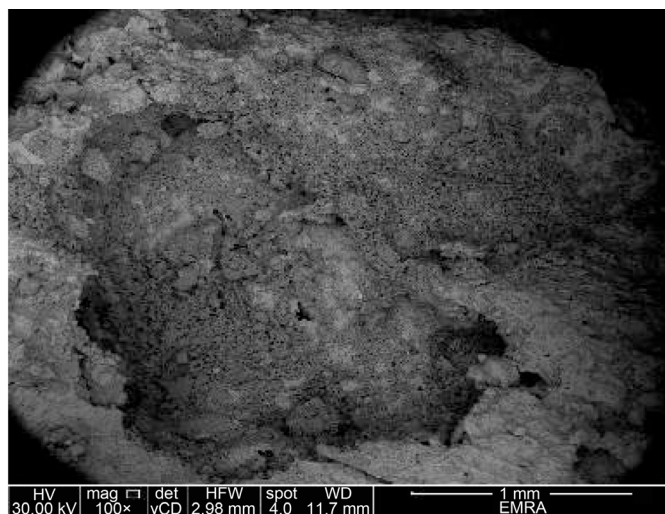
The morphological description by SEM showed that, the grains of Quartz, Lime and Gypsum pellets within the mortars. This corresponds to the results of XRD, as shown in **Figure 38**. The examination indicated the presence of alumina, silica, breaking of bricks and lime aggregates inside the mortar blocks. This indicates that this mortar is hydraulic lime based mortar and this corresponds to the results of the XRD. The SEM observations indicated that there is relatively leaching of calcium from the binder due to the physiochemical actions (e.g. the ground water table and acid rains) which decreased the alkalinity and strength and increased the sorptivity of this lime mortar. The lime binder becomes less hydraulic but having the highest leaching resistance, some observations indicated the presence the intensive presence of Halite inside the mortar composition. Also the presence of Carbon and residues of organic matter inside the mortar composition was obvious (**Figures 36-44**).

Figure 38. SEM image showing the brick aggregate fractures inside the mortar sample.

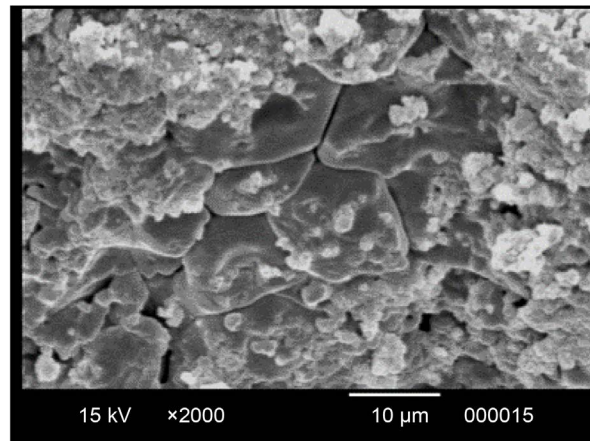
Figure 43. SEM image showing Quartz, Calcite and Halite Crystals in the mortar sample.
