Reconstruction and Restoration of Main Facade and Wooden Ceilings of Hasan Basha Tahir Kuttab & Sabil, Cairo—Egypt

Mahran F. Anwar

How to cite this paper: Anwar, M.F. (2019) Reconstruction and Restoration of Main Facade and Wooden Ceilings of Hasan Basha Tahir Kuttab & Sabil, Cairo—Egypt. *World Journal of Engineering and Technology*, 7, 175-192.

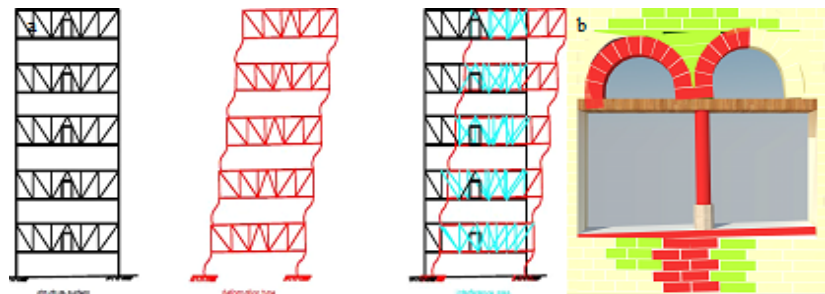
Figure 5. The bearing walls under the influence of the wheel of vibration and horizontal pressures due to earthquakes.

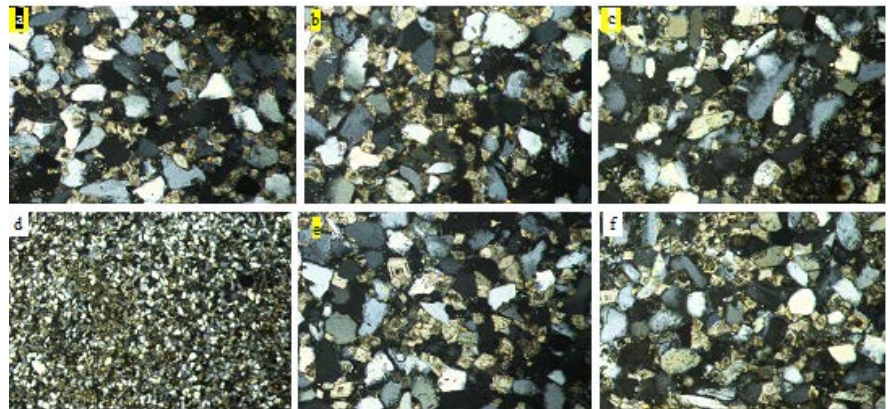
Examination of thin sections of the limestone samples under polarized light microscope (**Figure 10**) displayed fine-grained calcite crystals, on top of iron oxides, clay minerals and numerous grains of quartz that were also found occurring as sub rounded to angular.

Figure 10. The examination of the limestone samples under polarized microscope, (a), (b) Fine grained calcite (micrite), (c) iron oxides, (d) numerous grains of quartz, (e) (f) fossils fragments.

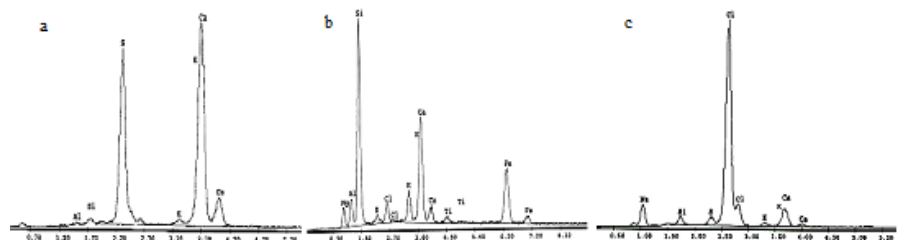
EDX analysis of altered limestone (**Figure 13(a)**) commonly consisted of Ca, S, Si, K, Al and Fe. Considering the above results, it can be claimed that, the limestone in façade consists of calcite (Ca CO_3), quartz (SiO_2), clay minerals and iron oxide. The analysis also revealed a high concentration of sulfate S which may be attributed to the crystallization of gypsum salts on the wall. EDX microanalysis of the mortar samples (**Figure 13(b)**) showed that Ca, Si and Fe are the major ions contained, while Mg, S, Cl and K are secondary elements. Considering this result, it can be claimed that mortar between the blocks in the façade is lime mortar, which consists of calcite (lime) quartz (sand). EDX analysis of salt samples (**Figure 13(c)**) indicated that high concentration of chlorine (Cl) which attributed to the crystallization of halite salt.

Figure 13. EDX Pattern of limestone, mortar and salt samples from Hassan Taher Mosque.

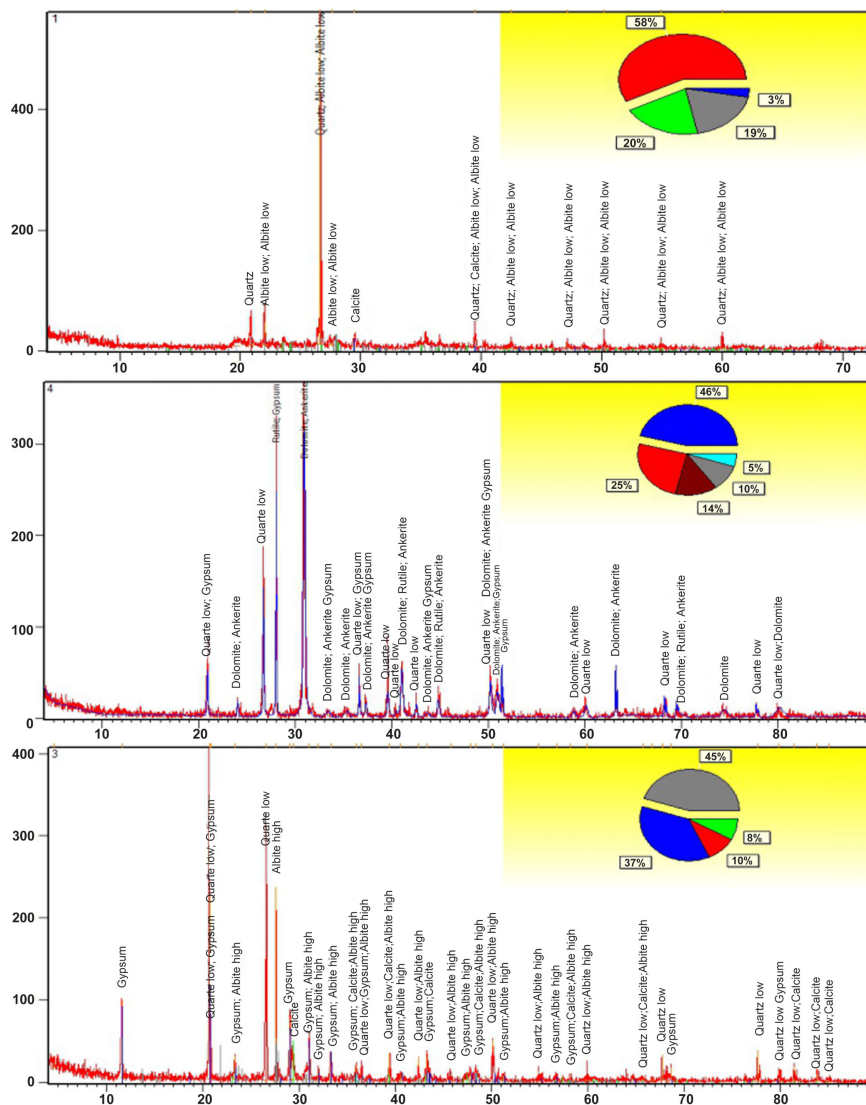
XRD patterns of the limestone samples are given in (**Figure 14**), show that the sample consists essentially of calcite CaCO_3 , Quartz SiO_2 , Albite $\text{NaAlSi}_3\text{O}_8$ and traces of iron oxide.

Figure 14. Patterns of XRD analysis of limestone samples, (a) foundation underground, (b) hard crust layer on stone surface, (c) internal filler point.

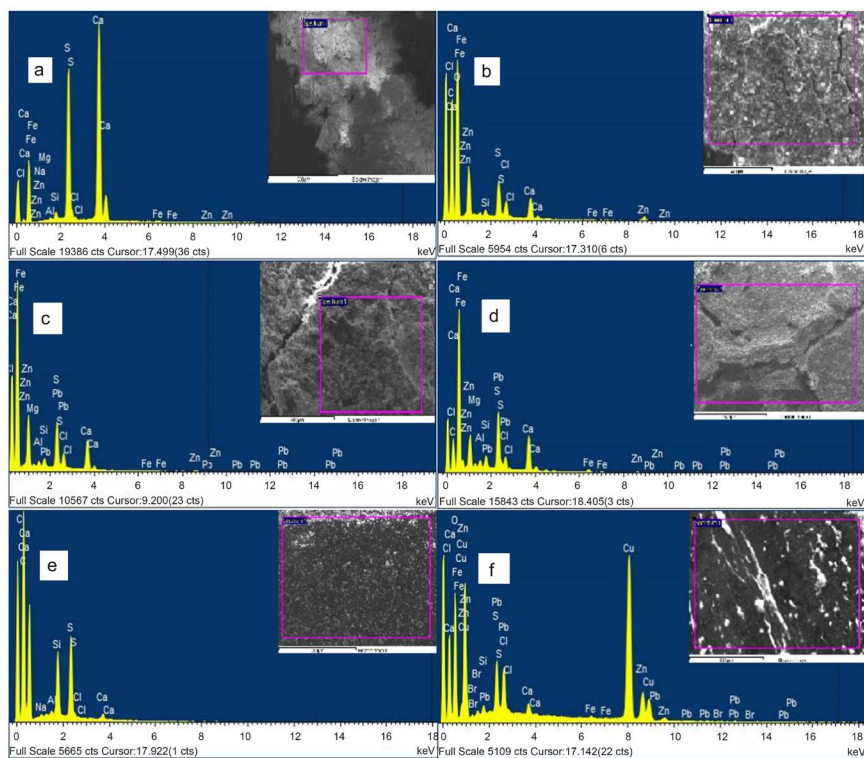
The elemental composition analysis carried by EDS of ground layer (Figure 16(a)), revealed that they were consisted of high amounts of calcium (Ca), Sulphur (S) and iron (Fe) with low amounts of zinc (Zn), magnesium (Mg), chlorine (Cl) and Sodium (Na). Considering this result, it can be claimed that, the ground layer consisting of mixture of lime, gypsum and low amount of zinc. The presence of Mg attributed to dolomitic limestone used in lime, chlorine attributed to crystallization of halite.

Figure 16. EDX patterns of paint layer; (a) Ground layer, (b) red paint, (c) brown paint, (d) yellow paint, (e) black paint, (f) gilded layer.

Red pigment: The elemental composition analysis of the red sample (**Figure 16(b)**) indicates that, it is mainly composed of calcium (Ca), iron (Fe), zinc (Zn), Sulphur (S) and chlorine (Cl). These results suggesting that, this colored paint could be prepared by iron oxide.

Brown pigment: The elemental composition analysis of the red painting surfaces (**Figure 16(c)**) indicate that it is mainly composed of iron (Fe), calcium (Ca), Sulphur (S), zinc (Zn) and lead (Pb). According these results, the brown paint was prepared by mixture of iron oxide and red lead (minium, Pb_3O_4).

Yellow pigment: The elemental composition analysis of the yellow paint (**Figure 16(d)**) indicate that it is mainly composed of iron (Fe), calcium, (Ca), Sulphur (S), zinc (Zn), lead (Pb), magnesium (Mg) and chlorine (Cl) According these results, the yellow paint prepared by mixture of iron oxide.

Black pigment: The elemental composition analysis of the black paint (**Figure 16(e)**) indicate that it is mainly composed of, calcium, (Ca), carbon (C) sulphur (S). According these results, the yellow paint is carbon.

Gilded layer: Examination of the gilded layer in the ceiling (**Figure 16(f)**) indicate that it is mainly composed of Cupper (Cu), Zink (Zn), calcium (Ca), Sulphur (S). According to these results the gilded layers showed high percentage of copper and zinc indicating that the gilded layer may be brass, Cu-Zn alloy.

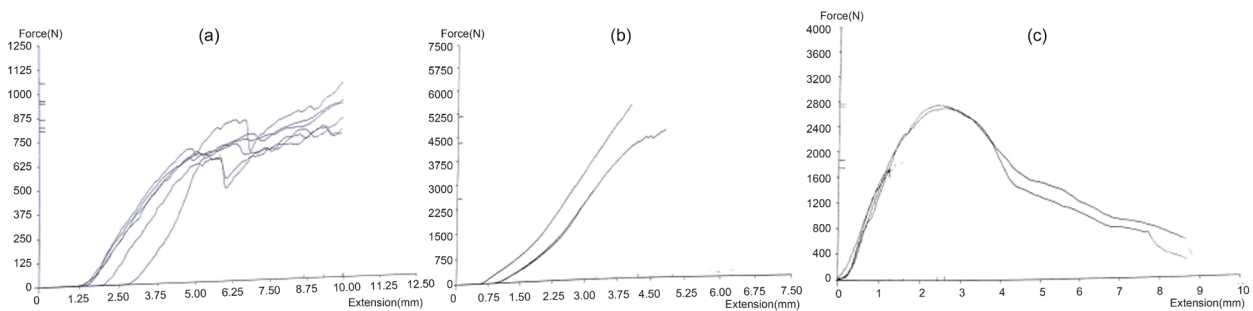
This part is aimed to outline and discuss the measured mechanical properties of the wood samples the wood ceiling. Compressive strength (**Figure 18(a)**), tensile strength (**Figure 18(b)**) and shear strength (**Figure 18(c)**) are presented in **Table 2**.

**Figure 18.** Mechanical testing of wood sample.
