Mosul Dam Problem and Stability

How to cite this paper: Al-Ansari, N., Adamo, N., Al-Hamdani, M.R., Sahar, K. and Al-Naemi, R.E.A. (2021) Mosul Dam Problem and Stability. *Engineering*, 13, 105-124. <https://doi.org/10.4236/eng.2021.133009>

Mosul Dam is located on the River Tigris about 60 km northwest Mosul in Iraq. It is the biggest dam where its storage capacity reaches 11.11 billion cubic meters at normal operational level (330 m. above sea level). The dam was constructed on alternating beds of karstified limestone, gypsum and marl. This dam suffered from water seepage under its foundation since its operation in 1986. Grouting operations were implemented since that time to overcome this problem. This seepage is believed to be due to dissolution of gypsum beds under the foundation, which was not carefully considered by the designers. It was recommended by the international board of experts that the water level should be kept at or below 319 m.a.s.l. to minimize damages in case of the failure of the dam. ISIS occupied the dam site on 8 August 2014 and it was seized back from the hands of ISIS on the 16th of the same month. They did plenty of damage despite the short period they

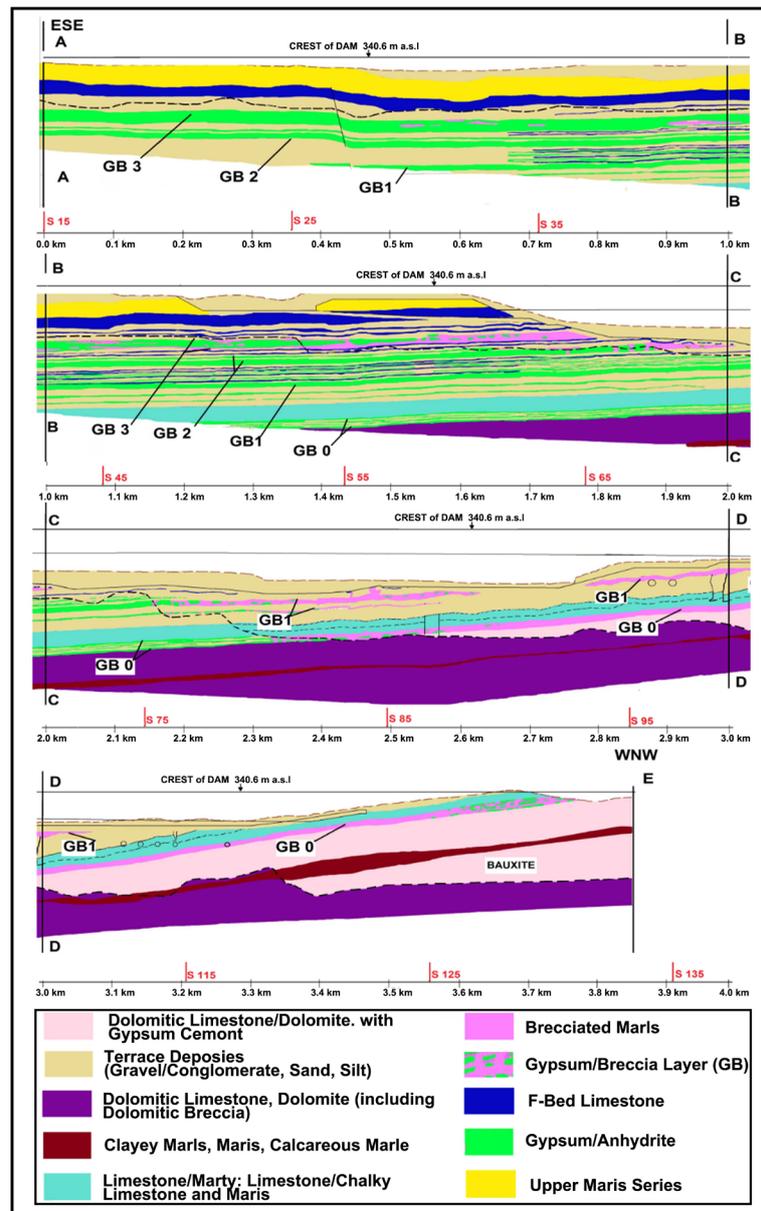
The nature of the rocks (e.g. limestone and gypsum) within the abutments and foundations Mosul Dam site (Figure 7) have high dissolution ability, which are

Figure 7. Geologic cross sections along the axis of the dam ([47]).

highly karstified [47] (Al-Ansari *et al.*, 2015). Most of the karst forms are sinkholes that were developed in gypsum and/or limestone [56]-[67] (Figures 8-10). The karst extends to a depth of about 100 m below the dam foundation (Figure 8).

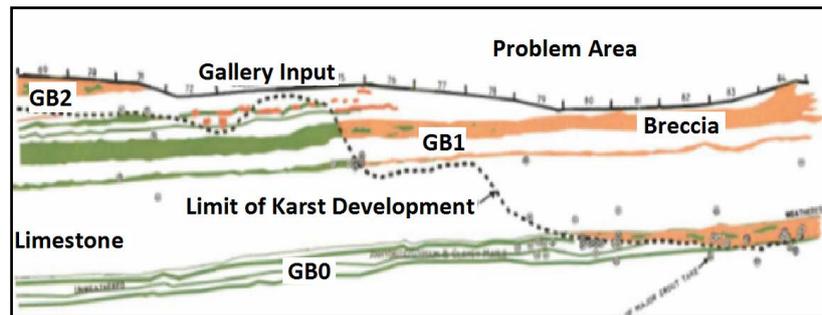
Figure 8. Location of the Karst line ([55]).

and jointing. In addition, deep curtain grouting was performed to stop the seepage in the foundations under the dam, also to reduce the permeability of the grouted zone (see **Figure 8**). Lugeon tests were used to make sure that grouting operations fulfilled the engineering requirements. The aim was to close all the openings within the rocks under the foundation of the dam. Due to the dissolution of gypsum, there were openings created within the deep curtain. To close these openings, massive grouting operations were performed. Despite all the maintenance program, which was carried out seepage of water under the foundation, did not stop and in fact the situation was worsening.

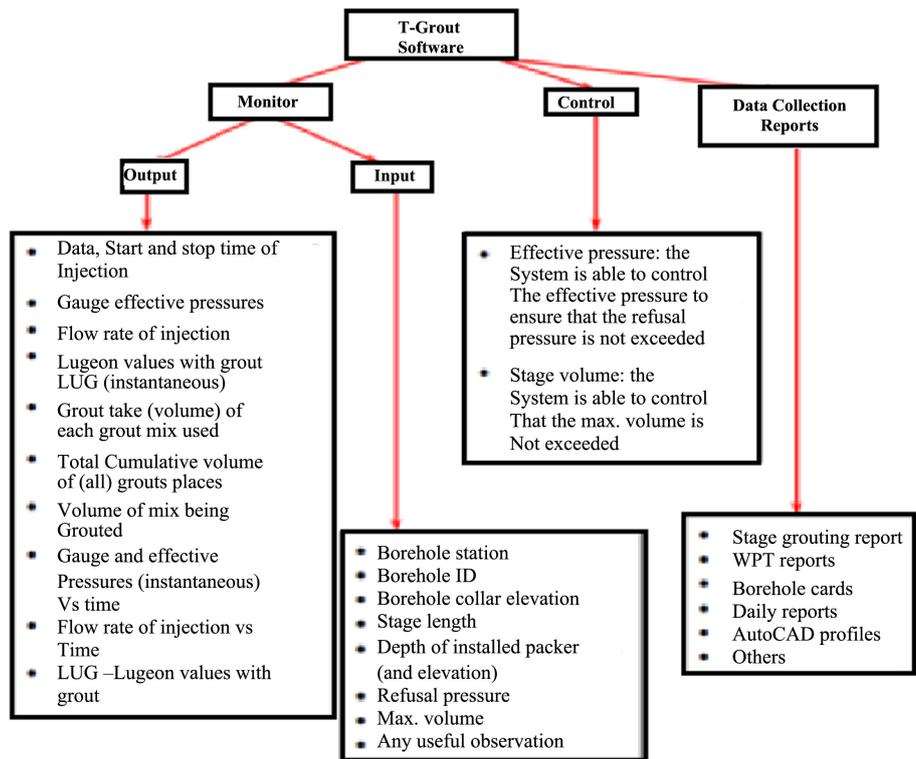
Figure 15. Grouting system used at Mosul Dam site.

Grouting operations now follow very highly upgraded system (Figure 15). Furthermore, advanced stations and equipment for preparing and pumping grout mix are used now. All the operation is computerized. All electrical cables (98 km long) were replaced in grouting galleries. Pipes that are used for pumping grout mix (15 km long with 1.5-inch diameter) and water pipes (5.7 km long and 6 inches diameter) were all replaced (Figure 16).

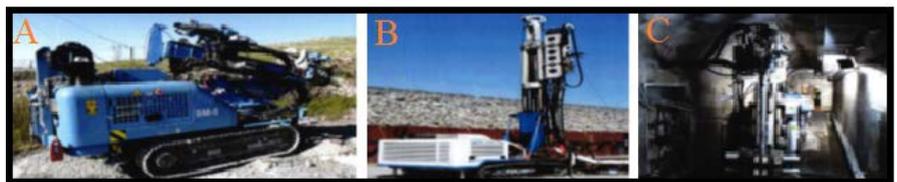
Figure 17. Drilling machines used at Mosul Dam, (A) Small Diesel machine (B) large machine (C) Small machine for tight areas.

New 18 drilling machine are used now where 11 of them are electric machines and the remainder are diesel-operating machines (Figure 17). All drilling machines are equipped with advanced technologies to register drilling speed, rotations per minute and liquid pressure. This gives accurate information about the beds and all data are displayed on the computer. Three preparation and grout pumping stations were installed that covers all the required areas (Figure 18) and there are 32 secondary grout-pumping stations (Figure 19). It should be mentioned however, that the grout mix is prepared using special computer program to ensure good required specifications (Figure 20). The overall grouting operation is controlled from the control room (Figure 21). From this room all grouting operations are monitored and can be controlled. In addition, all the

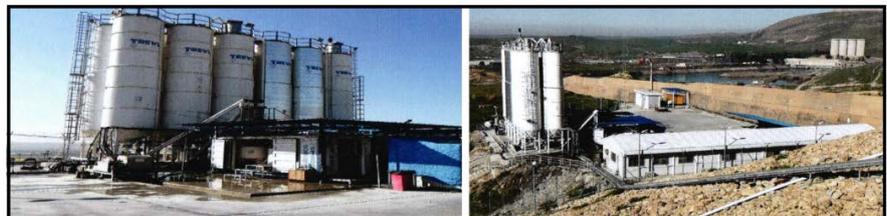
Figure 18. Grout mixing and pumping stations.

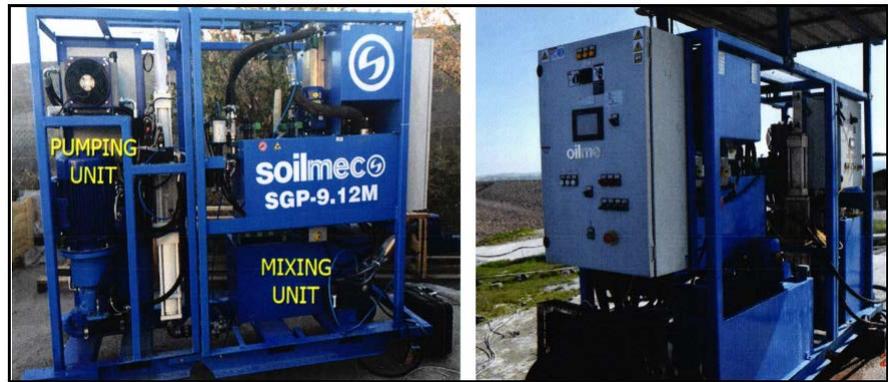
Figure 19. Secondary Grout mixing and pumping stations.

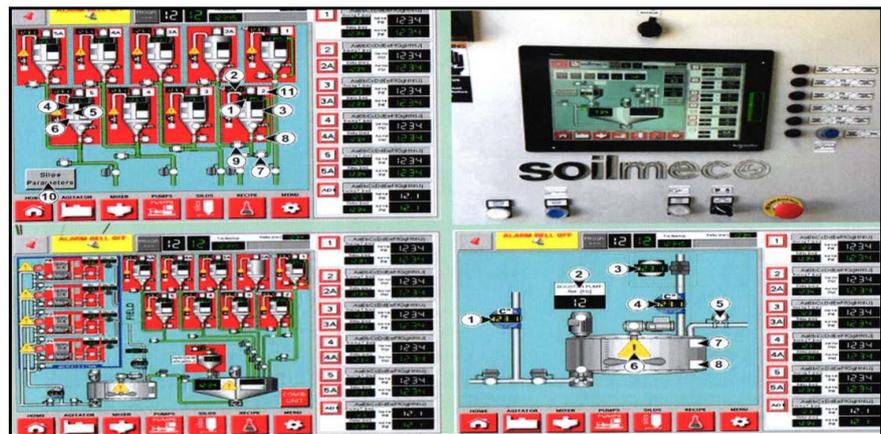
Figure 20. The grout mix is prepared using special computer program to ensure good specifications required.

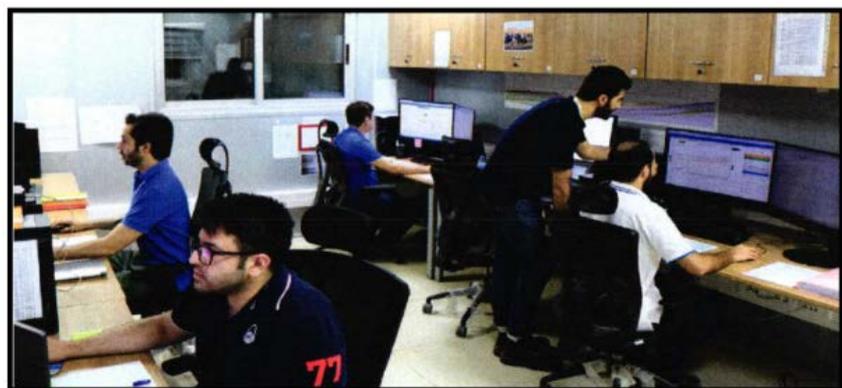
Figure 21. Control room for Grout operations.
