Dye Test within Mosul Dam Area

Mohammed Sami Safi¹, Nadhir Al-Ansari²

Abstract

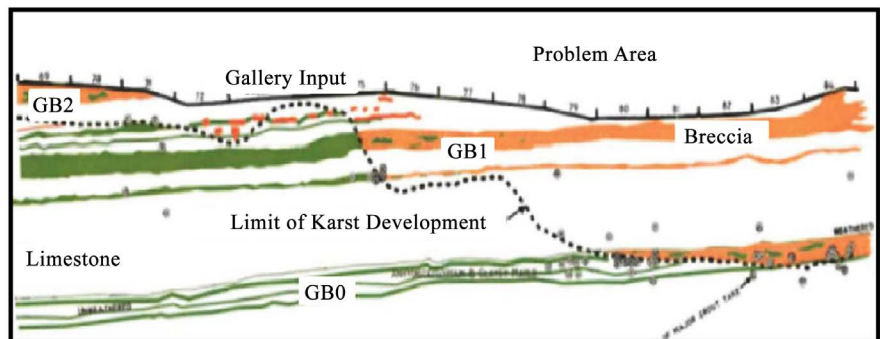
Figure 5. Location of the Karst line.

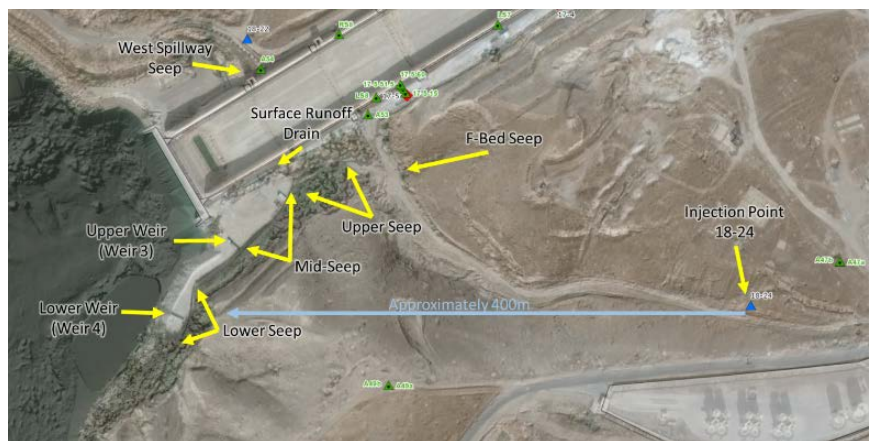
The first dye test at 18 - 24 was conducted on 8 April 2019 in the F-Fed Limestone Aquifer, with the hole open from depth 28.5 m to 38.0 m. The test was designed to see if a groundwater connection could be confirmed from the east hills to the large water seeps that flow near the spillway (**Figure 8**). The F-bed Limestone is highly fractured and is known as a good aquifer. Flows from the F-Bed seeps increase with rises in the reservoir pool level, showing that there is some hydrologic connection from the pool. The dye test from 18 - 24 was designed to show that the directional flow path of the groundwater in the F-Bed might be in an east-to-west direction in addition to a more direct upstream to downstream direction. After preparing two large water tanks with green dye (**Figure 9**), the green water was pumped into the F-Bed at 18 - 24 from 11:07 in

Figure 8. 18 - 24 dye test injection point and observation points.

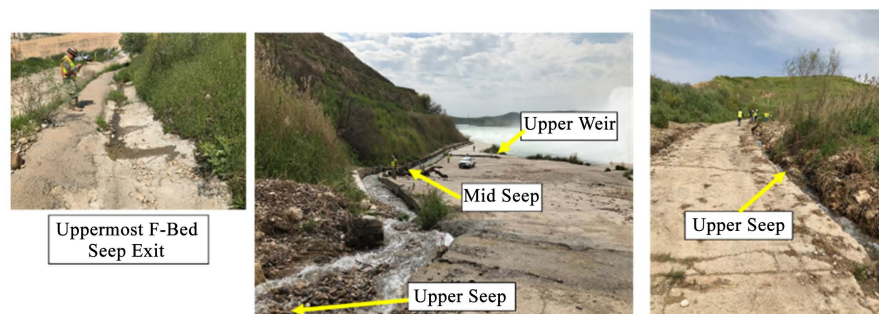
the seeps near the spillway from the time pumping started until about 17:00 in the afternoon, but no dye was visually observed (**Figure 10**).

Figure 10. 18 - 24 dye test observation teams looking for green dye.

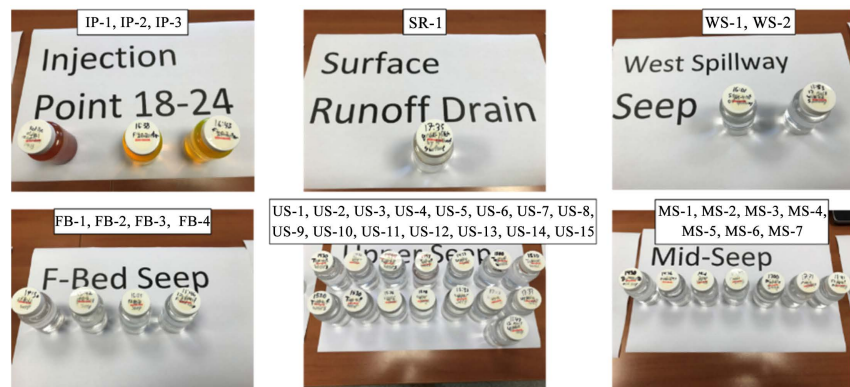
All of the water samples collected were labeled with the location and time of collection, and sent to the water lab to analyze them for the presence of green or red dye (Figure 16). No red dye was detected, but several samples tested positive for the presence of green dye. The machine used to test for the presence of the dye is a 1995 Kontron Instruments SFM 25 Spektrafluorometer (Figure 17). The machine analyzes the wavelength of light passing through the samples with green dye from the injection point, and then compares that wavelength to the collected water samples. The results are shown in Figure 16 and Figure 17 and Table 1.

The results show that both the F-Bed Limestone and Lower Marl Series Aquifers have a component of flow from the east hills to the large seeps near the Spillway. Flowrates through the bedrock were longer than originally estimated, with the dye taking well over a day to cover the 400 m distance from 18 - 24 to the seeps. The F-Bed Aquifer has a smaller and slower flow, and potentially took several days to be detected. However, we cannot be certain about F-Bed flowrates since no water samples were collected during the first days of the dye testing. The Upper Seep that flows towards Weir 3 never had any signs of dye,

Figure 16. 18 - 24 dye test samples sent to the water lab for analysis of dye.

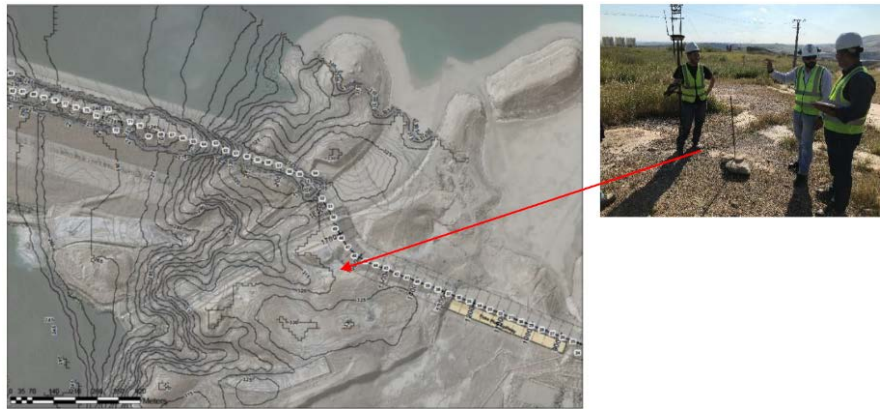
Figure 18. Location of point Pz 19 - 1.

The second dye test at 19 - 1 was conducted on 5 May 2019 in the F-Fed Limestone and Lower Marl Series Aquifer, it's done on 3 steps (stages). With the hole open from depth 40 m to 60.5 m this is stage 1. The test was designed to see if a groundwater connection could be confirmed from, the east hills to the large water seeps that flow near the spillway the area of the saddle dam on the left (east) crest (**Figures 18-20**).

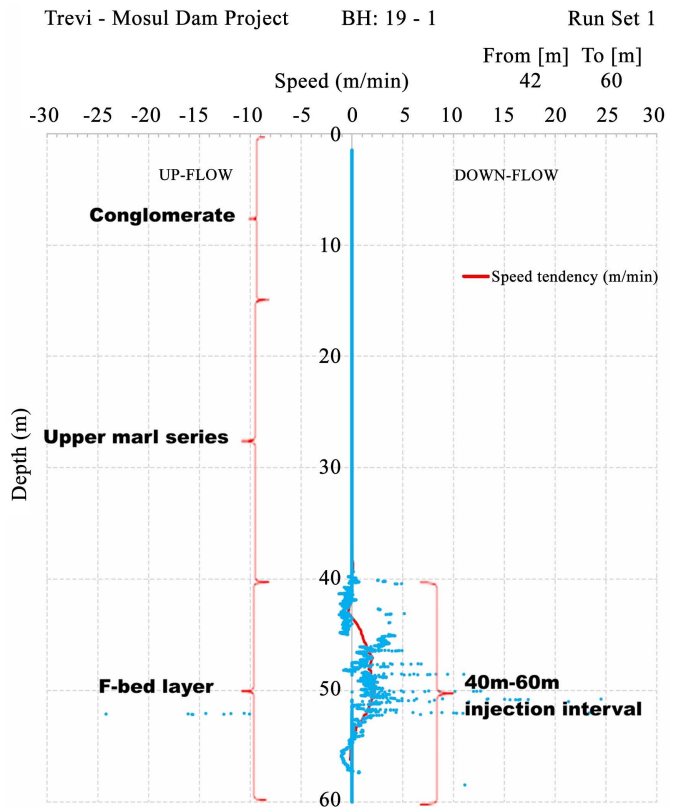
Figure 20. Flow speed of water within the piezometer during stage 1.

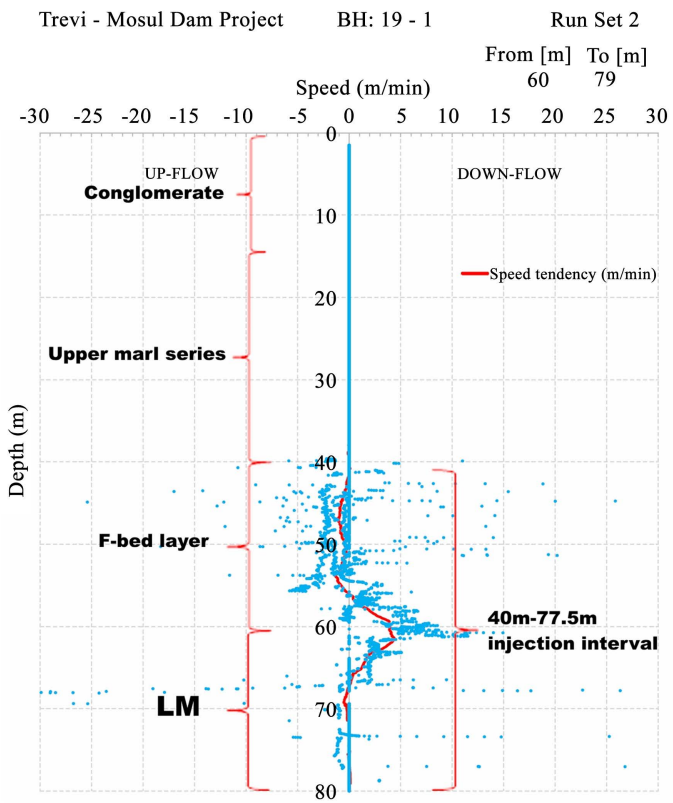
Figure 21. Flow within the lower marl series during stage 2.

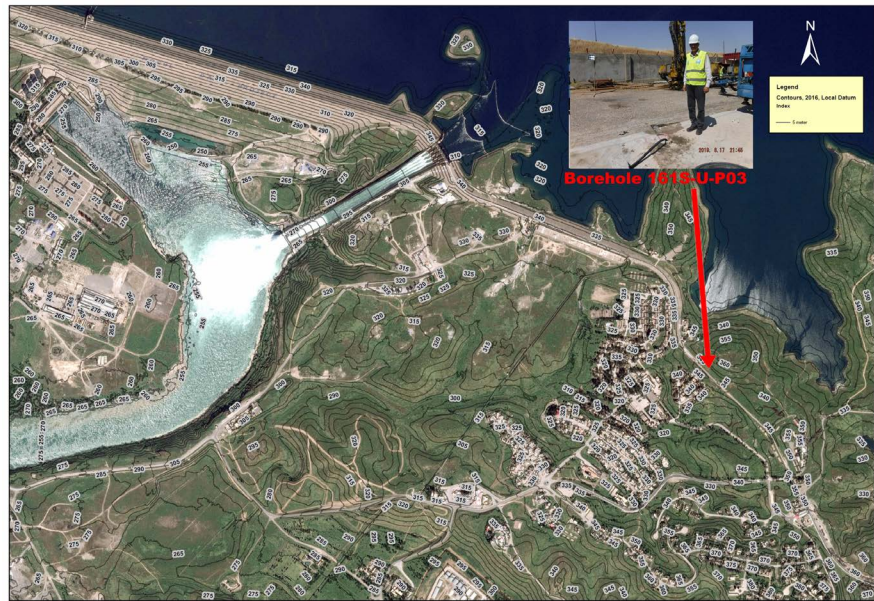
Figure 22. Location of 3.3 Piezometer 161S-U-P03.

The dye test at Borehole 161S-U-P03 was conducted on 18 June 2019 in the F-Fed Limestone Aquifer, with the borehole open from depth 31 m to 40 m. The test was designed to see if the groundwater connection could be confirmed from the east hills of the grout curtain extension to the large water seeps that flow near the spillway, the area of the saddle dam on the left (east) crest. And it's been agreed to do this test after hearing a very high flow of water during the activity of the drilling and grouting in this hole (**Figure 22** and **Figure 23**).

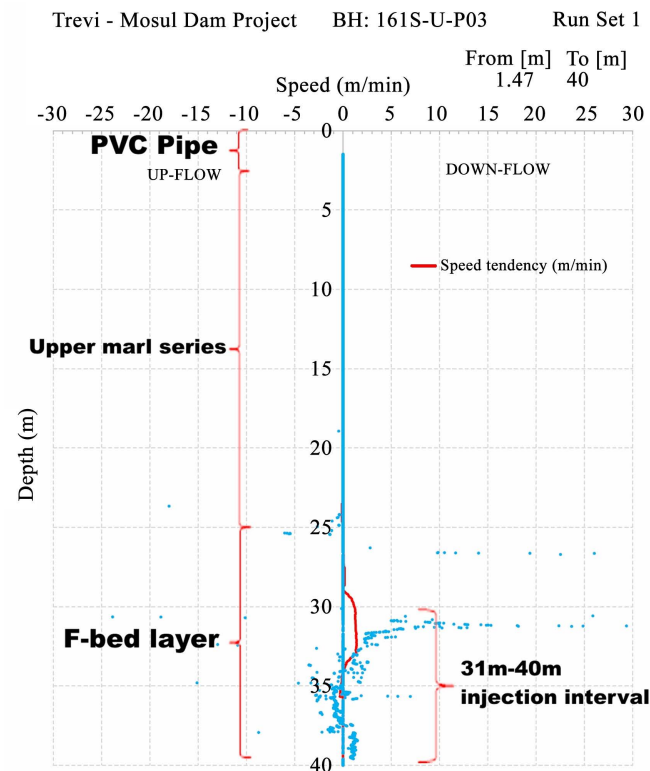
The green water was pumped into the F-Bed at 16S-U-P03 from 9:45 in the morning to 1:00 in the afternoon, for a total pumping time of 3 hours and 15 min. A total of 10,000 liters of dyed water was pumped in the F-Bed Aquifer. And the result is also positive in this test. Figure 24 shows the results of the test in the borehole.

Figure 24. Flow within the lower marl series during stage 2.
