The Effects of Freight Vibrations on Slope Stability along the SH35, Bay of Plenty East, New Zealand

Angelo Indelicato

Stantec UK, Reading, UK

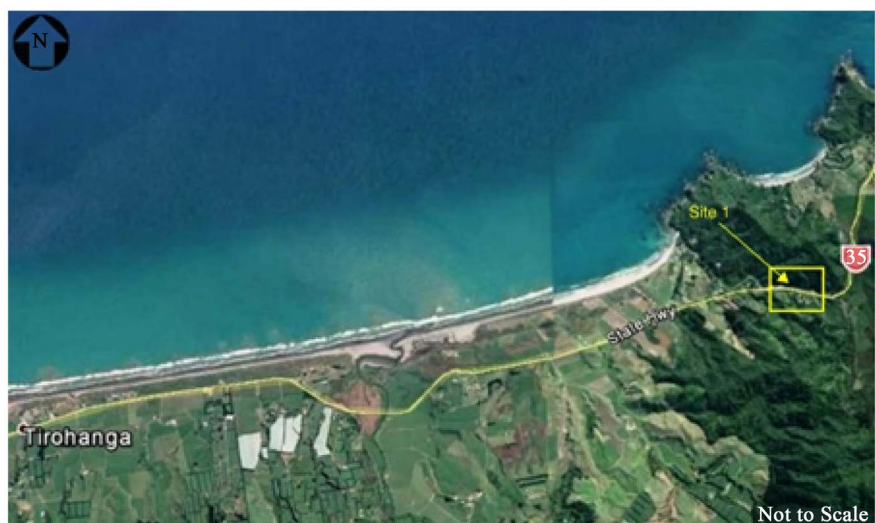
Figure 2. Site 1 location (©Google Map 2018).

Site 1 is an under slip located at circa 7.7 km East of Tirohanga (Figure 2). The first slip developed in 2016. The most recent slip surface occurred in early September 2018 (Figure 3). The scar is 6 - 7 m high and 13 m wide with a crown that is 0.85 m away from the edge line. The pavement has been undercut so that it is currently overhanging, (i.e. the slip surface is under the road surface). The slope is made of silty clayey sand with an occasional gravel from the Quaternary terrace deposit. Spring water is also present on the slipping surface.

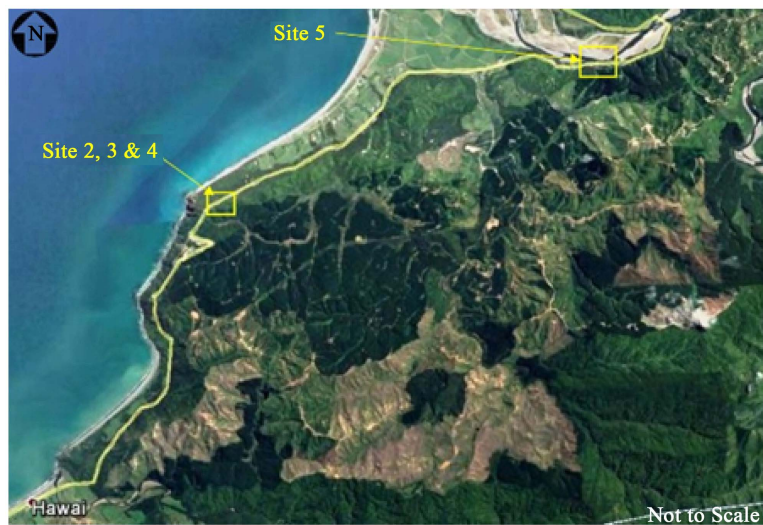
Figure 4. Sites 2 to 5 (©Google Map 2018).

Sites 2, 3, and 4 are located at approximately 5.5 km NNE of Hawaii (Figure 4).

Site 2 under slip occurred in mid-July 2018 (Figure 4) along the white edge line of the carriageway (Figure 5). The width is approximately 35 m. Tension cracks measure up to 100 mm wide with vertical displacements below 80 mm in length. Based on the scouring on greywacke at the cut slope above the carriageway at road level, it is concluded that the slump area was likely within the water runoff flow path. There were visible signs of erosion at the base of the cut slope.

Close to the Site 2 under slip, other failures were recorded at the same time of the year between 500 m and 6 km away from the previous under slip (Figure 4).

Site 3 under slip measures 12 m wide with 2 m long tension cracks located 1.1 m away from the road edge line. The slip affected only the top 6 m of the slope as debris was likely stopped by the thick vegetation present below.

Site 4 over slip released a fair amount of debris estimated to be between 400 to 500 m³. The geometry follows what appears to be a wedge feature within the residual soil. Spring water was still present at the base of the gully (Figure 6).

Site 5 over slip is located approximately 9.5 km NNE of Hawai and measures 22 m in height and 10 - 12 m in width. Debris is mostly residual soil that overlies a heavy folded greywacke. The total debris is estimated to be approximately 200 m³. Some blocks are overhanging and still pose a hazard to the corridor and traffic.

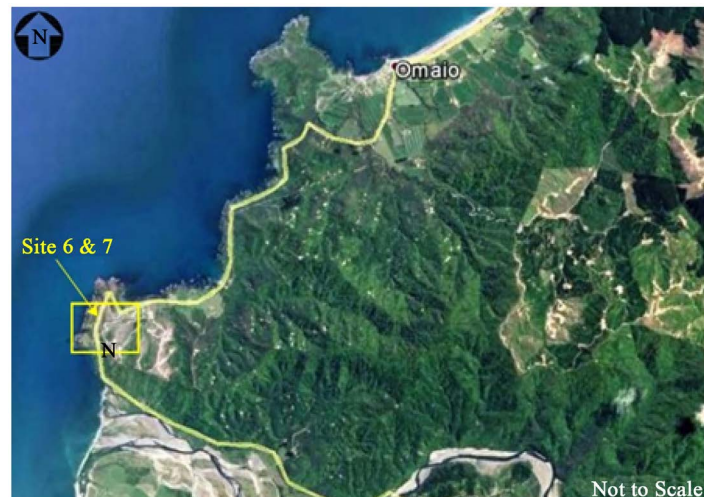
Figure 7. Sites 6 & 7 (©Google Map 2018).

Site 6 slip is located approximately 4.5 km of Omaio (Figure 7). The occurrence was at the end of August 2018. The scarp measures 13 m in width and 10 - 12 m in height. The failure surface slopes at 75° in the upper portion and, at the base, it is almost vertical. The debris is almost entirely residual soil from completely weathered greywacke. No rocks are present within the soil matrix. Tension cracks are visible at approximately 1.7 m from the center line and 1.1 m from the crown.

Site 7 slip is located 500 m north of Site 6. It occurred early September 2018 (Figure 7). The area affected by the slope failure measures 15 m in height and 50 m in width and consists of multiple semi-rotational slips. Most of the displaced material is still intact; it did not turn into loose material. The material consists of loose to medium dense clayey silty fine sand, being dark yellowish orange in color. Adjacent land use consists of forestry. The area located immediately up-slope appears to have been recently harvested. As the vegetation was still developing, the shallow soils were likely reworked and left loose undermining the stability of the overall slope.

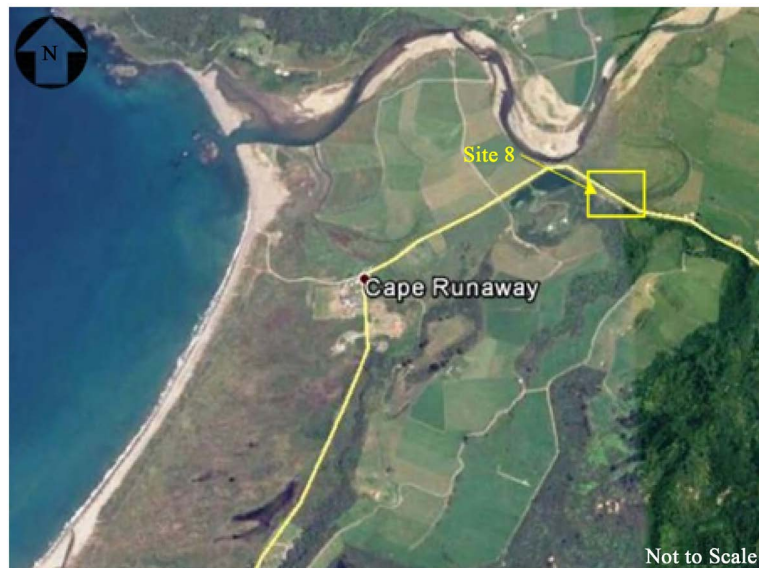
Figure 8. Site 8 (©Google Map 2018).

On June 20th, 2018, an earthquake of 4.7 m centered 4 km deep and approximately 35 km southwest of the current rock fall location was recorded. The seismic event may have damaged the already marginally stable site and pushed it close to failure.

One month later, the heavy rain has triggered the rock fall which affected an area 30 m wide by 20 m high located approximately 1 km East of Cape Runaway (Figure 8). The geology of the area shows the failing slope is made of weak to moderately strong sandstone with local tuff beds and marine sandy cemented deposits (Figure 9). Jointing daylight on the road are at an angle of 45°. Bedding plane appears to dip gently back into the slope. Sub-vertical cracks have been identified at the time of failure, and these were likely responsible for the rock fall.
