Assessment of the Current State of Qanibay al-Rammah Complex (908 AH/1502 AD), as a Procedure Precedes the Restoration Process

Essam H. Mohamed

Archaeological Conservation Department, Faculty of Archaeology, South Valley University, Qena, Egypt
Email: essam.mohamed@arch.svu.edu.eg

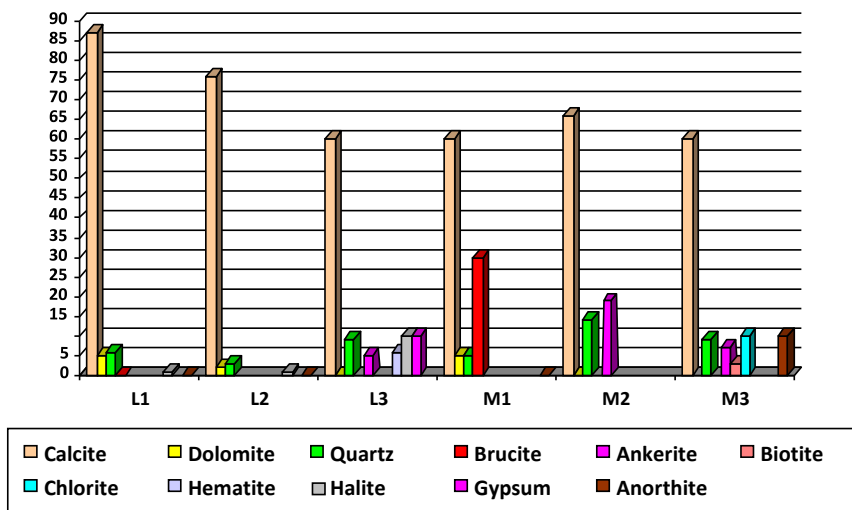
The limestone samples (L1 to L3) were investigated by XRD to determine the different mineral components of samples. All results are shown in (**Table 2**) and (**Figure 7** and **Figure 8**), the results of the study show that the deteriorated limestone samples mainly consists of calcite (CaCO_3), dolomite ($\text{Ca, Mg}(\text{CO}_3)_2$), in addition to quartz (SiO_2), ankerite ($\text{Ca}(\text{Fe, Mg, Mn})(\text{CO}_3)_2$), as a minor minerals and halite (NaCl), gypsum ($\text{CaSO}_4 \cdot 2\text{H}_2\text{O}$), hematite (Fe_2O_3) as impurities.

Figure 7. Comparison of X-ray diffraction analysis results of limestone and marble samples.

Through results of XRD analysis of limestone samples we observed that the limestone used in the building contains many of the products of damage such as gypsum due to interaction of air pollution gases with limestone components, presence of halite salts due to effect of contaminated ground water, when a large amount of this salt is presented in stone's pores physiochemical effects on building materials occur, in addition to presence of iron oxides which are facilitated weathering of building materials of Qanibay al-Rammah madrasa, resulted to presence several deterioration aspects on stone surfaces such as, roughening, relief, calcined salts, and hard black crust due to effect of air pollution, in addition to granular disintegration into grains, loss of stone materials, peeling, exfoliation, and bleeding of stone.

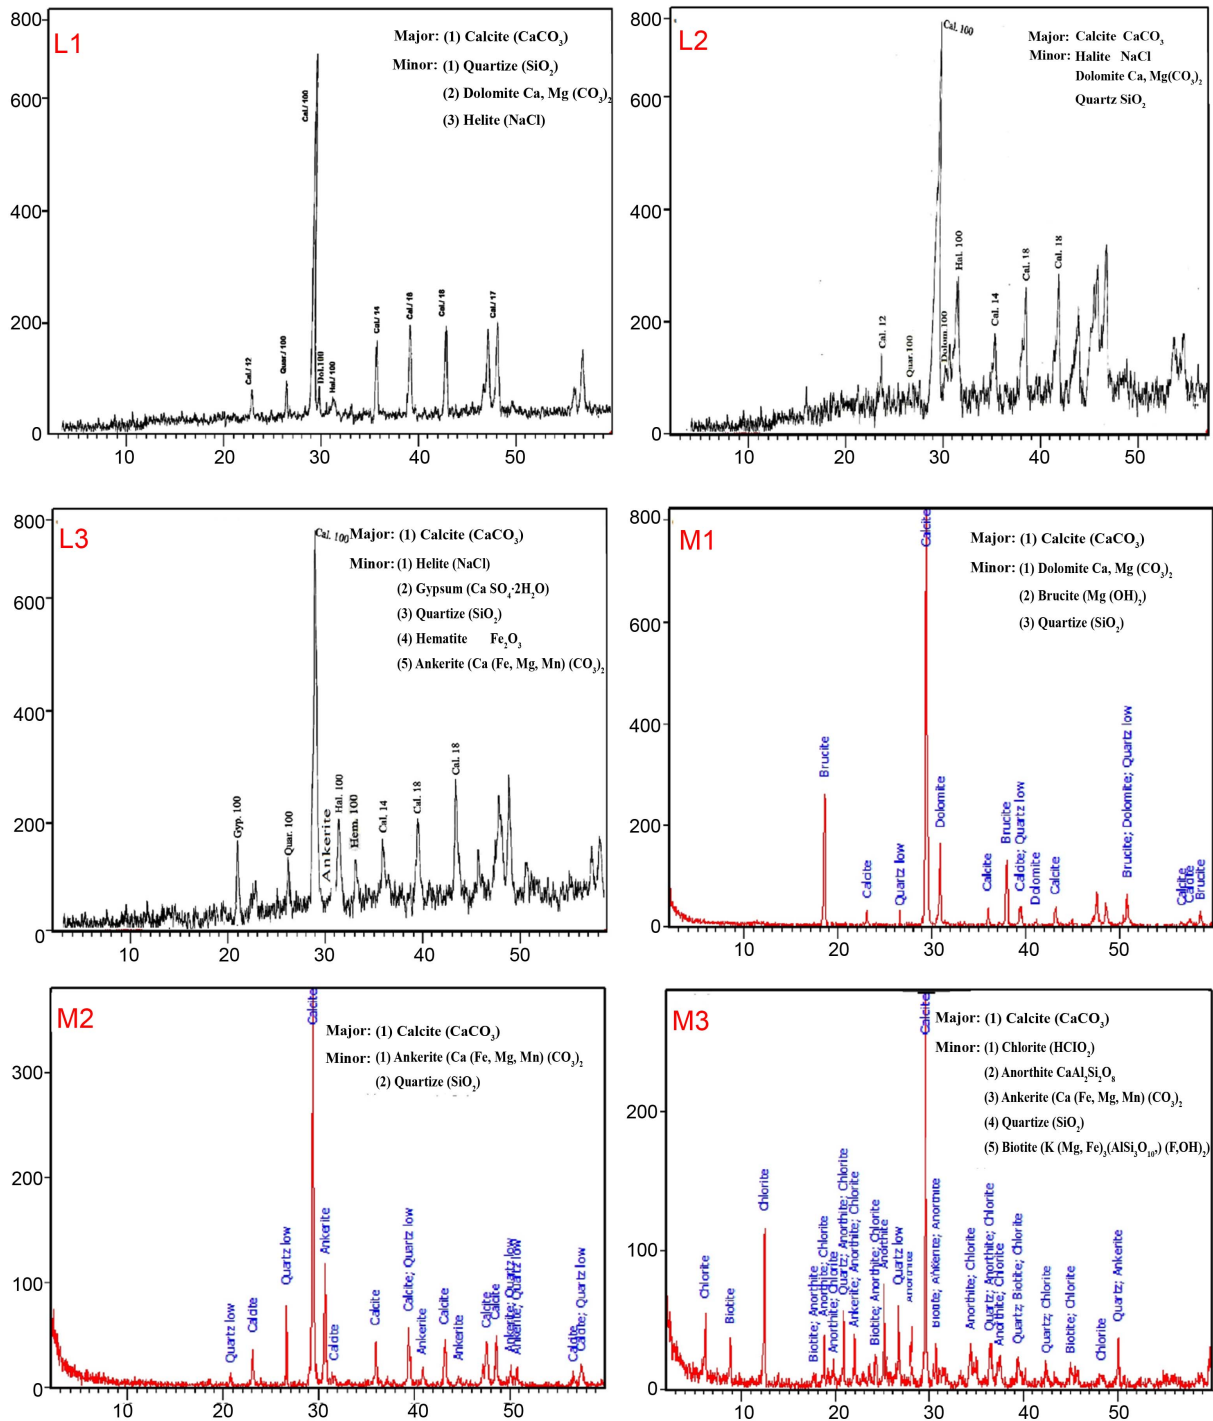
Figure 8. X-ray diffraction patterns of limestone and marble samples.

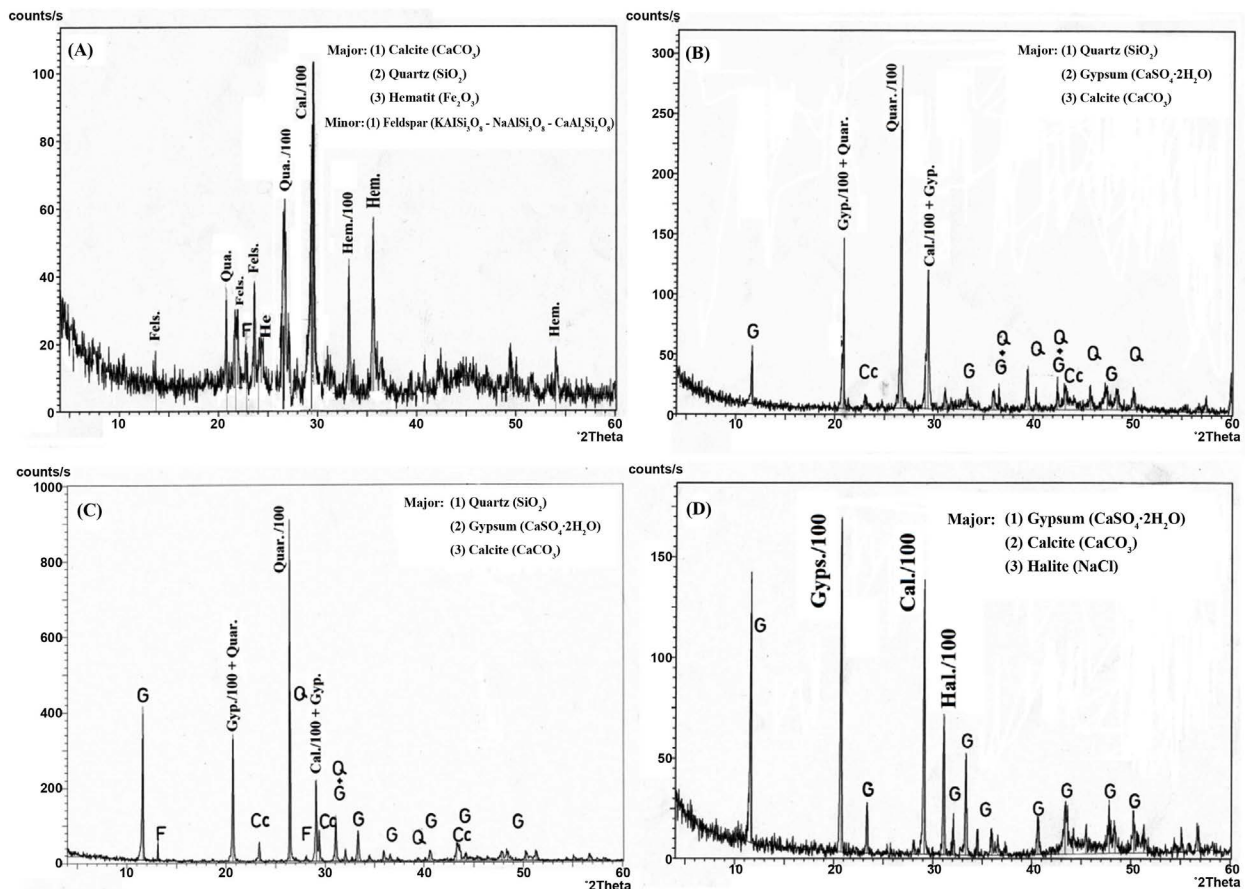
X-ray diffraction patterns of mortars samples revealed that the lime mortar mainly consist of calcite, quartzite, hematite and feldspar, where presence of hematite and feldspar indicate on use of red brick powder between the components of the lime mortar. Investigated gypsum mortar by XRD showed it consist of quartzite and gypsum as major minerals, in addition to minor minerals of calcite (**Figure 10** and **Table 5**).

Figure 10. X-ray diffraction patterns of (lime (A, D)—Gypsum (B, C)) mortars samples.
