Effect of Low Velocity Impact Damage on Buckling Properties

The work described herein consists of experimental measurement of the post-impact buckling loads of E-glass/epoxy laminates. Composite samples with stacking sequence of $[+45/-45/90/0]_{2s}$ were subjected to low-velocity impact loading at energy levels of 36, 56.13, 79.95, 110.31 and 144 J. The impact tests were conducted with a specially developed vertical drop weight testing machine. Impact parameters like peak load, absorbed energy, deflection at peak load and damage area were evaluated and compared. Damaged specimens were subjected to compressive axial forces and buckling loads of the specimens were obtained. The relation between energy levels and buckling loads is investigated.

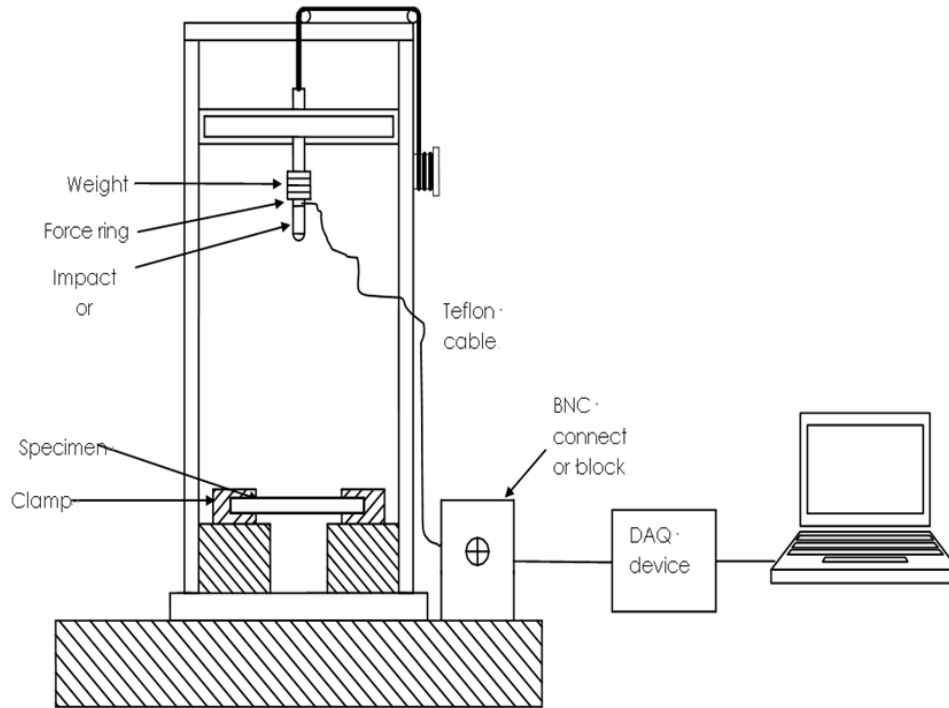
Figure 1. A schematic of drop tower impact machine.

The impact equipment was used to conduct the low velocity impact tests. Figure 1 shows the rig used in this investigation.

Different energy levels can be applied to the clamped specimen by using the impact machine. This machine has three main parts; a drop weight tower, a base plate which holds the specimen and a control unit housing. When the weight released the cylindrical impactor with a hemispherical head (Figure 2) strikes the specimen, the data is recorded by the computer.

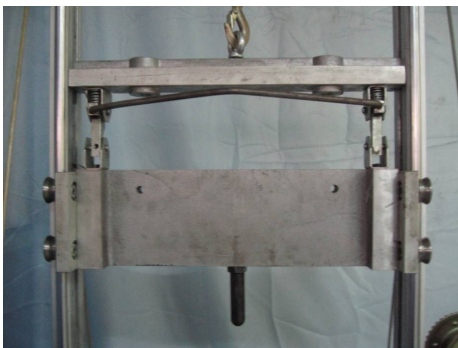
Figure 2. The weight and the impactor head.

The specimens were firmly fixed at all edges using clamps and were impacted producing damage up to perforation. The total mass, including impactor, load cell, carriage with linear roller bearings and add-on weights, was 18 kg. Five different energy levels were used for each panel configuration 36, 56.13, 79.95, 110.31 and 144 J to obtain 2.0, 2.5, 3.0, 3.5 and 4.0 m/s impact velocities, respectively. A sophisticated instrumentation is used to record the impact event.

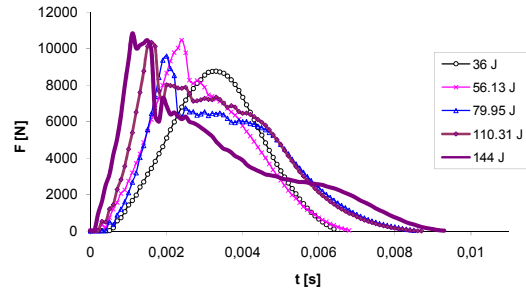
Figure 3. Impact force versus time for 36, 56.13, 79.95, 110.31 and 144 J.

Specimens were tested under five energy levels 36.00, 56.13, 79.95, 110.31 and 144 J. It was observed that the average peak load (Figure 3) at which the specimens failed is 8.758 kN at 36 J, 10.47 kN at 56.13 J, 9.58 kN at 79.95 J, 10.12 kN at 110.31 J and 10.83 kN at 144 J. This shows that there was an increase in the peak load as the energy levels were increased but at 79.95 J there is a drop in force because of the beginning of the perforation. The absorbed energy at 36.00, 56.13, 79.95, 110.31 and 144 J was 25.4, 45.8, 76.7, 105.9 and 141.9 J respectively. Absorbed energy is the energy at the peak load deducted from the total energy. As the composite materials are generally brittle in nature, it is assumed here that the energy up to the peak load is absorbed through elastic deformation and all the energy that is absorbed beyond that is assumed to be absorbed through the creation of damages.

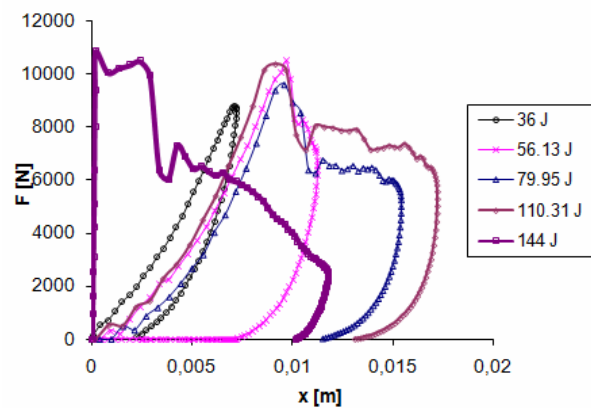
Figure 4. Impact force versus indentation for 36, 56.13, 79.95, 110.31 and 144 J.

Figure 4 shows the relation between the instant impact force (F) and deflection of the specimen (x). The work done on the sample was calculated from the area under the force- displacement curve. Deflection at peak load for 36, 56.13, 79.95, 110.31 and 144 J is 7.11, 9.67, 9.56, 9.12 and 0.22 mm, respectively. After the beginning of the perforation (at 79.95 J) the deflection decreases. Because some of the energy is used to perforate the laminate.

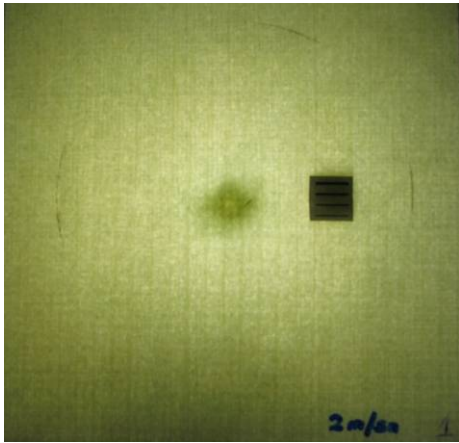
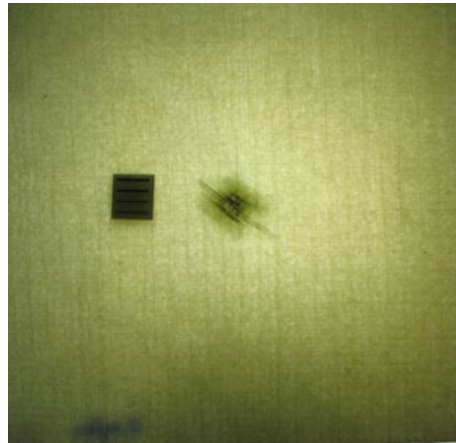
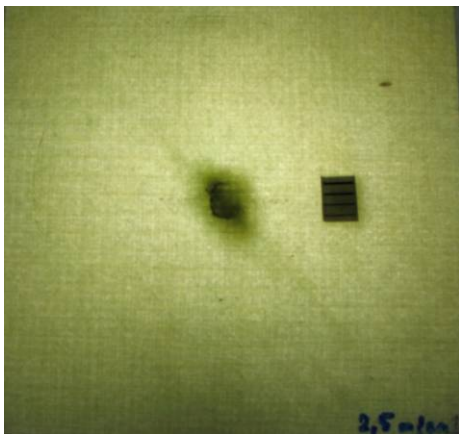
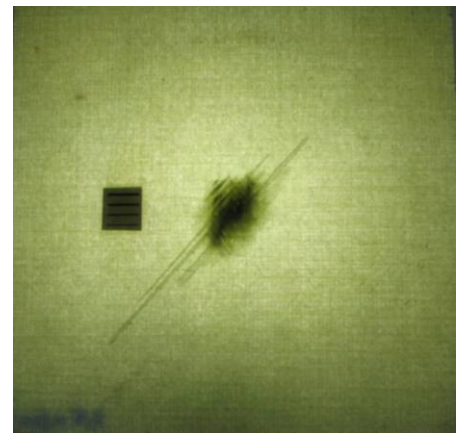
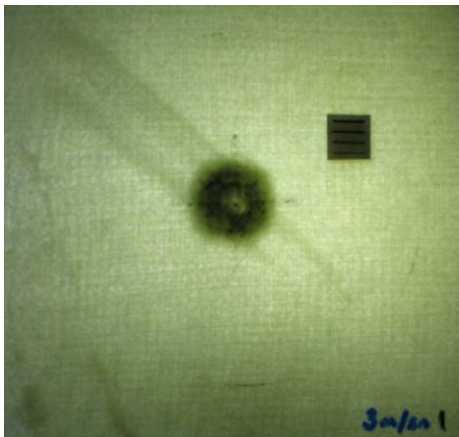
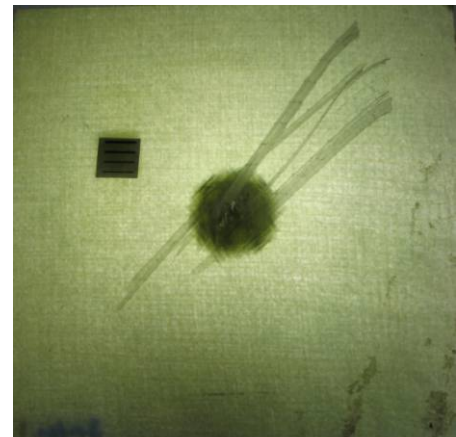
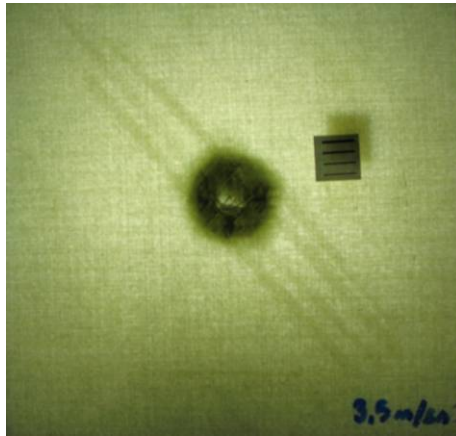
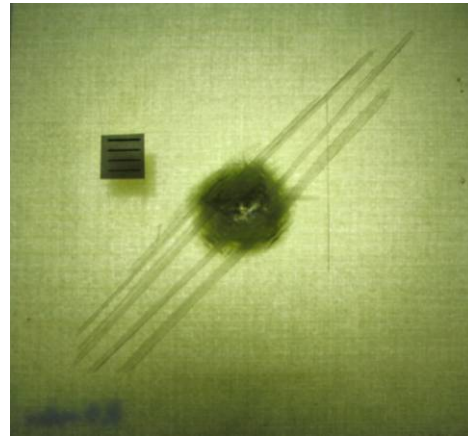
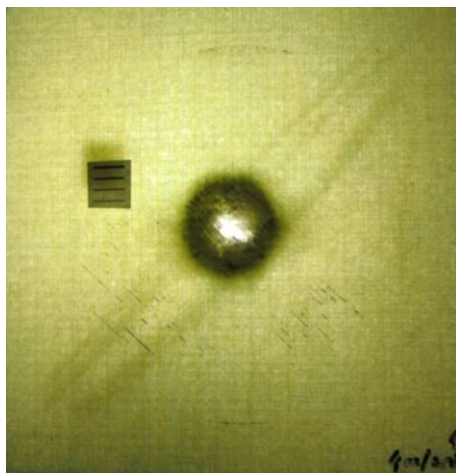
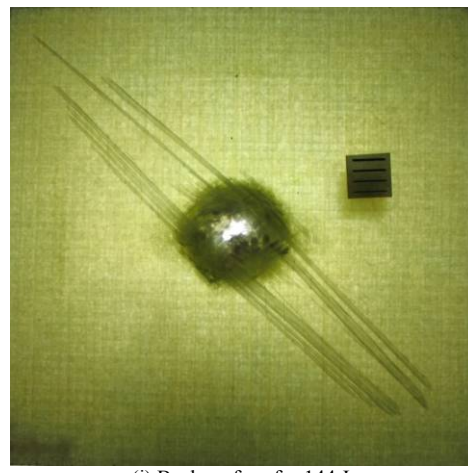
(a) Front surface for 36 J.

(b) Back surface for 36 J.

(c) Front surface for 56.13 J.

(d) Back surface for 56.13 J.

(e) Front surface for 79.95 J.

(f) Back surface for 79.95 J.

(g) Front surface for 110.31 J.

(h) Back surface for 110.31 J.

(i) Front surface for 144 J.

(j) Back surface for 144 J.

Figure 5. Damage areas of impacted specimen.**Table 2. Buckling load for 36, 56.13, 79.95, 110.31 and 144J.**

The impact energy is defined as a sum of absorbed and rebound energies. Matrix cracking, delamination and fiber breakage is caused by this absorbed energy. The damage areas of the specimens for 36, 56.13, 79.95,

110.31 and 144 J are 278, 499.19, 683.75, 655.24 and 558 mm² (Figure 5). It is seen that the damage area is increasing by increasing the energy level until the perforation starts. After the perforation by increasing the energy level the damage area is decreasing. Because at this stage absorbed energy is used for fiber breakage. Figure 5 also shows front and back surface of the laminates. Because of the moment, on the back surface tensile and on the front surface compressive stress is taken place. On the back surface of the laminates diagonal debonding is greater than the front surface.
