Experiment and Simulation of Earthen Embankment Breach

Abstract

2.1. Experiment Setup

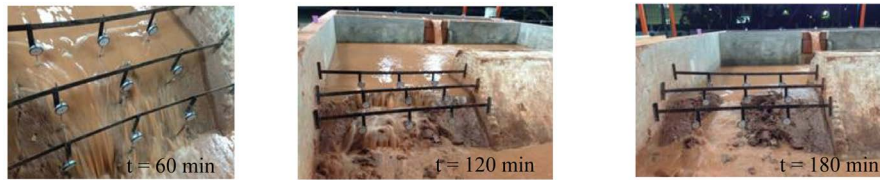
Figure 2. The failure characteristics of the earthen embankment; overtopping case (at $Q = 16.84$ l/s).

The first surface erosion started to form a few minutes after the initial overtopping of the embankment. Almost simultaneously another larger head cut started to form at approximately mid-height of the embankment slope. The surface erosion characteristics observed in this case were more of detachment of lumped material than of individual particle detachment. This head cut was wider than the one at the toe and deepened vertically. Other smaller head cuts were also observed. As time progressed, predominant water path in the middle of the embankment was observed. The development of breach depth is presented in **Figure 2** and **Figure 3**. The embankment breach cross-section may be an approximate trapezoid. The data resembles an exponential curve. Once it reached the lower elevation, the breach widened and the material was eroded from the sides and from the upstream side. The breach remained stable after 130 minutes, the maximum breach depth and width were 0.26 and 1.12 m, respectively. Most of the time the flow remained attached to the head cut wall, except when mass erosion of the vertical wall became imminent. **Figure 4** shows the time series of embankment erosion width, depth, and volume of soil. The water in the testing channel was gradually drained out through the circulated channel until it was dry. The breached channel dimensions and the scour and deposition profile on the embankment foundation on the downstream side were measured in details.

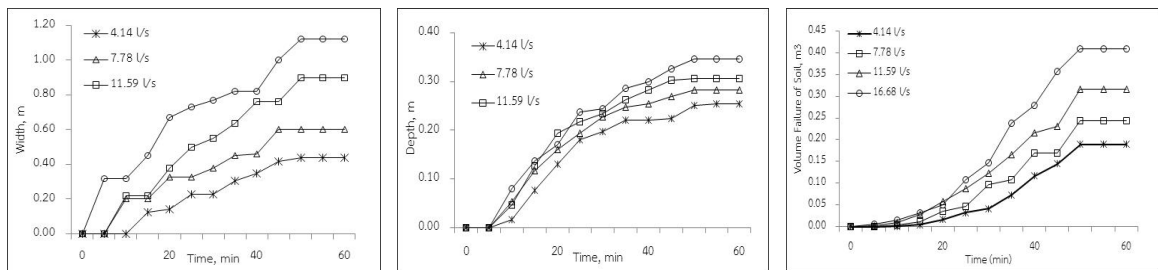
Figure 4. Time series of embankment erosion width, depth, and volume of soil of overtopping case.

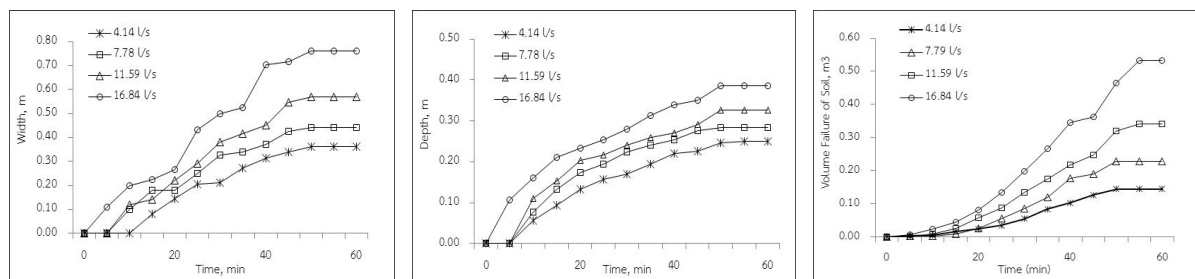
Figure 7. Time series of embankment erosion width, depth, and volume of soil of; beneath structure case.

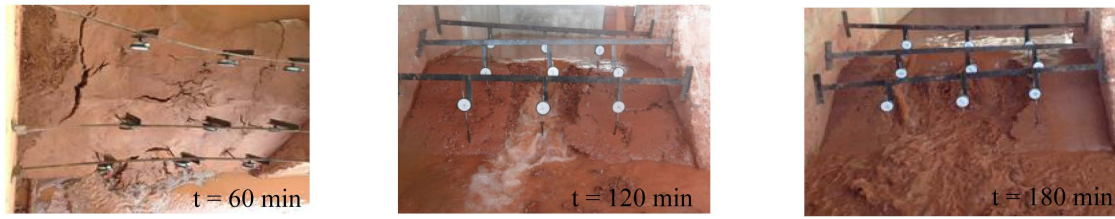
Figure 8. The failure characteristics of the earthen embankment; piping hole case (at $Q = 16.84$ l/s).

the embankment crest. The lumped material simultaneously dropped, another larger head cut started to form at approximately mid-height of the embankment slope. The surface erosion characteristics were observed in this case. The development of breach depth is presented in **Figures 8-10**. The breach remained stable after 130 minutes, the maximum breach depth and width were 1.34 and 0.26 m. Excessive foundation seepage through permeable substrata is often accompanied by the formation of sand boils, which often look like miniature volcanoes ejecting water and sediment, and may result in piping failure if not controlled. High uplift pressure and saturation of foundation materials may give rise to slope instability and sliding failure. The piping failures caused by

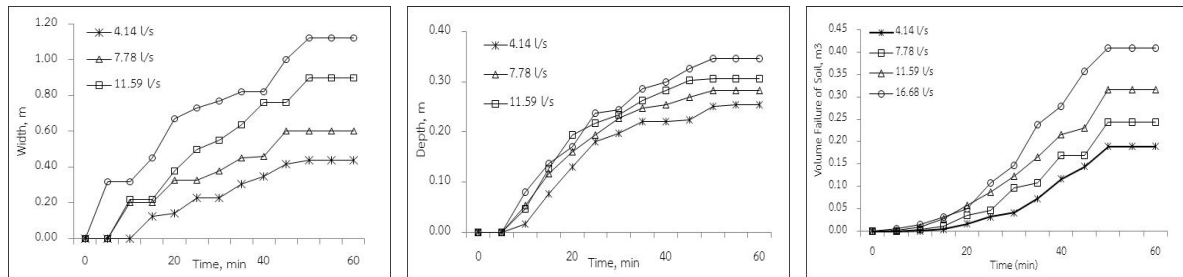
Figure 10. Time series of embankment erosion width, depth, and volume of soil; piping hole case.
