Effect of Repainting Process on Atmospheric Corrosion Behavior of Perforated Panels

In this study, we investigated the effects of the repainting process on the corrosion behavior of perforated panels.

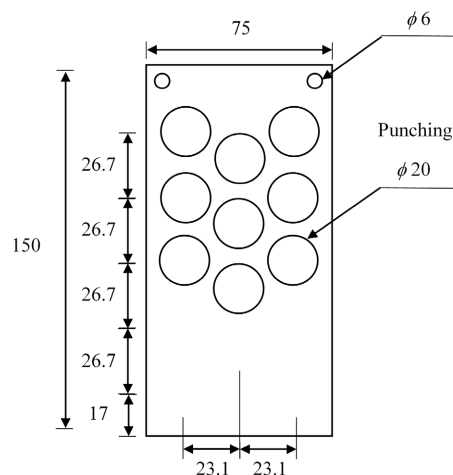
The specimens were perforated Steel Plate Cold Commercial (SPCC) sheets with a diameter of 20 mm, which were pretreated by salt spraying, blasting, zinc phosphate treatment, and painting to reproduce the repainting process (Figure 1). The salt-sprayed specimens were used as rust specimens and the as-received specimens were used as new specimens. The unprocessed general area was referred to as the flat area, the perforated section as the whole area, and the perforated corner as the edge area. The painting thickness of the flat part was set to 60 μm using a thickness meter (DUALSCOPE MP0R; Kett Scientific Laboratory, Tokyo, Japan), and the time until painting was set to 4 or 48 hours. Specimens were sprayed with salt water (5% NaCl aqueous solution) for 1600 hours at a temperature of $35^\circ\text{C} \pm 1^\circ\text{C}$, and white alumina grids with grain sizes of 850 - 1180 μm (hereafter referred to as #20) and 600 - 850 μm (hereafter referred to as #24) blended at a ratio of #20: #24 = 1:3 were blasted at 0.4 MPa. Table 1

Figure 1. Geometry of the specimens (mm).

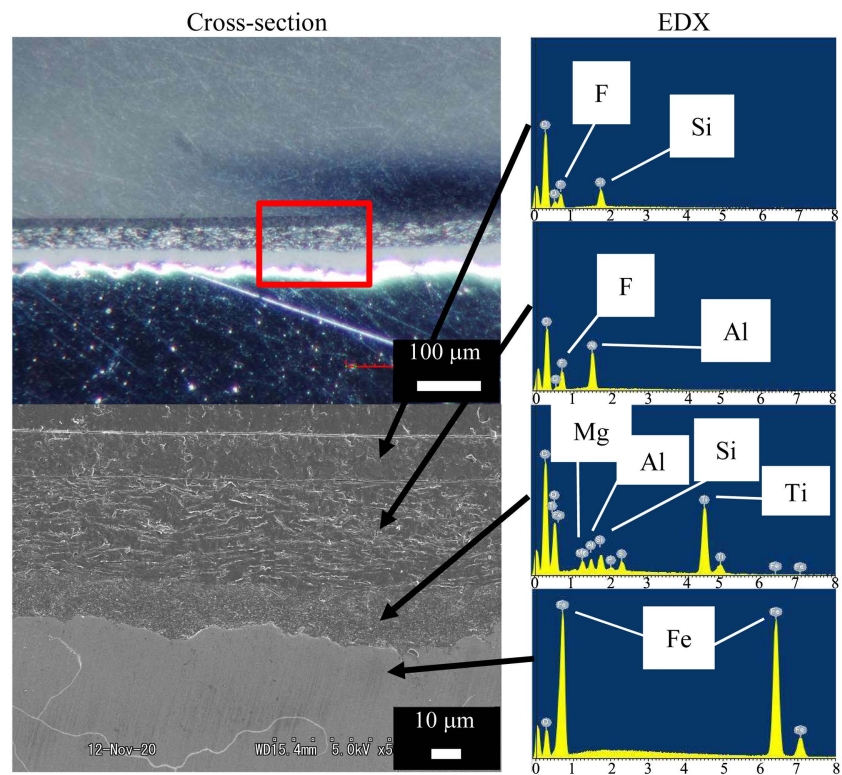
Figure 3 shows the results of SEM and EDX analysis of the cross-section of No. 1. From the observations of cross-sections, it was confirmed that the coating

Figure 3. Observation of cross-sections and EDX analysis.

film had a three-layer structure. The first layer on the base iron was white layer composed mainly of Ti about 20 mm thick that was not uniform due to the unevenness of the base metal surface caused by blasting. The second layer was a silvery-white layer composed of Al and F. There were horizontal streaks on the base material in the layer. The third layer, which was in contact with the outside

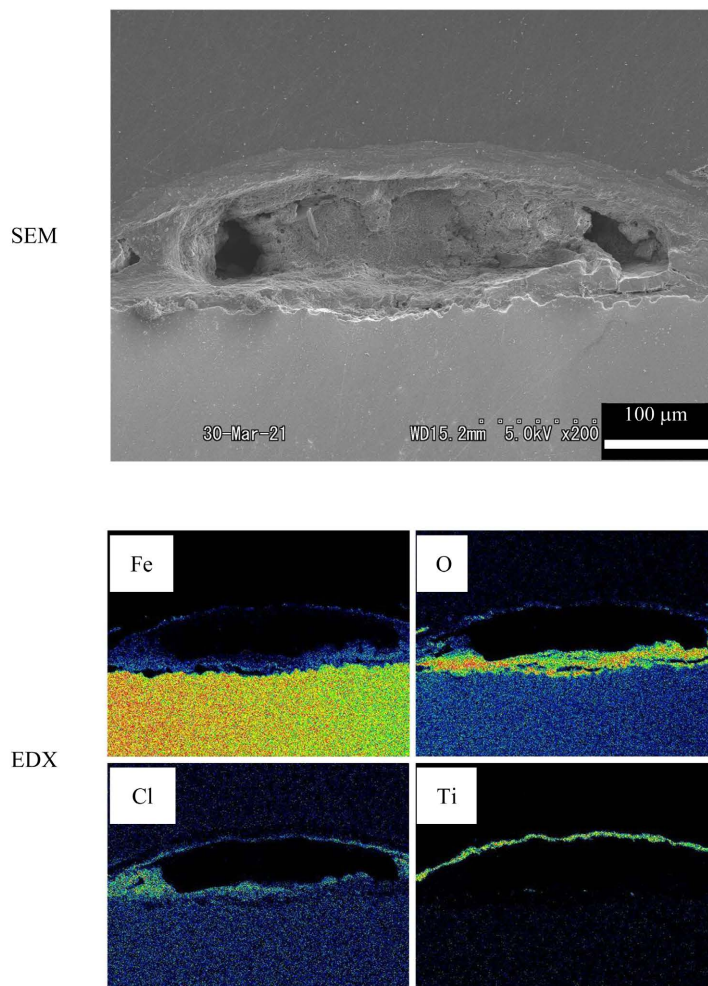
Figure 5. Results of EDX analysis of a cross-section of No. 4 after 2 months.
