Esthetic and Functional Rehabilitation of Amelogenesis Imperfecta: Report of Four Cases with a One-Year Follow-Up

In this report, we describe the performance of a conservative and minimally invasive dental approach in four patients exhibiting Amelogenesis Imperfecta (AI), a structural anomaly of the enamel. In each patient, approximately 0.5 mm of the most external, porous, and colored enamel layer was removed, and the teeth were restored using two different nanocomposites. Posterior restorations were completed with the same approach. As a result, this contemporary restorative system is a conservative and successful treatment option to restore the loss of oral esthetics and function due to AI. Rehabilitation with direct resin restorations is not only an inexpensive treatment choice, but also a more conservative technique that reduces the amount of preparation required for teeth that are already compromised.

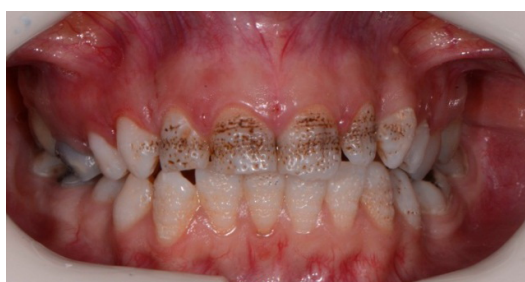
Case 1 had been treated previously with amalgam restorations on teeth 16, 17, 27, 37, 46, and 47 (**Figure 1**). All old amalgam restorations were replaced with composites, and a root canal treatment was performed and fiber posts were placed on teeth 26 and 36. Tooth 45 was extracted because of its position out of the mandibular arch. The upper canine teeth and lower mandibular third molar teeth were determined to be embedded in bone, and required extraction. The erupted teeth, including the anterior and posterior regions, were of normal dimension and morphology. All teeth showed normal mesial and distal contact, normal occlusion, and a normal angle Class I dental relationship. Open bite and overjet were not observed between the mandible and maxilla. There was no occlusal tooth wear or fractured enamel. The patient's vertical dimension (the vertical distance between the

Figure 1. Clinical view at the first appointment for Case 1.

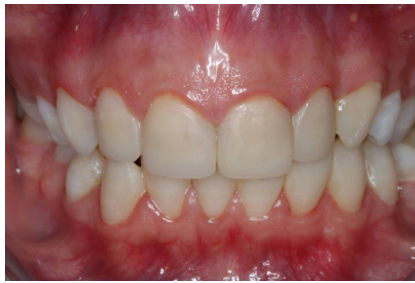
Figure 2. Intraoral view of composite laminate veneers on anterior teeth and class I, II, and III restorations on posterior teeth of Case 1. Teeth 11, 12, 14, 41, 42, and 43 were restored with Clearfil Majesty ES-2. Teeth 21, 22, 24, 31, 32, and 33 were restored with Filtek Ultimate Body.

A total-etch strategy using 37% phosphoric acid and bonding was applied according to the manufacturers' instruction (Table 2). After the bonding procedures, buccal/labial surfaces of upper and lower first premolars were covered with composite restorations by direct procedures. Accordingly, teeth 11, 12, 14, 41, 42, and 43 and posterior restorations of same region were constructed using Clearfil Universal Bond-Clearfil Majesty ES-2 (Figure 2). Left quadrants composite veneers at teeth 21, 22, 24, 31, 32, and 33 and posterior restorations were constructed using Single Bond Universal/Filtek Ultimate Body.

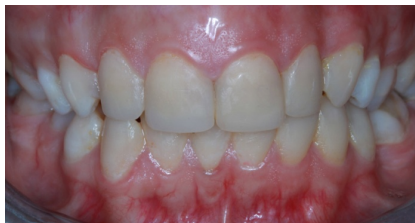
Figure 3. Clinical view of restorations after one year follow-up for Case 1.

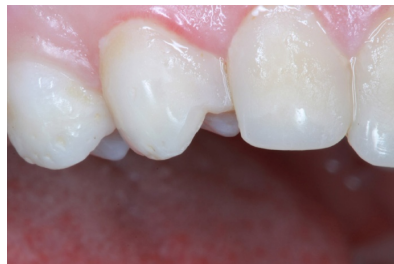
Each layer composite was cured for 20 s using an LED light curing unit (Elipar S10, 3 M, ESPE, St Paul MN, USA) having a minimal output of 1200 mW/cm². The light intensity output was monitored using a dental radiometer (Hilux Ledmax Light Curing Meter, Benlioğlu Dental Inc., Ankara, Turkey). Final counterering and finishing of the restorations were performed using polishing points (PoGo, Dentsply), flexible discs, and finishing strips (Sof-Lex, 3 M ESPE, St Paul MN, USA). Clinical view of restorations after one year is presented in Figure 3. Fracture was observed on right maxillary first premolar at the end of one year (Figure 4).

Figure 4. Fracture on right maxillary first premolar at the end of one year.

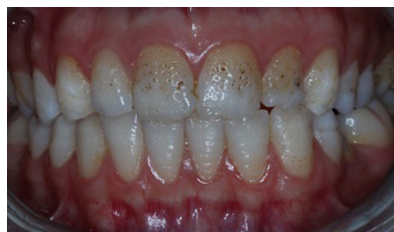
Case 2 was a 17-year-old female patient (D.Y.) with esthetic inadequacy of the anterior teeth. She had slightly yellowish/brown and stained, pitted, and hypoplastic enamel (Figure 5). The enamel appeared hard and shiny. The patient was the cousin of Case 1, and most enamel structure was similar to that of Case 1 with only low severity. There was no occlusal tooth wear, fractured enamel, or tooth sensitivity. Case 2 had small enamel and superficial dentin caries, and 2 old amalgam restorations on molar teeth 46 and 47. The erupted teeth, including the anterior and posterior region, were of normal dimension and morphology, and all teeth showed normal mesial and distal contact, normal occlusion, and normal angle Class I dental relationships. Open bite and overjet were not observed between the mandible and maxilla. The patient's vertical dimension was normal. Oral hygiene was good, and the gingival tissue was healthy (Figure 5).

Figure 5. Clinical view at the first appointment for Case 2.

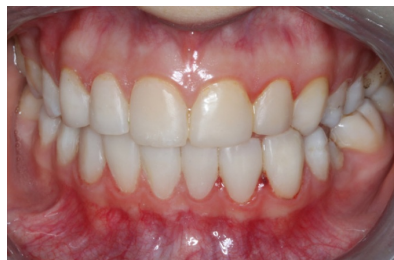
Figure 6. Intraoral view of composite laminate veneers on anterior teeth and class I restorations on posterior teeth of Case 2. Teeth 11, 12, 13, 41, 42, and 43 were restored with Clearfil Majesty ES-2. Teeth 21, 22, 23, 31, 32, and 33 were restored with Filtek ultimate body.

Composite veneers in the upper and lower right quadrants at teeth 11, 12, 13, 41, 42, and 43, and posterior restorations of same region were constructed using Clearfil Universal Bond-Clearfil Majesty ES-2 (Figure 6). Left quadrants composite veneers at teeth 21, 22, 23, 31, 32, and 33, and posterior restorations were constructed using Single Bond Universal/Filtek Ultimate Body (Figure 6). Resin composites were performed in the posterior area and freehand bonded composite restorations in the anterior area were performed as in Case 1. Clinical view of restorations after one year is presented in Figure 7. Fracture was observed on mandibular right lateral incisor at the end of one year (Figure 8).

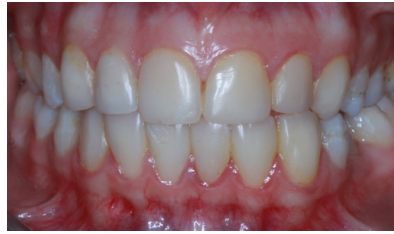
Figure 7. Clinical view of restorations after one year follow-up for Case 2.

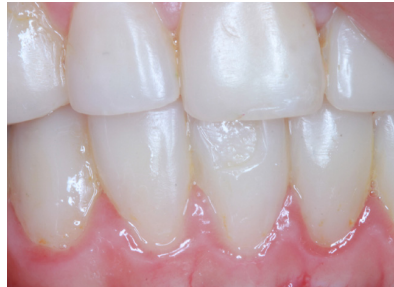
Figure 8. Fracture on mandibular right lateral incisor at the end of one year.

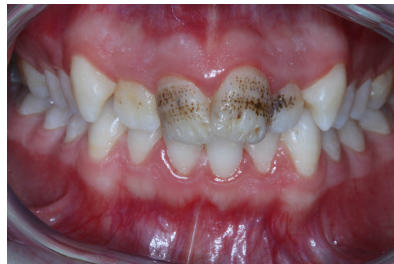
Case 3 was a 17-year-old female patient (G.Y.) who presented no abnormal medical history or systemic problems except for AI. She was a sister of Case 1. A diagnosis of hypoplastic AI was made as in Case 1. She had slightly yellowish/brown and stained, pitted, and hypoplastic enamel (Figure 9). The enamel appeared hard and shiny. There was no occlusal tooth wear, fractured enamel, or tooth sensitivity. The patient's vertical dimension was normal. Oral hygiene was good and the gingival tissue was healthy. Caries risk was assessed as a "low risk". Her primary concerns included esthetic failure of the upper anterior region teeth. No orthodontic treatment was performed because the patient refused to wear brackets.

Figure 9. Clinical view at the first appointment for Case 3.

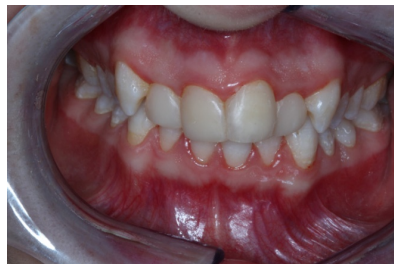
Figure 10. Intraoral view of composite laminate veneers on anterior teeth and class I restorations on posterior teeth of Case 3. Teeth 11 and 12 were restored with Clearfil Majesty ES-2. Teeth 21 and 22 were restored with Filtek ultimate body.

Case 3 had small enamel and superficial dentin caries on molar teeth. Composite veneers in upper right quadrants at teeth 11 and 12 and posterior restorations of same region were constructed using Clearfil Universal Bond-Clearfil Majesty ES-2 (Figure 10). Left quadrants composite veneers at teeth 21 and 22 and posterior restorations were constructed using Single Bond Universal/Filtek Ultimate Body. Conservative resin composites were performed in the posterior area and freehand bonded composite restorations in the anterior area were per-
